**ANNUAL CCR SURFACE IMPOUNDMENT
INSPECTION REPORT (per 40 CFR 257.83(b)(2))**

Power Station: Baldwin Energy Complex

CCR Impoundment: West Fly Ash Pond

Date of Inspection: 8/19/2016

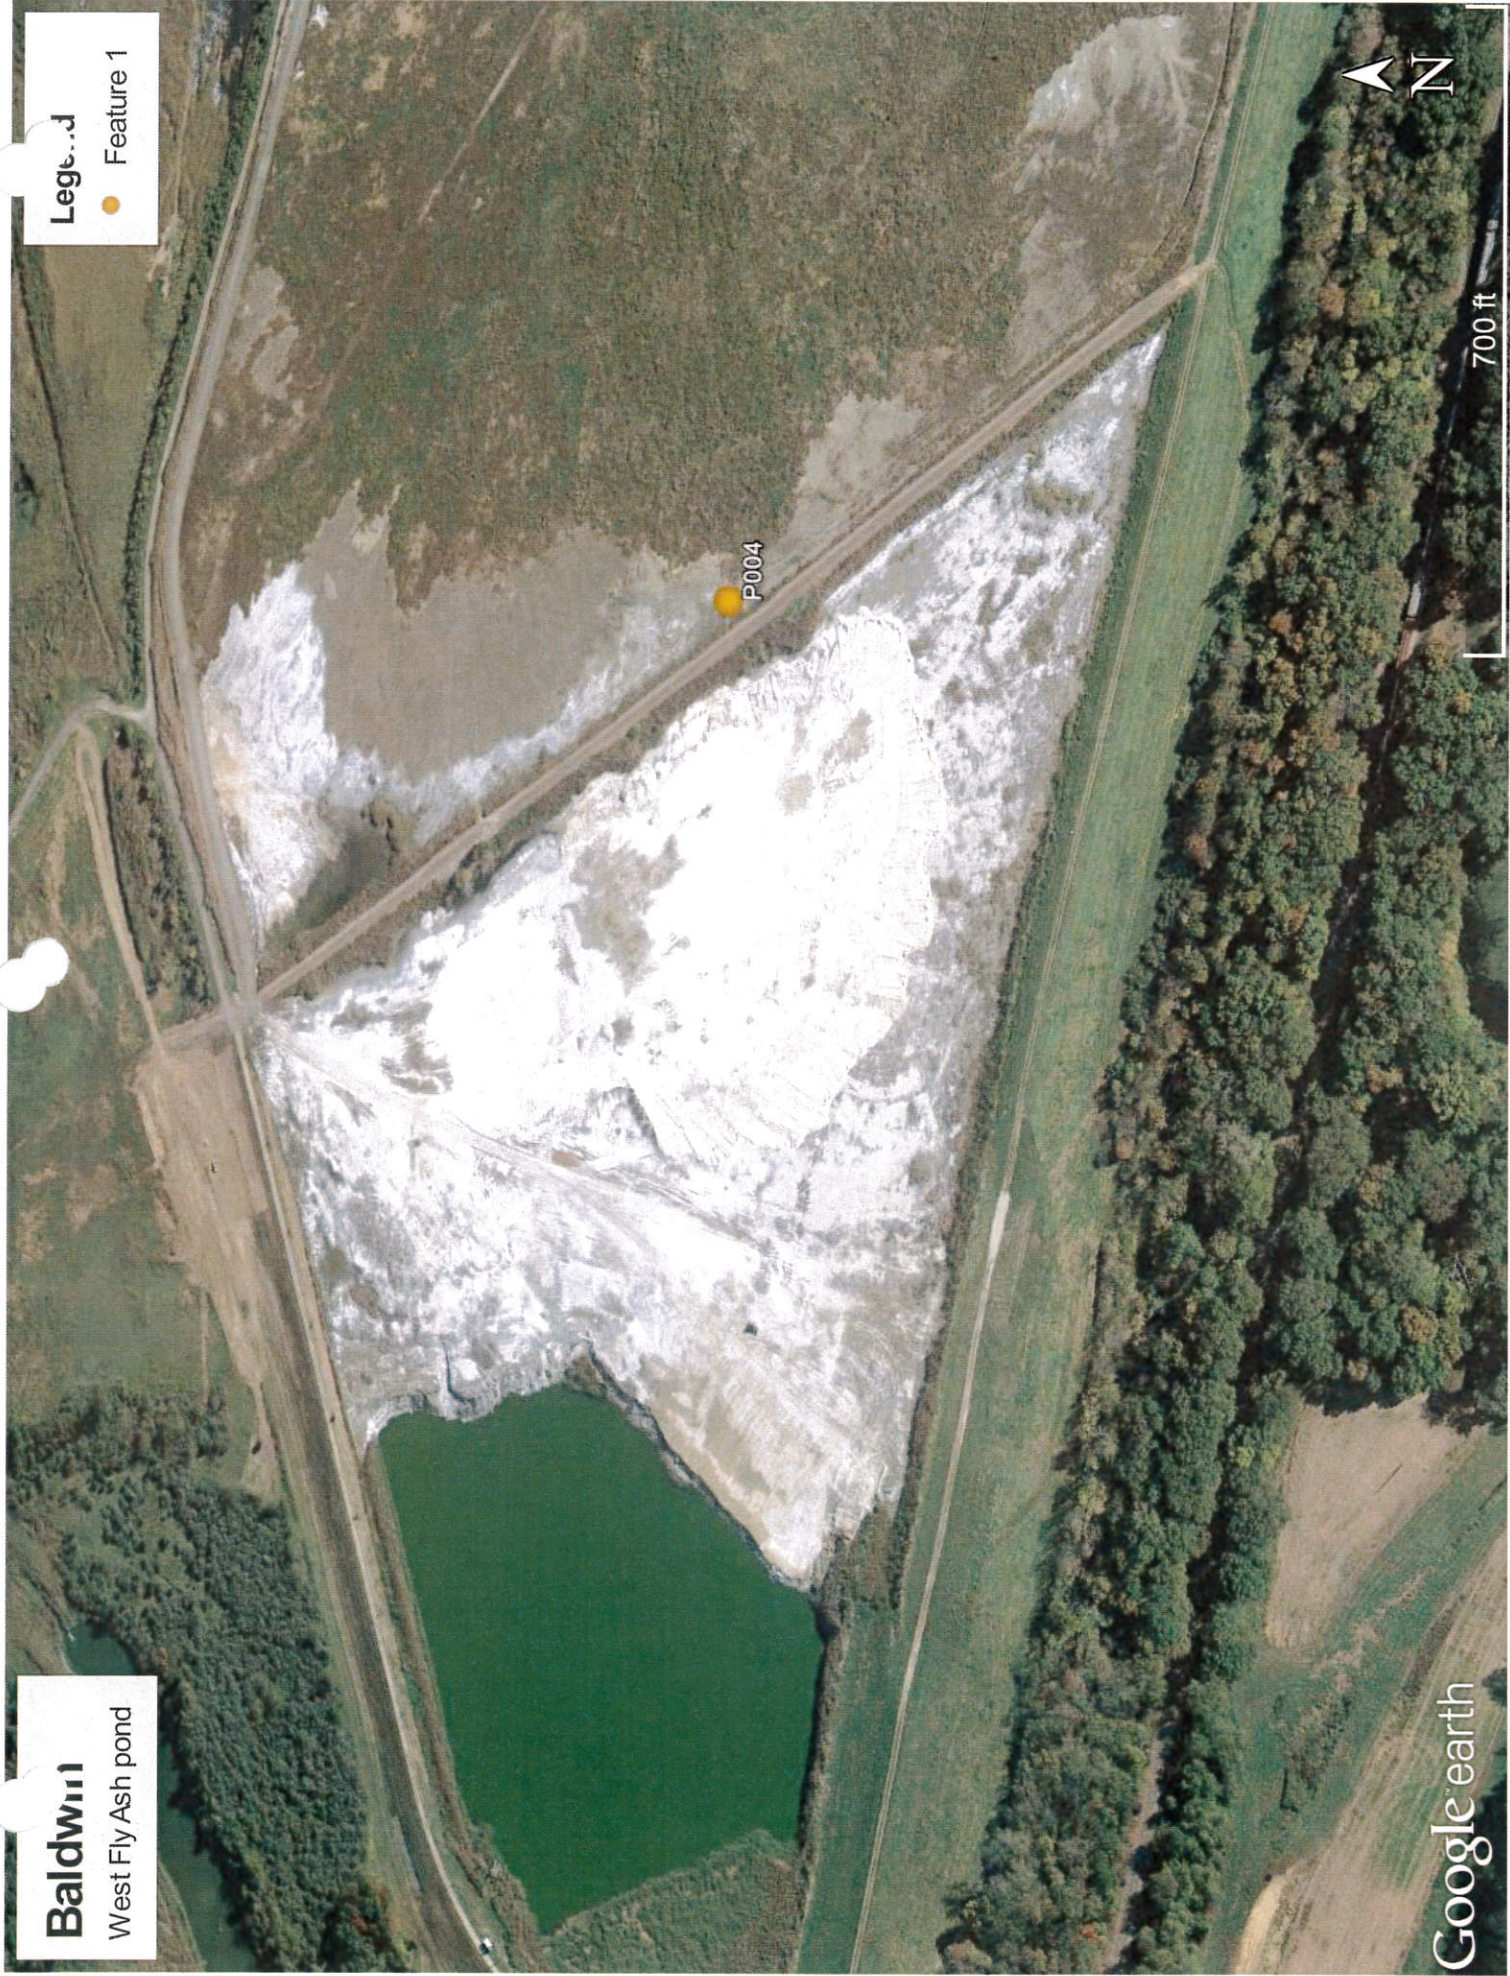
- ii) Instrumentation
 (Please see following page for instrumentation location map)

West Fly Ash pond

P004
