**ANNUAL CCR SURFACE IMPOUNDMENT
INSPECTION REPORT (per 40 CFR 257.83(b)(2))**

Power Station: Coffeen Power Station

CCR Impoundment: Ash Pond No. 2

Date of Inspection: 9/27/2016

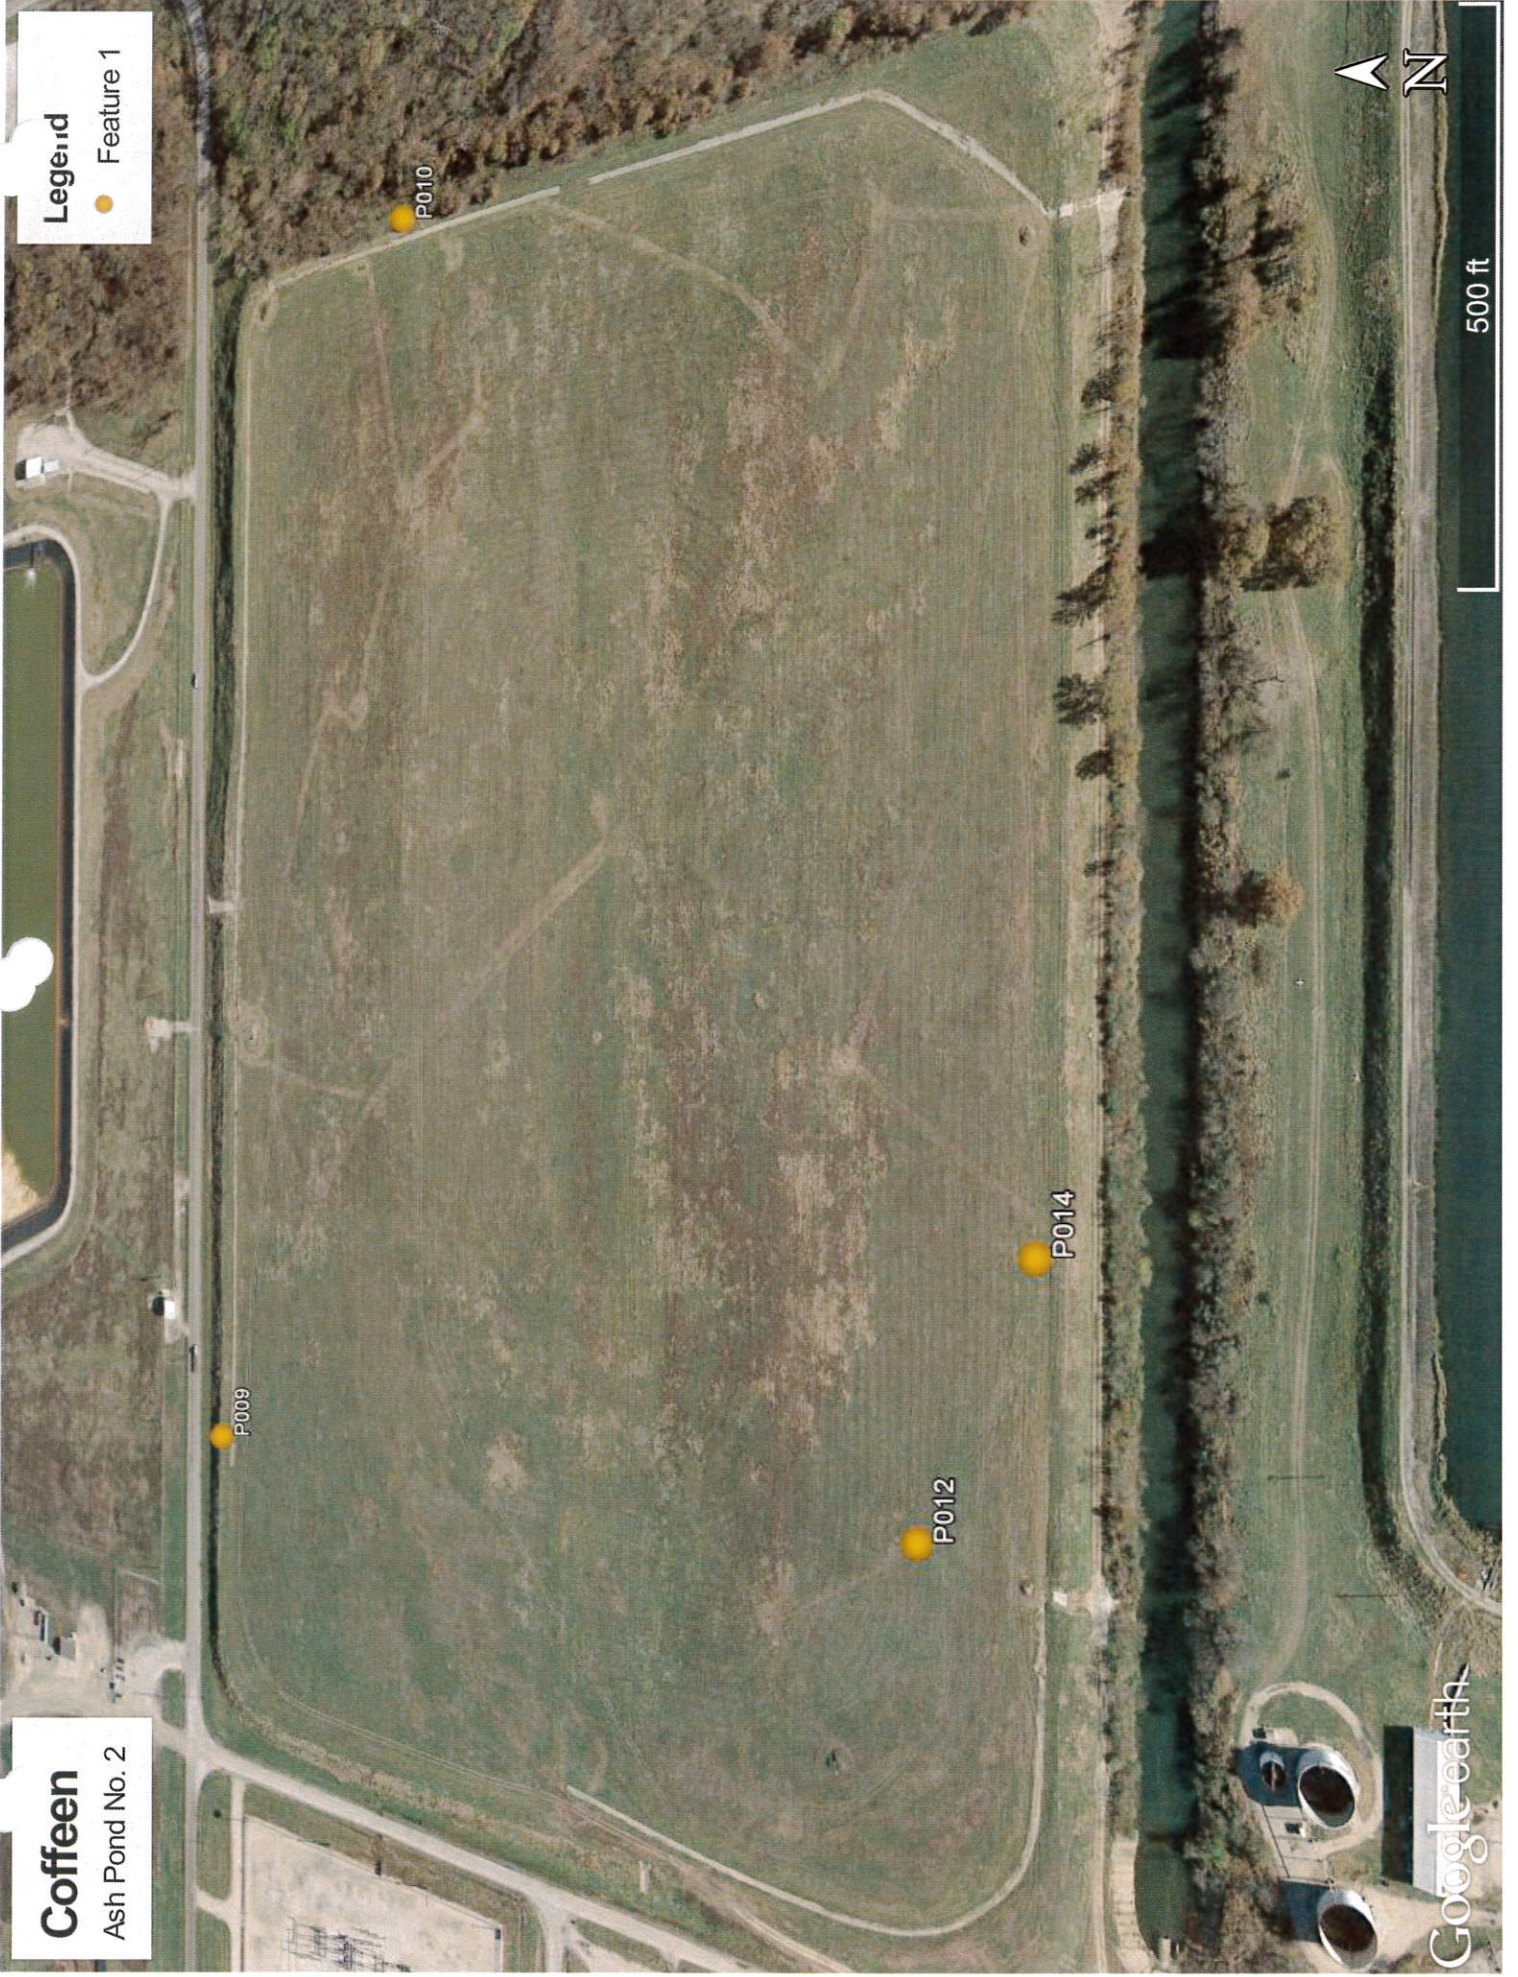
- ii) Instrumentation
 (Please see following page for instrumentation location map)
