DUCK CREEK POWER STATION
FULTON COUNTY, ILLINOIS

Emergency Action Plan (EAP)

**Coal Combustion Residual (CCR) Impoundments
& Related Facilities**

- Ash Pond No. 1 (NID # IL50715)
- Ash Pond No. 2 (NID # IL50014)
- Gypsum Management Facility (GMF) Pond (NID # IL50573)

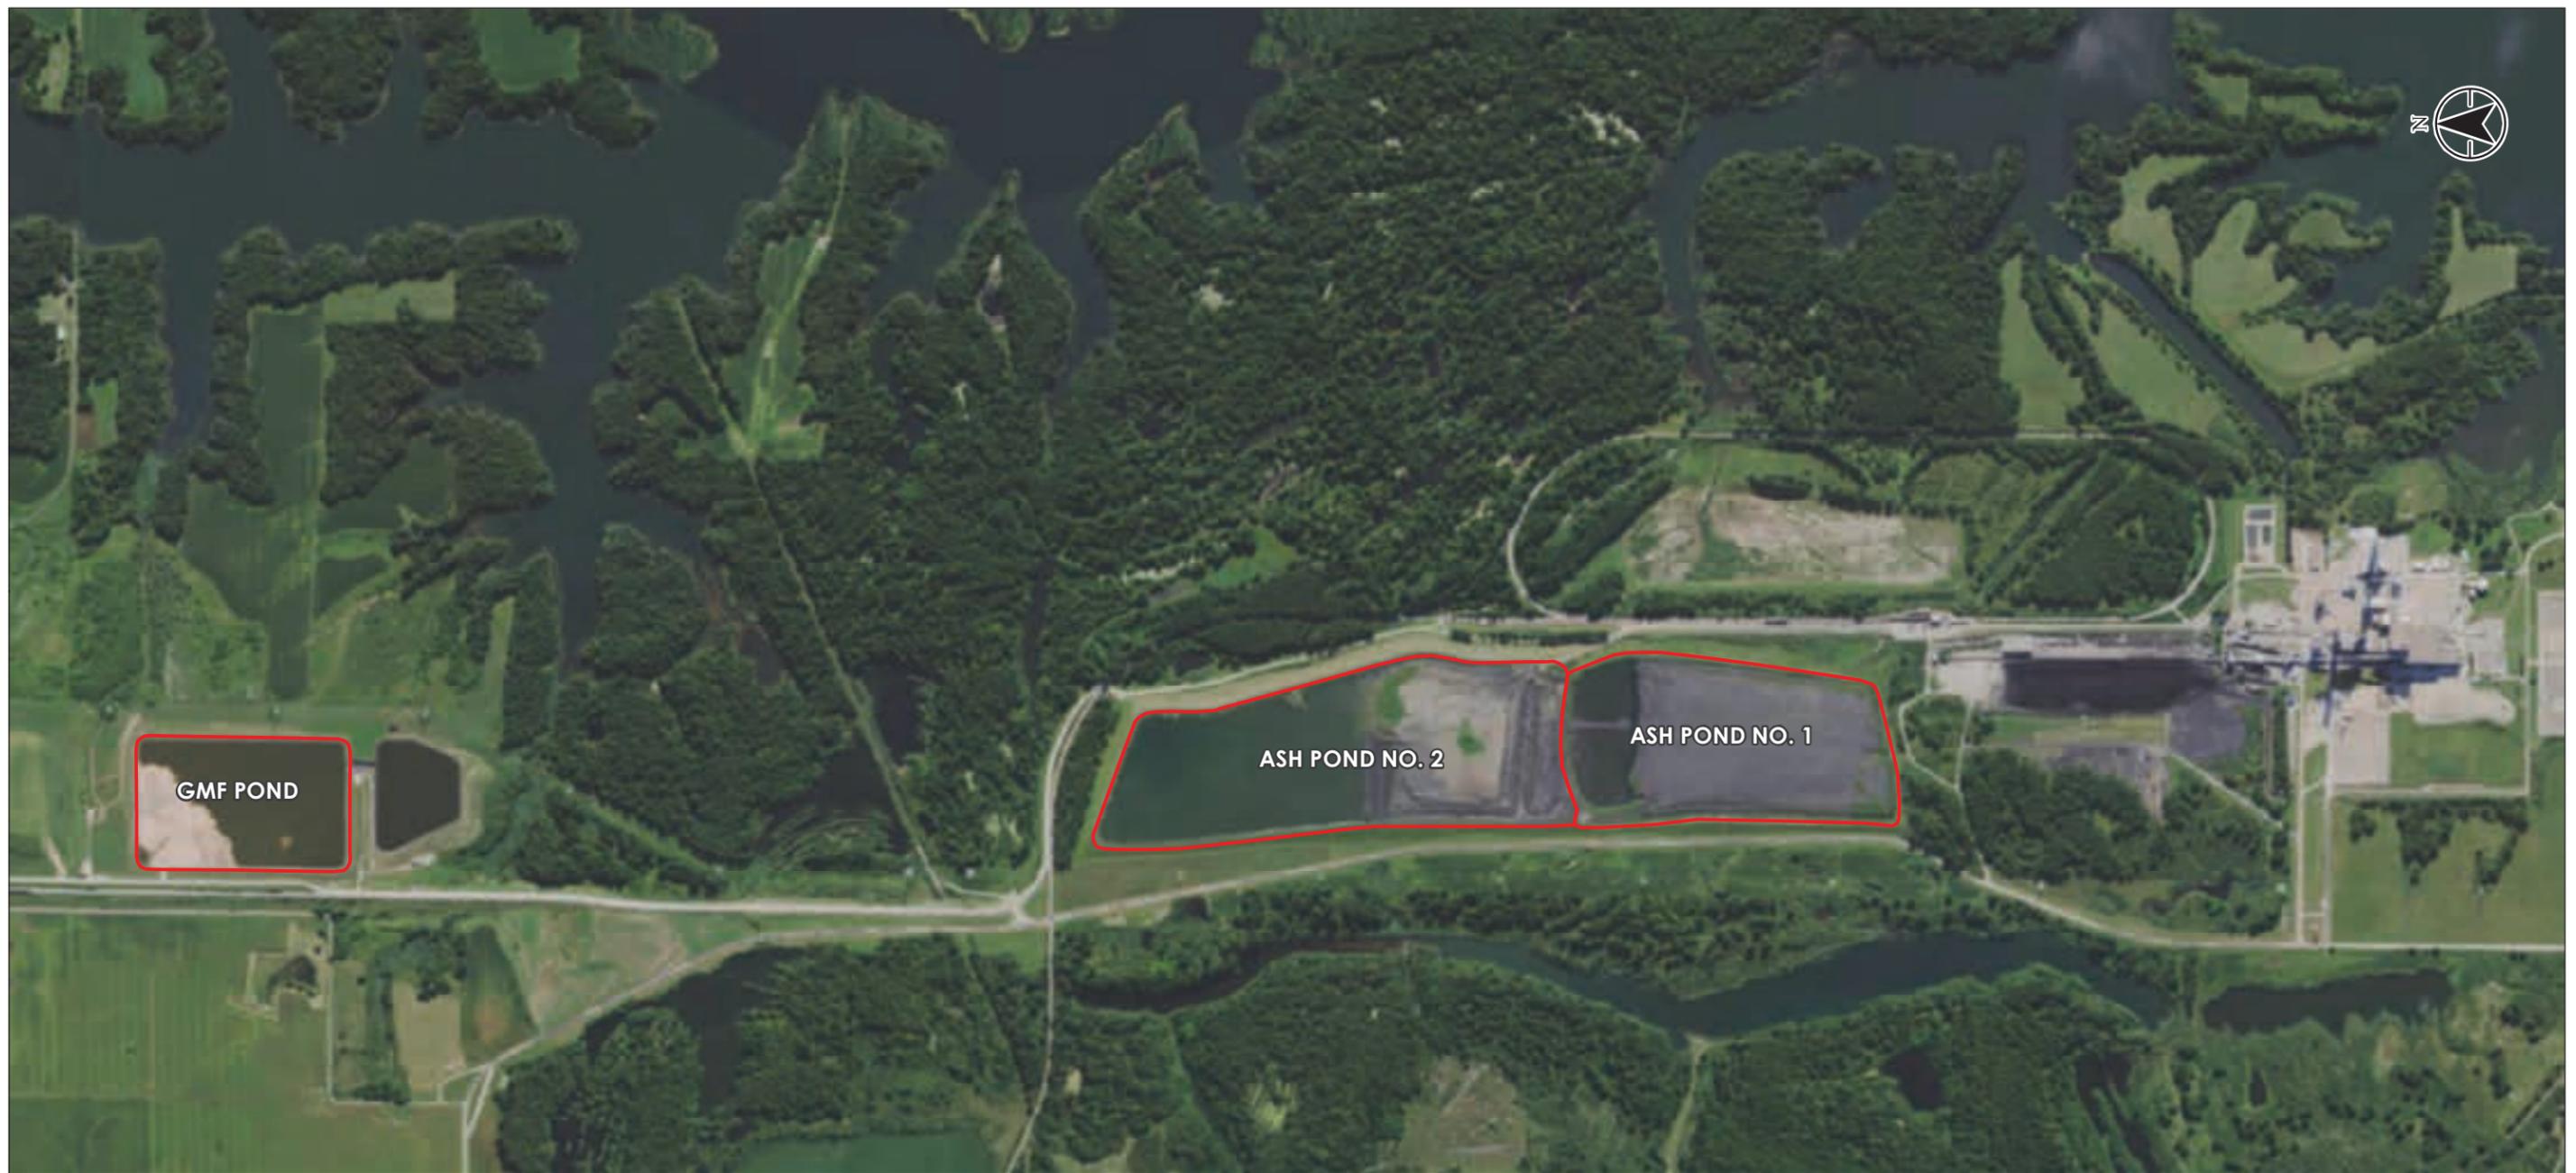
Legend

CCR Surface Impoundment Boundary

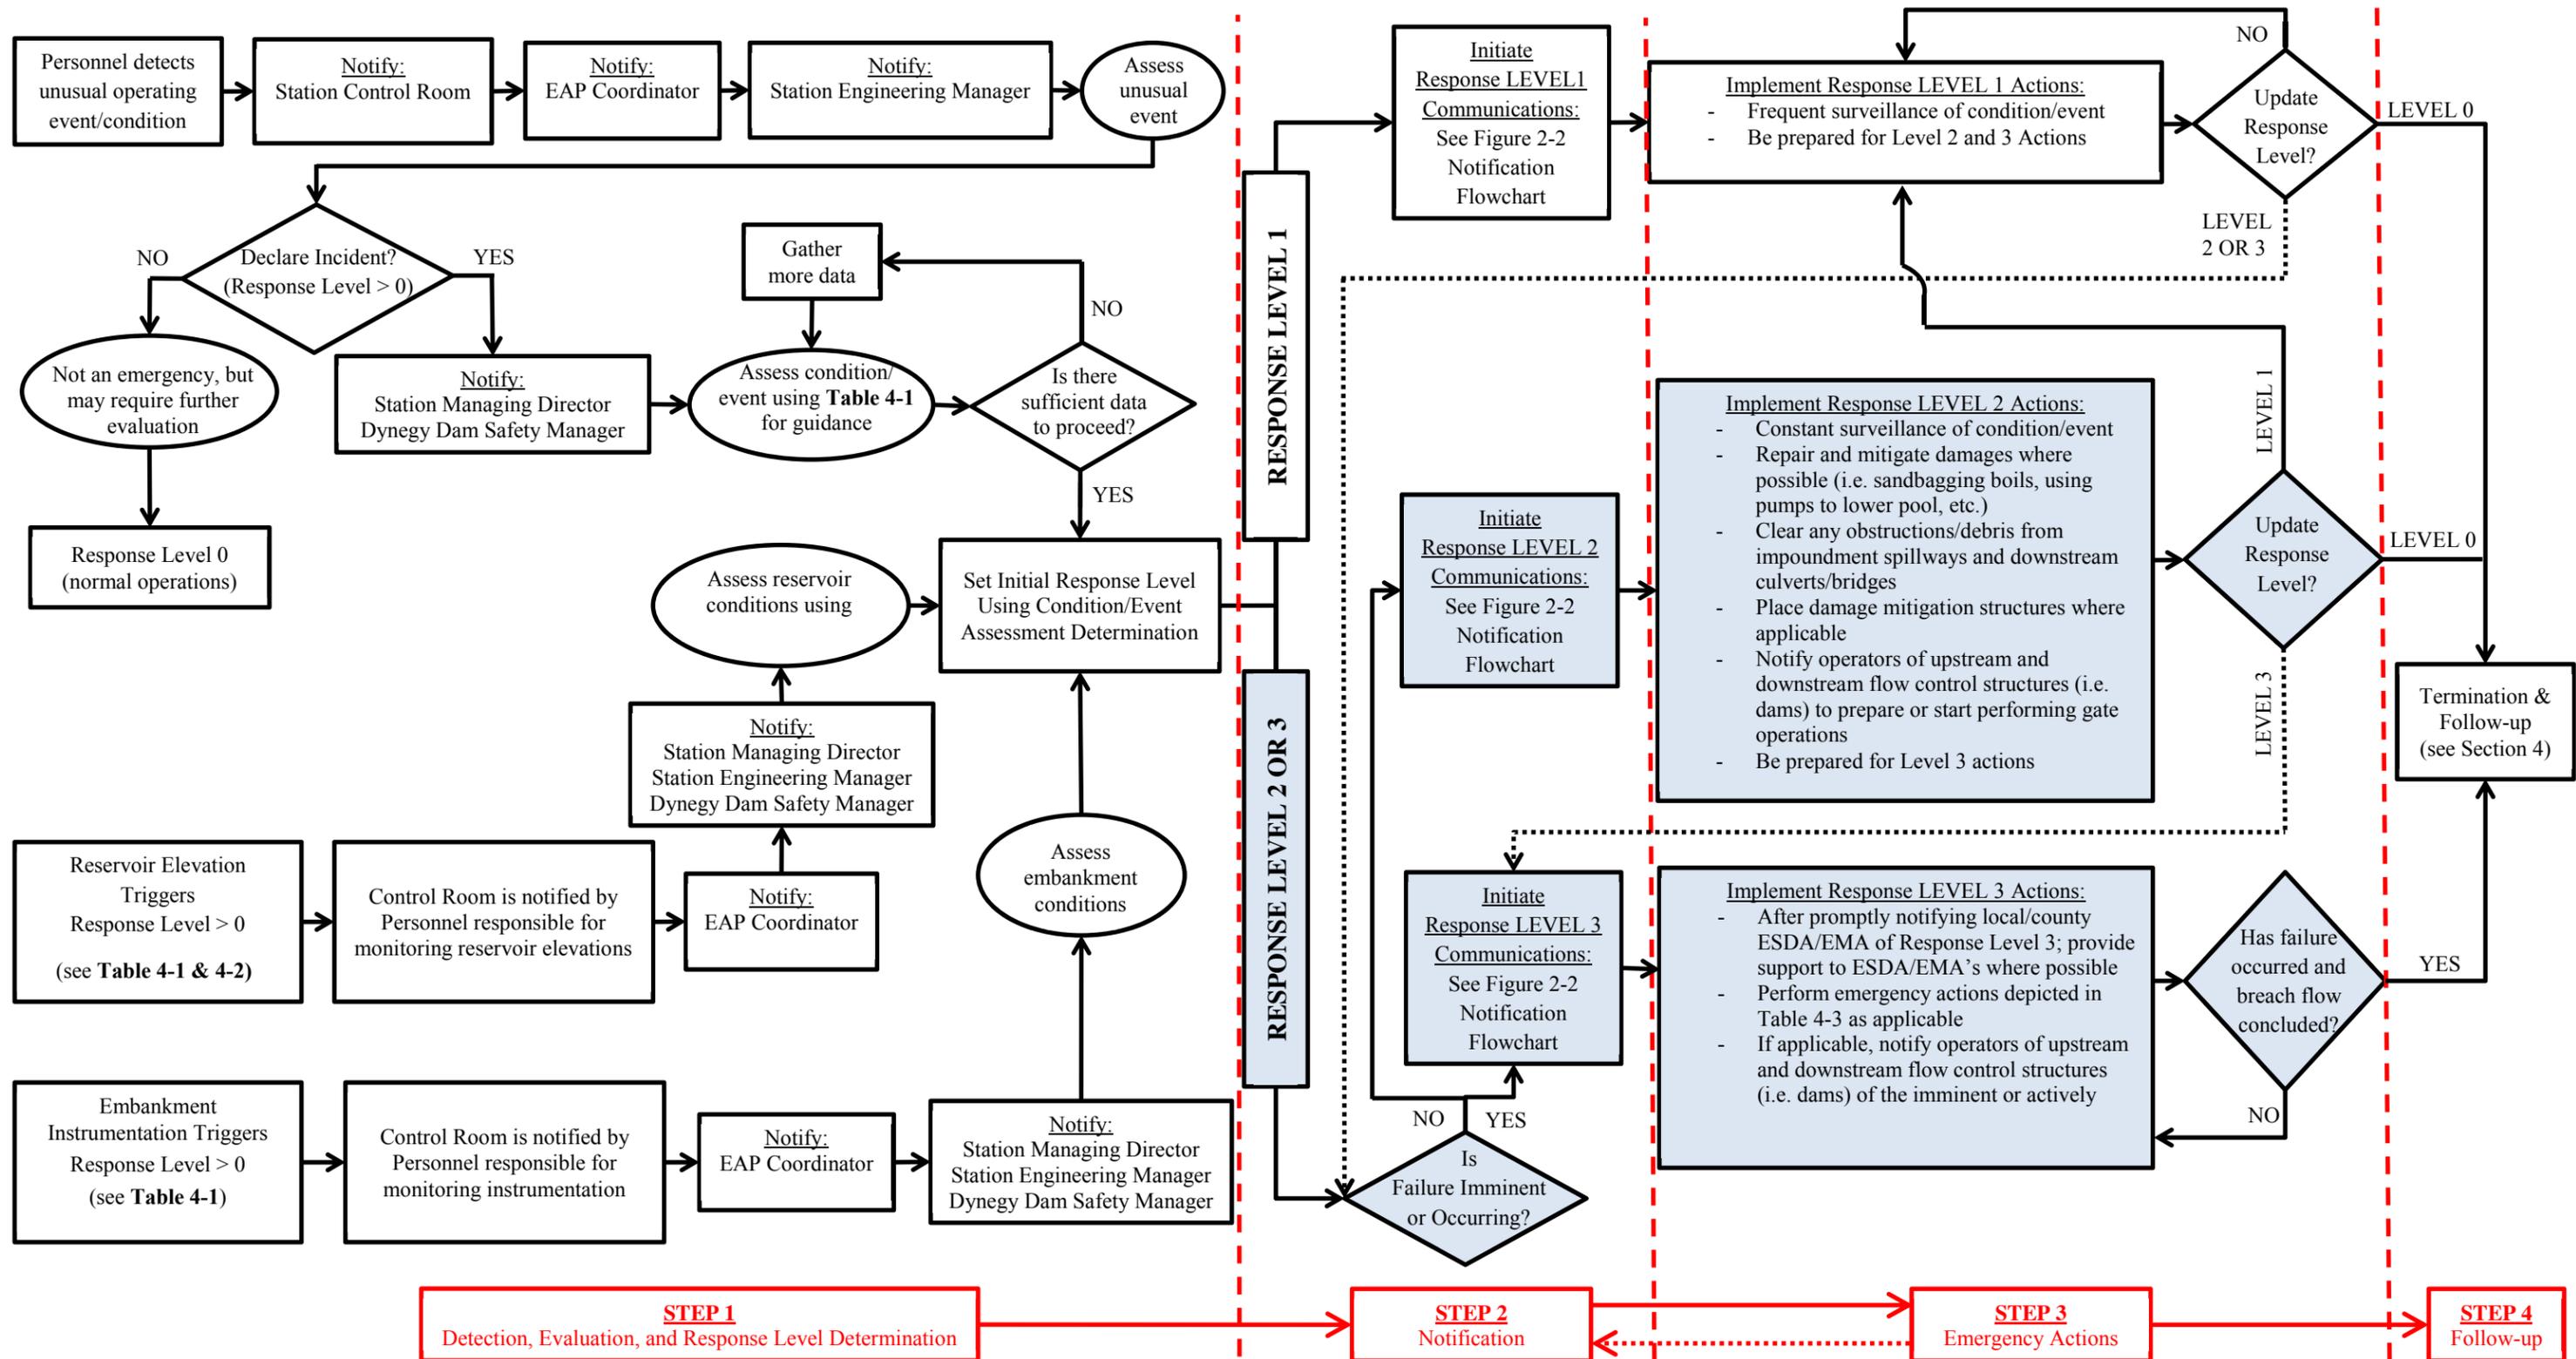
Figure 2-3. EAP Response Process Decision Tree

Note: At any given below, if failure is imminent or actively occurring CALL 911 IMMEDIATELY to notify emergency responders and then continue with process afterwards.

The 4-Step Incident Response Process is outlined in Figure 2-1. This should be used in conjunction with the Notification Flowchart (Figure 2-2) and EAP Decision Tree (Figure 2-3). Section 4 provides guidance tables for determining Response Levels and a table providing emergency actions to be taken given various situations. Table 2-1 lists contact information for the emergency responders.

The 4-Step Incident Response Process is shown in Figure 2-1. The Decision Tree shown in Figure 2-3 provides a flowchart for the various elements of the response process. Upon reaching Step 4 of the response process (termination and follow-up), the EAP Coordinator is responsible for notifying the ESDA/EMA's that the condition of the dam/impoundment has been stabilized. The purpose of this section is to provide specific information that can be used during a response. This information is provided in the following tables:

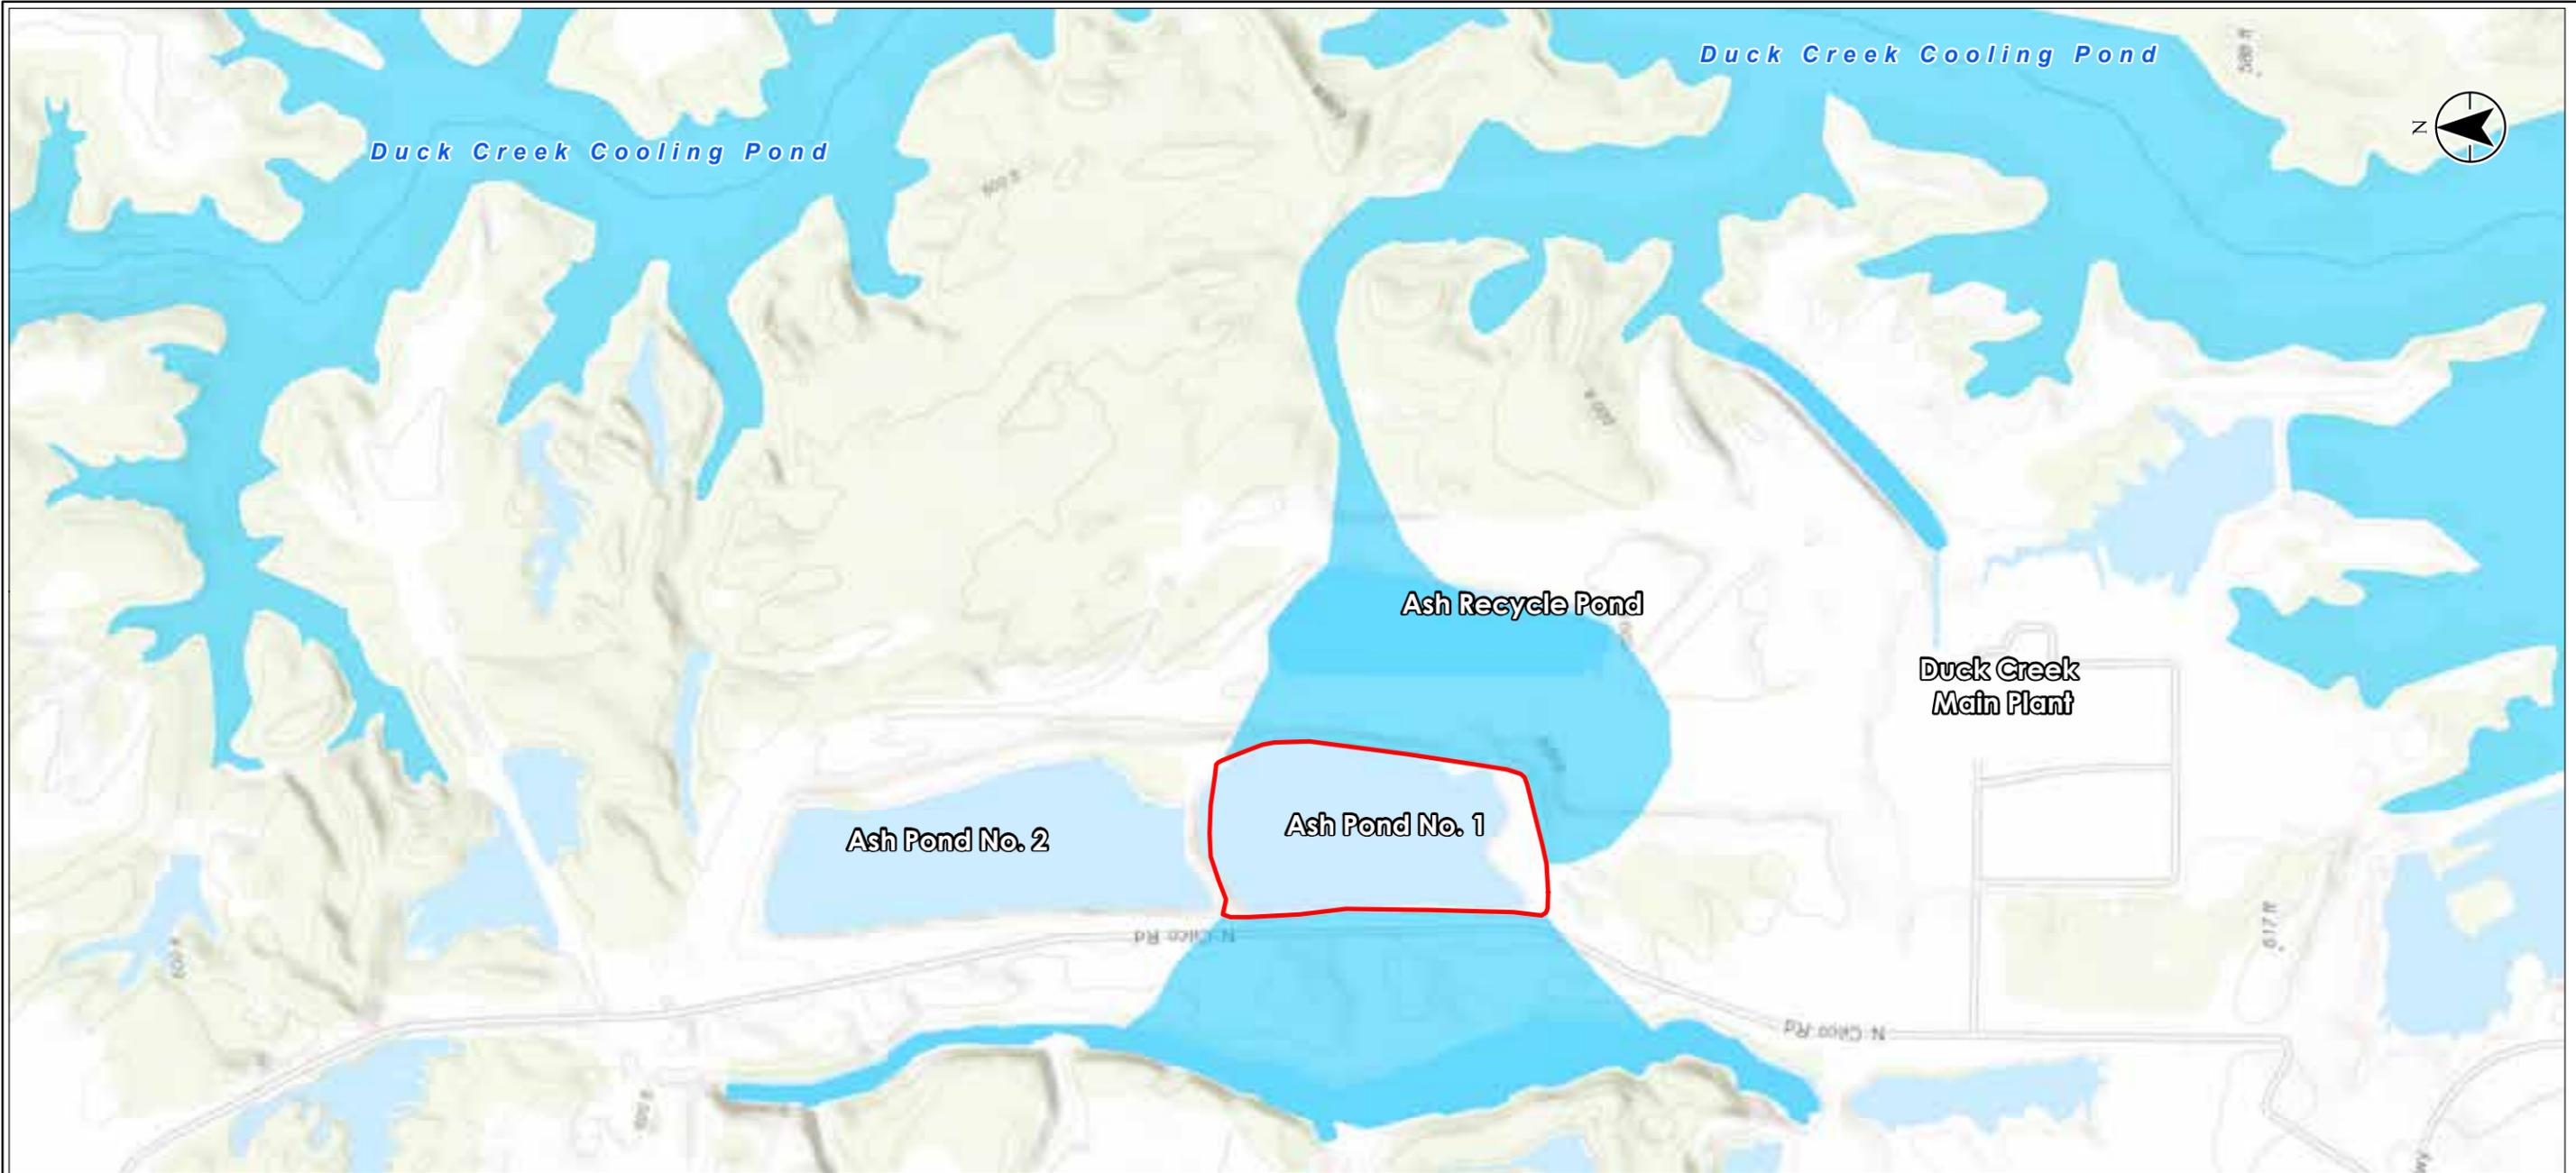
Figure No.
7-1

- Legend**
- Disposal Area Approximate Limits
 - Approximate Anticipated Inundation Extents

Three failure scenarios were identified at Ash Pond No. 1 and Ash Pond No. 2. At both impoundments, the breach would be contained in either the Duck Creek Cooling Pond or the unnamed body of water west of N. Cilco Road. Four failure scenarios were identified at the GMF Pond. Only Duck Creek Power Station owned structures were identified in the potential breach paths, with a breach contained in the Duck Creek Cooling Pond. The land between the impoundments and the Duck Creek Cooling Pond and unnamed body of water west of N. Cilco Road would also be inundated during a breach.

Approximate inundation areas are illustrated on Figure 7-1, Figure 7-2, and Figure 7-3.

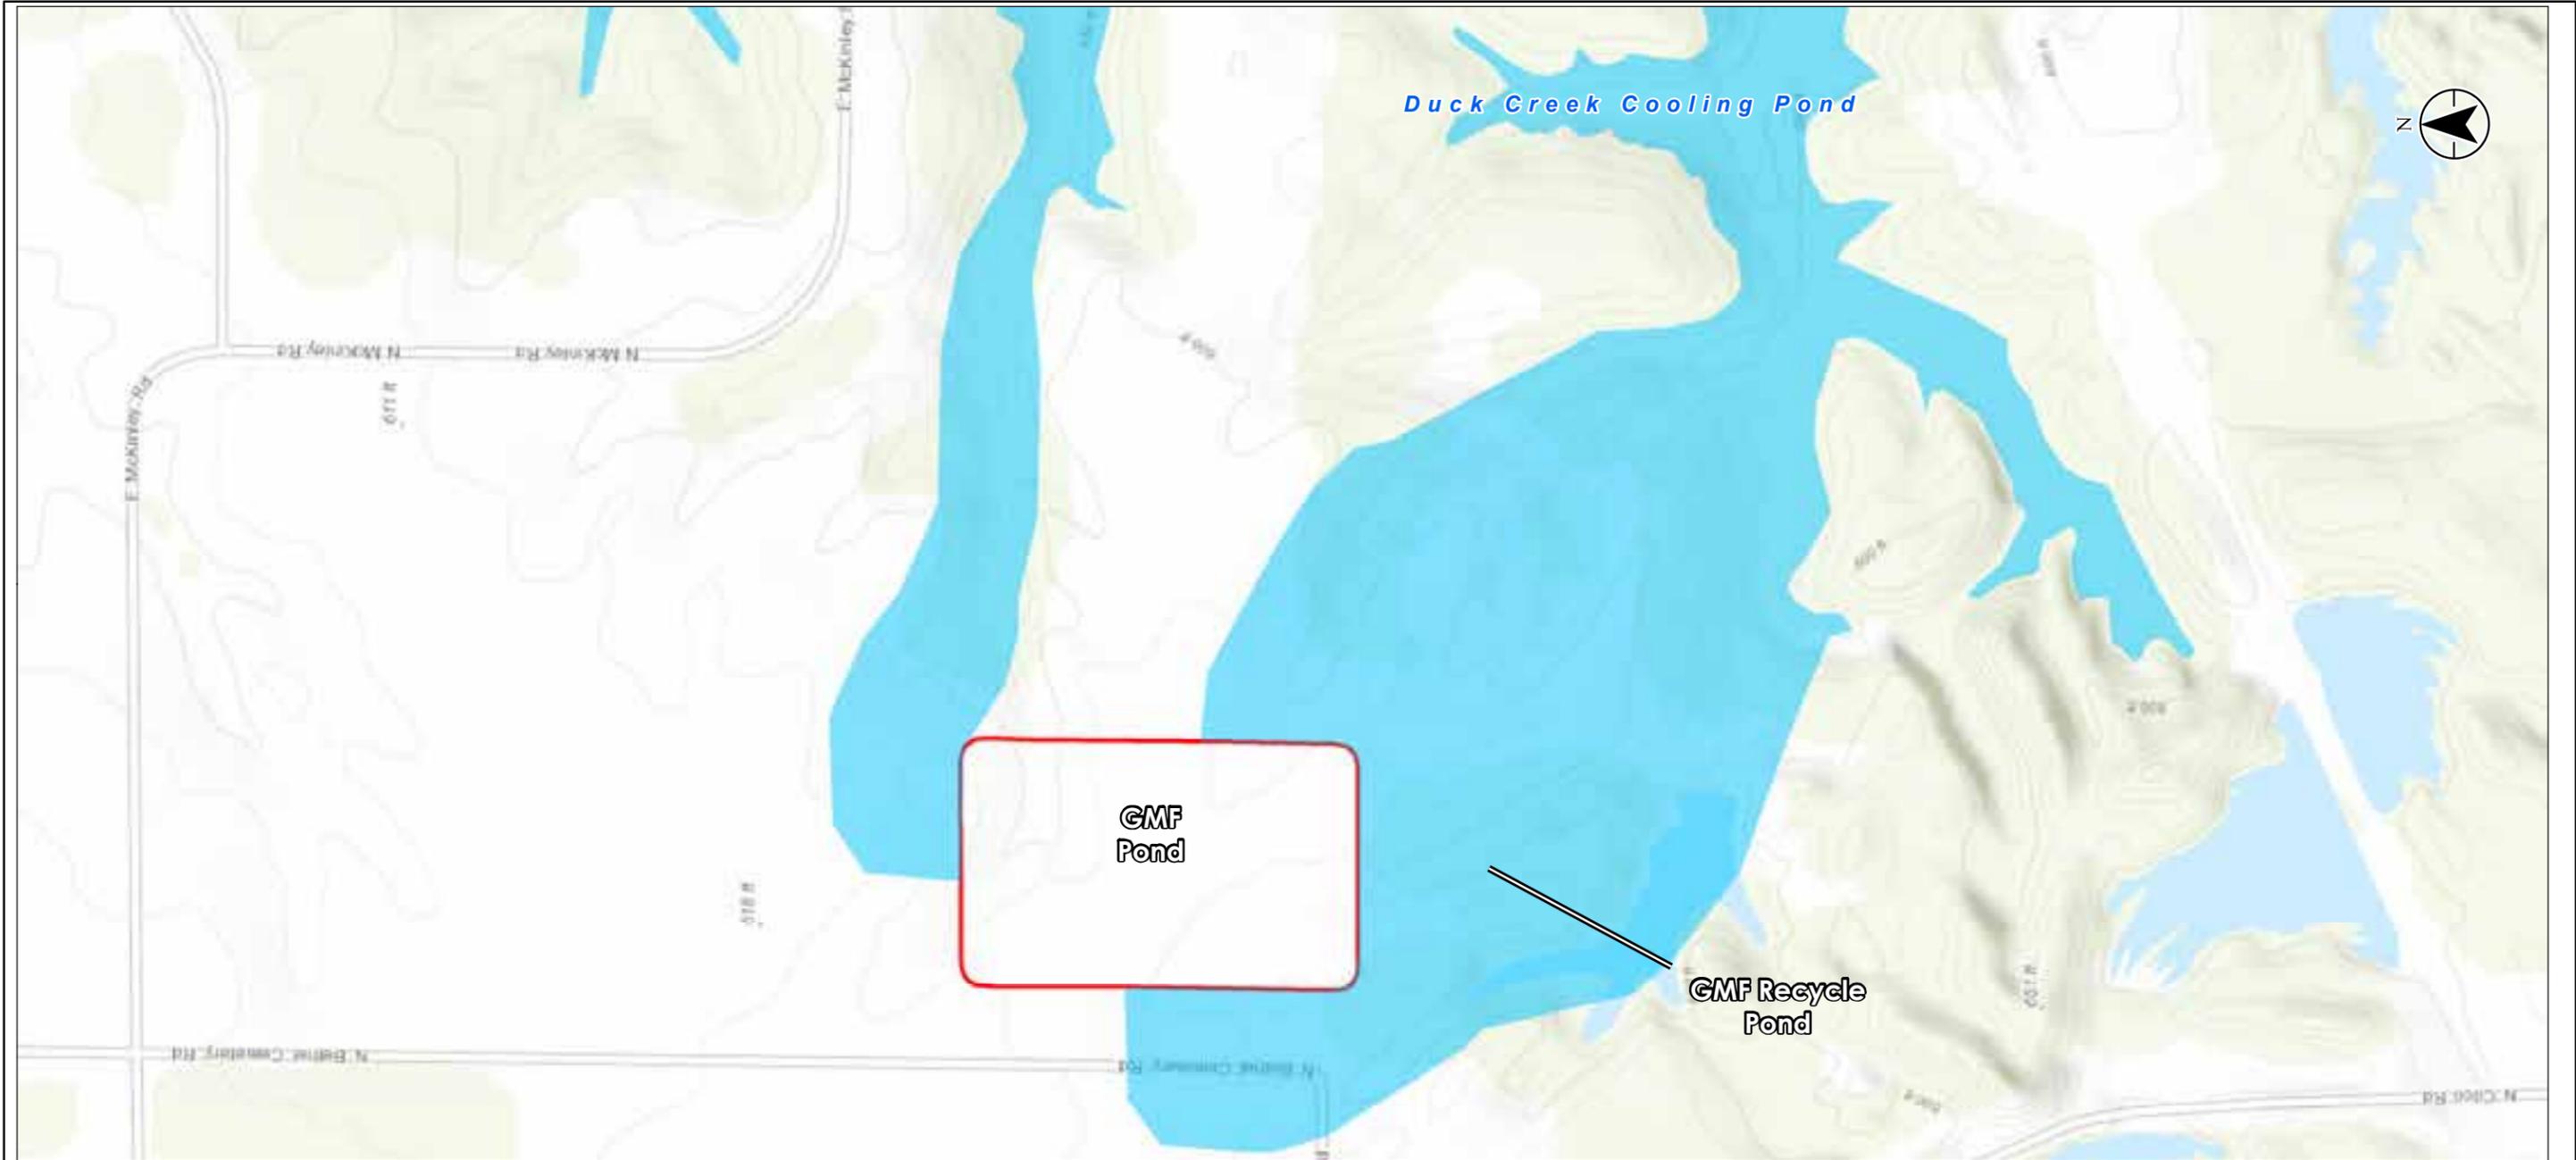
Figure No.
7-3

- Legend**
- Disposal Area Approximate Limits
 - Approximate Anticipated Inundation Extents
