**ANNUAL CCR SURFACE IMPOUNDMENT
INSPECTION REPORT (per 40 CFR 257.83(b)(2))**

Power Station: Joppa Power Station

CCR Impoundment: East Ash Pond

Date of Inspection: 10/8/2015

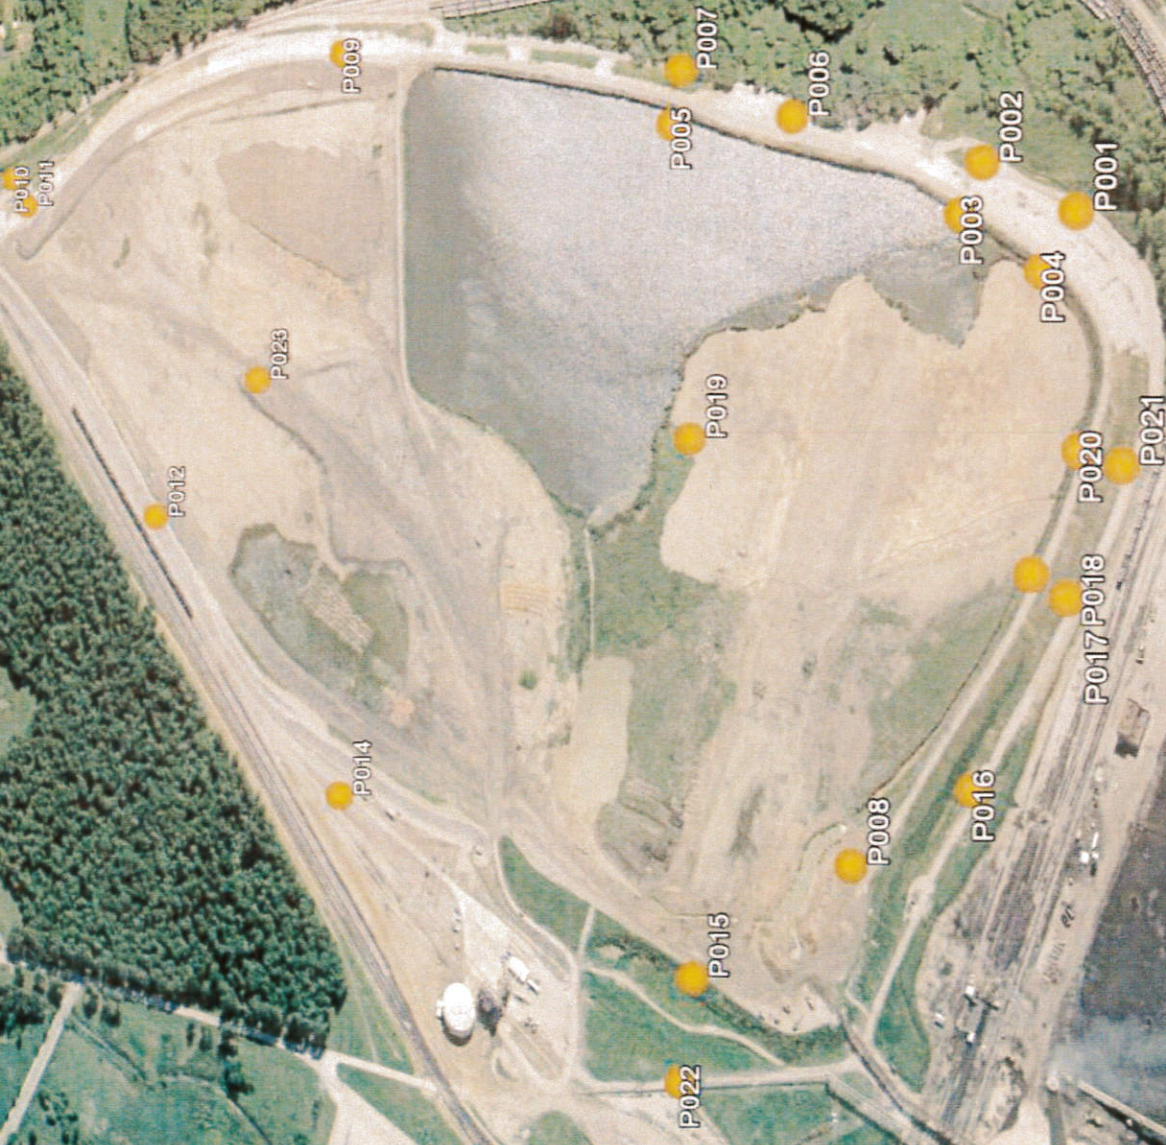
- ii) Instrumentation
(Please see following page for instrumentation location map)

Joppa

East Ash Pond
