**ANNUAL CCR SURFACE IMPOUNDMENT
INSPECTION REPORT (per 40 CFR 257.83(b)(2))**

Power Station: Joppa Power Station

CCR Impoundment: East Ash Pond

Date of Inspection: 10/26/2016

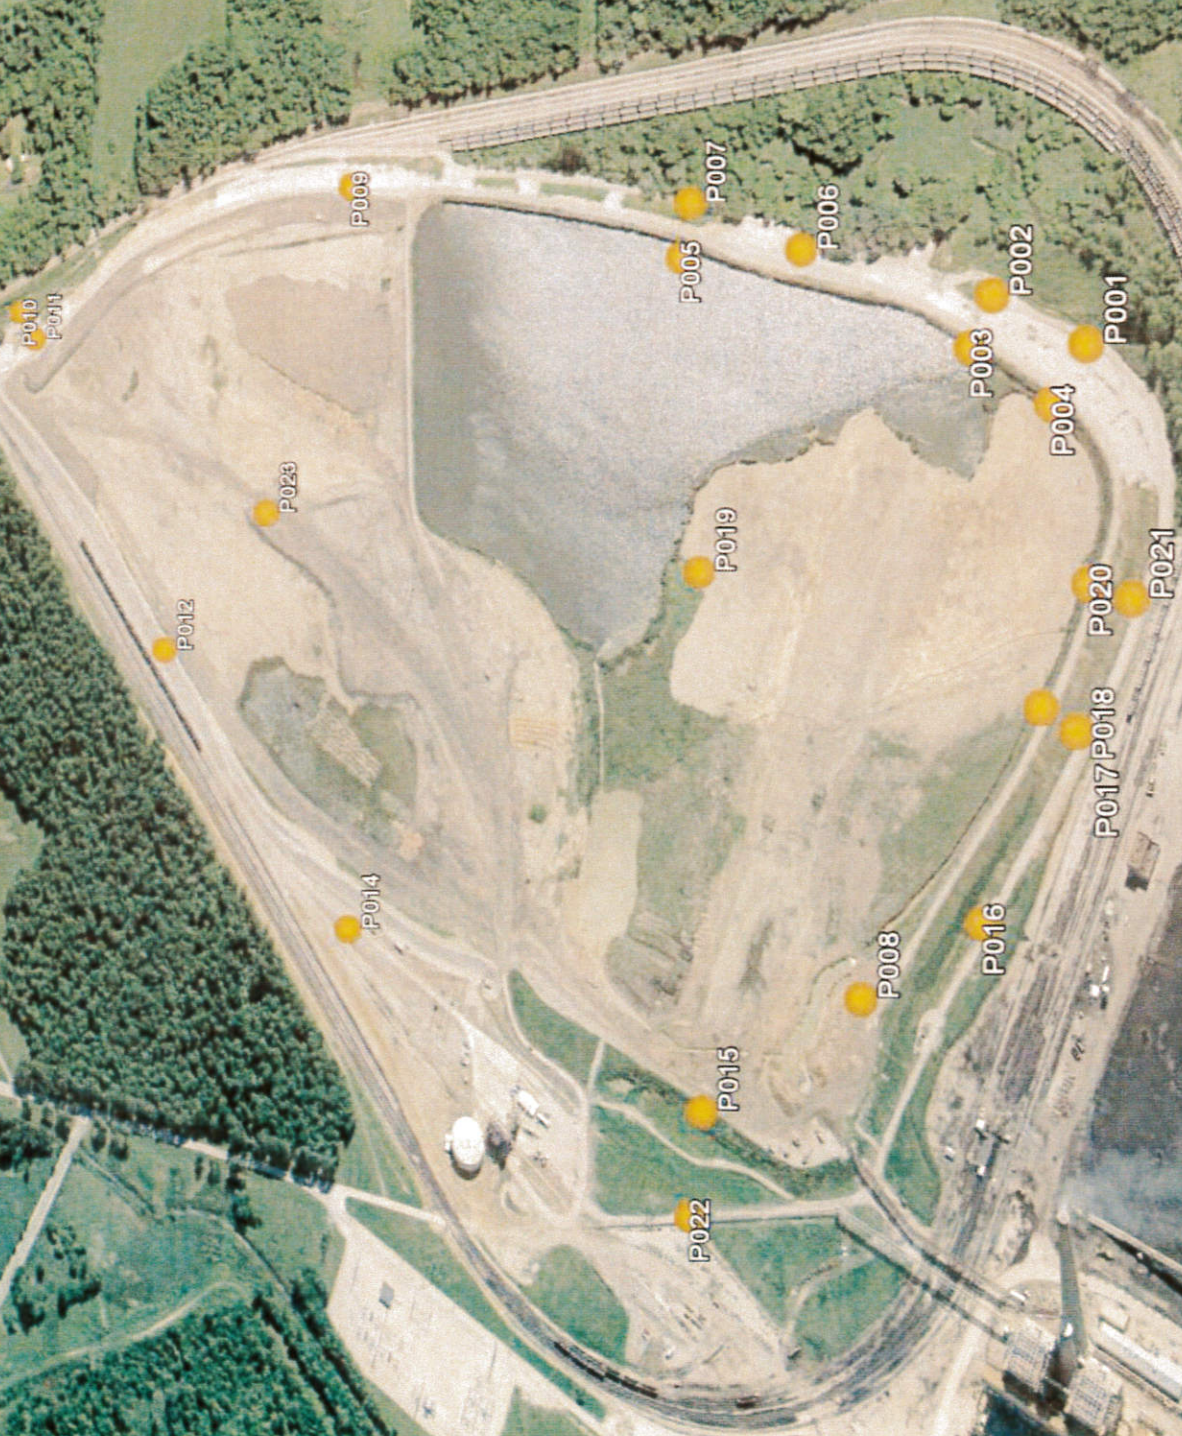
- ii) Instrumentation
(Please see following page for instrumentation location map)

Piezometer		
Number	Type	Max
JOP-B001	VWP	319.9'
JOP-B002	VWP	ABD
JOP-B003	VWP	ABD
JOP-B004	VWP	347.9'
JOP-B005	VWP	363.8'
JOP-B006	VWP	ABD
JOP-B007	VWP	322.4'
JOP-B008	VWP	359.3'
JOP-B009	VWP	362.8'
JOP-B010	VWP	337.8'
JOP-B011	VWP	336.3'
JOP-B012	VWP	346.2'
JOP-B013	VWP	ABD
JOP-B014	VWP	331.5'
JOP-B015	VWP	355.3'
JOP-B016	VWP	351.7'
JOP-B017	VWP	ABD
JOP-B018	VWP	ABD
JOP-B019	VWP	ABD
JOP-B020	VWP	352.0'
JOP-B021	VWP	325.8'
JOP-B022	VWP	ABD
JOP-B023	VWP	364.2'

VWP = Vibrating Wire Piezometer

ABD = Abandoned
