KINCAID POWER STATION
KINCAID, CHRISTIAN COUNTY, ILLINOIS

Emergency Action Plan (EAP)

40 CFR § 257.73(a)(3)
**Coal Combustion Residual (CCR) Impoundment
& Related Facilities**

- Ash Pond (NID # IL50706)

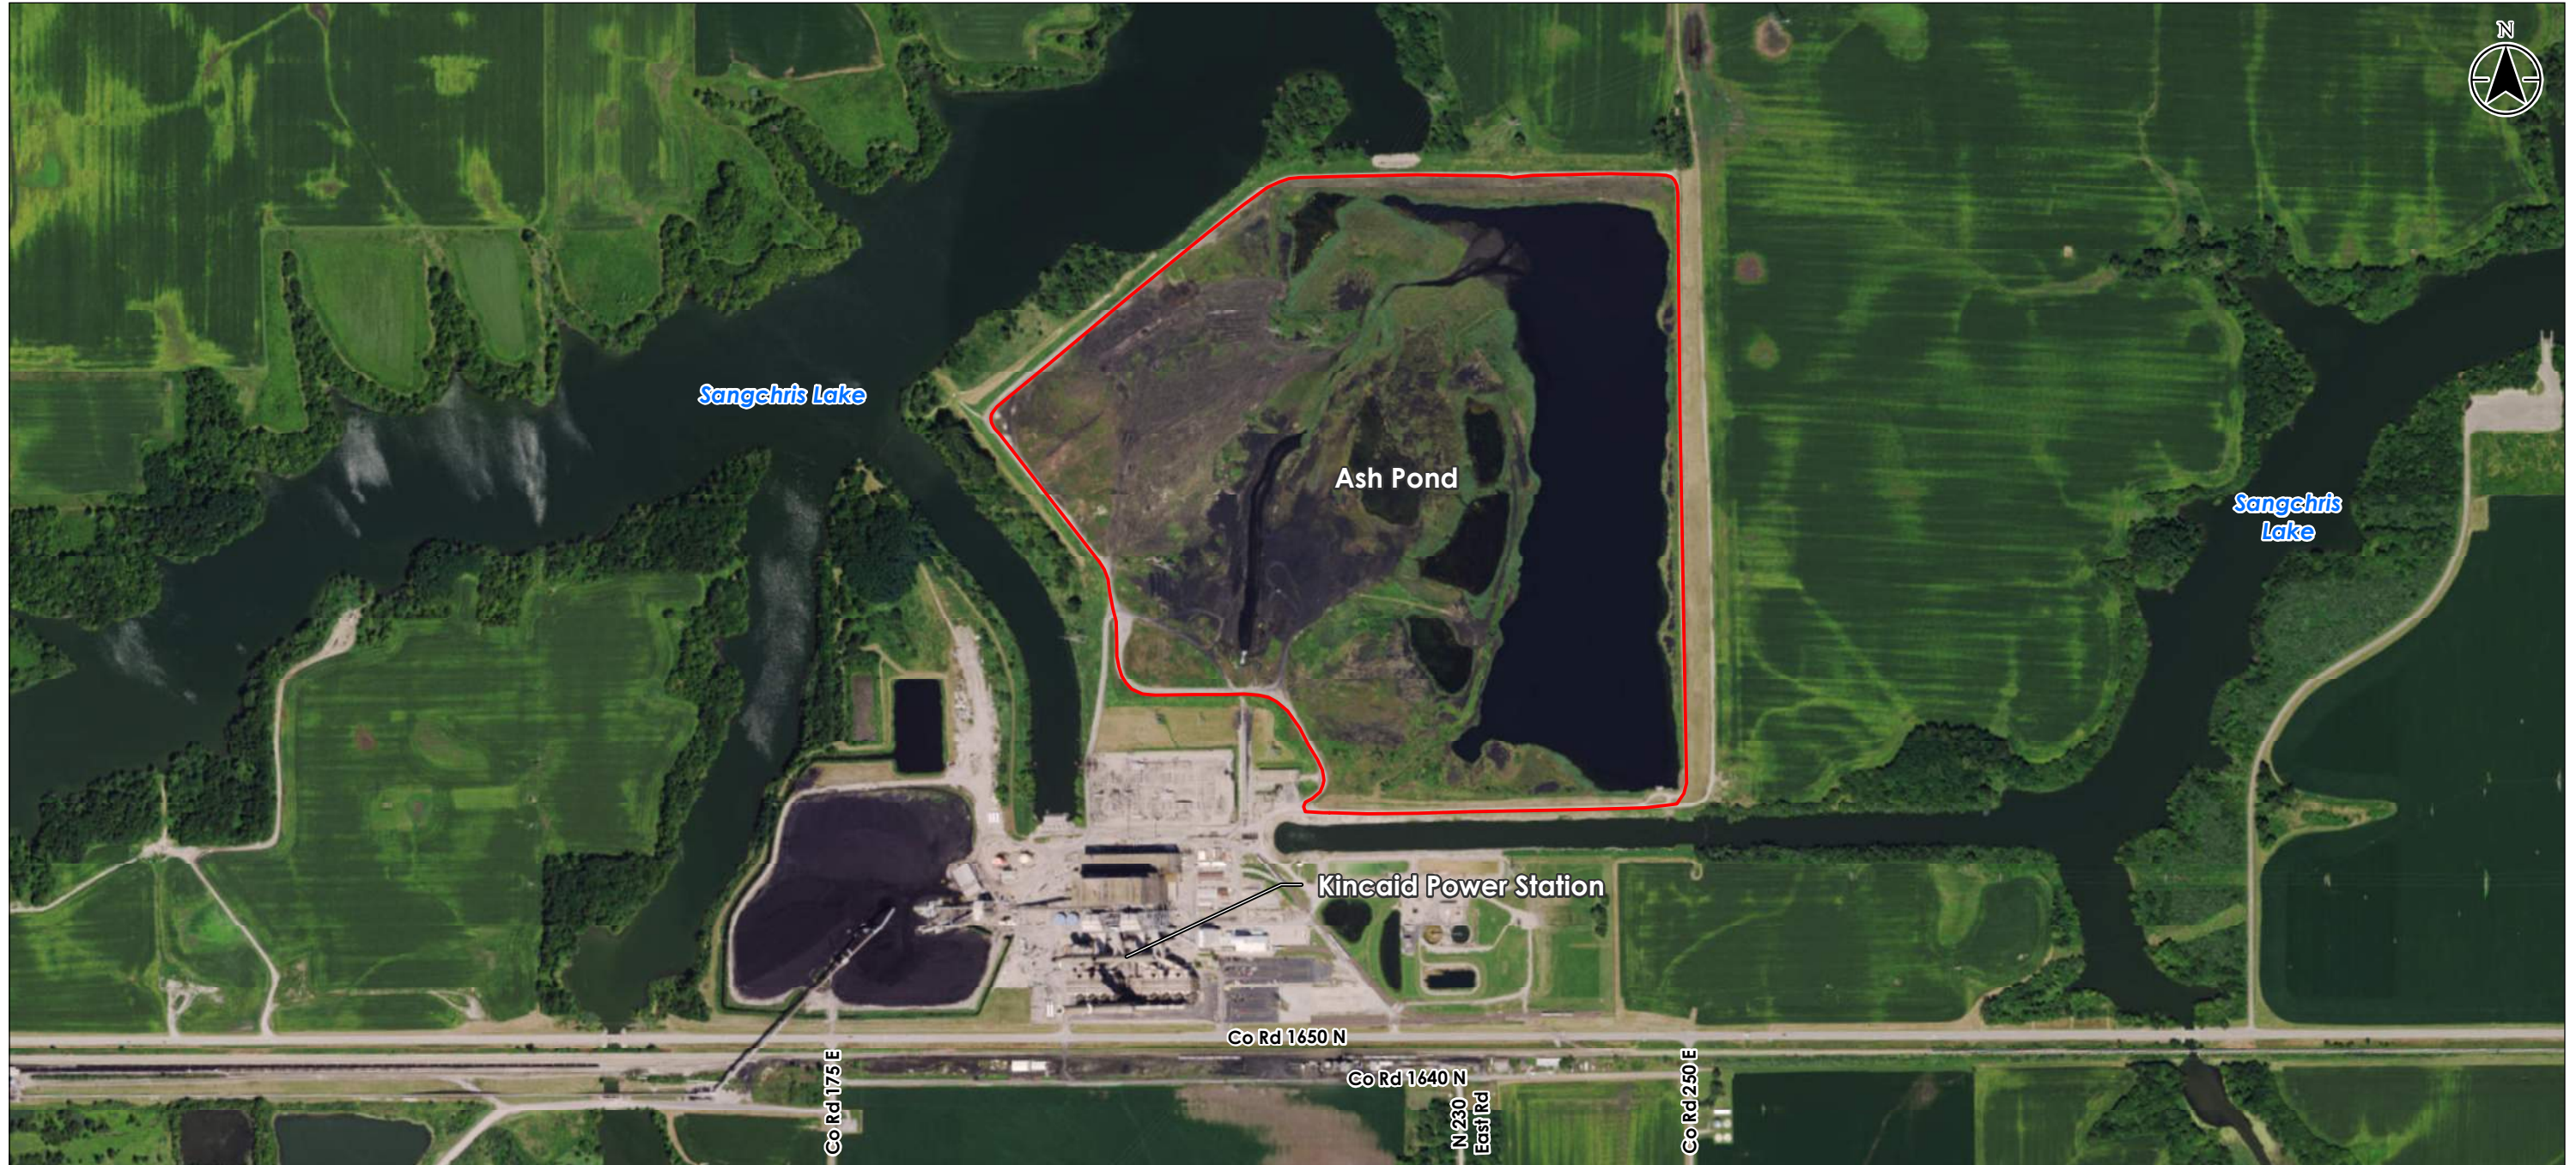
CCR Surface Impoundment Boundary

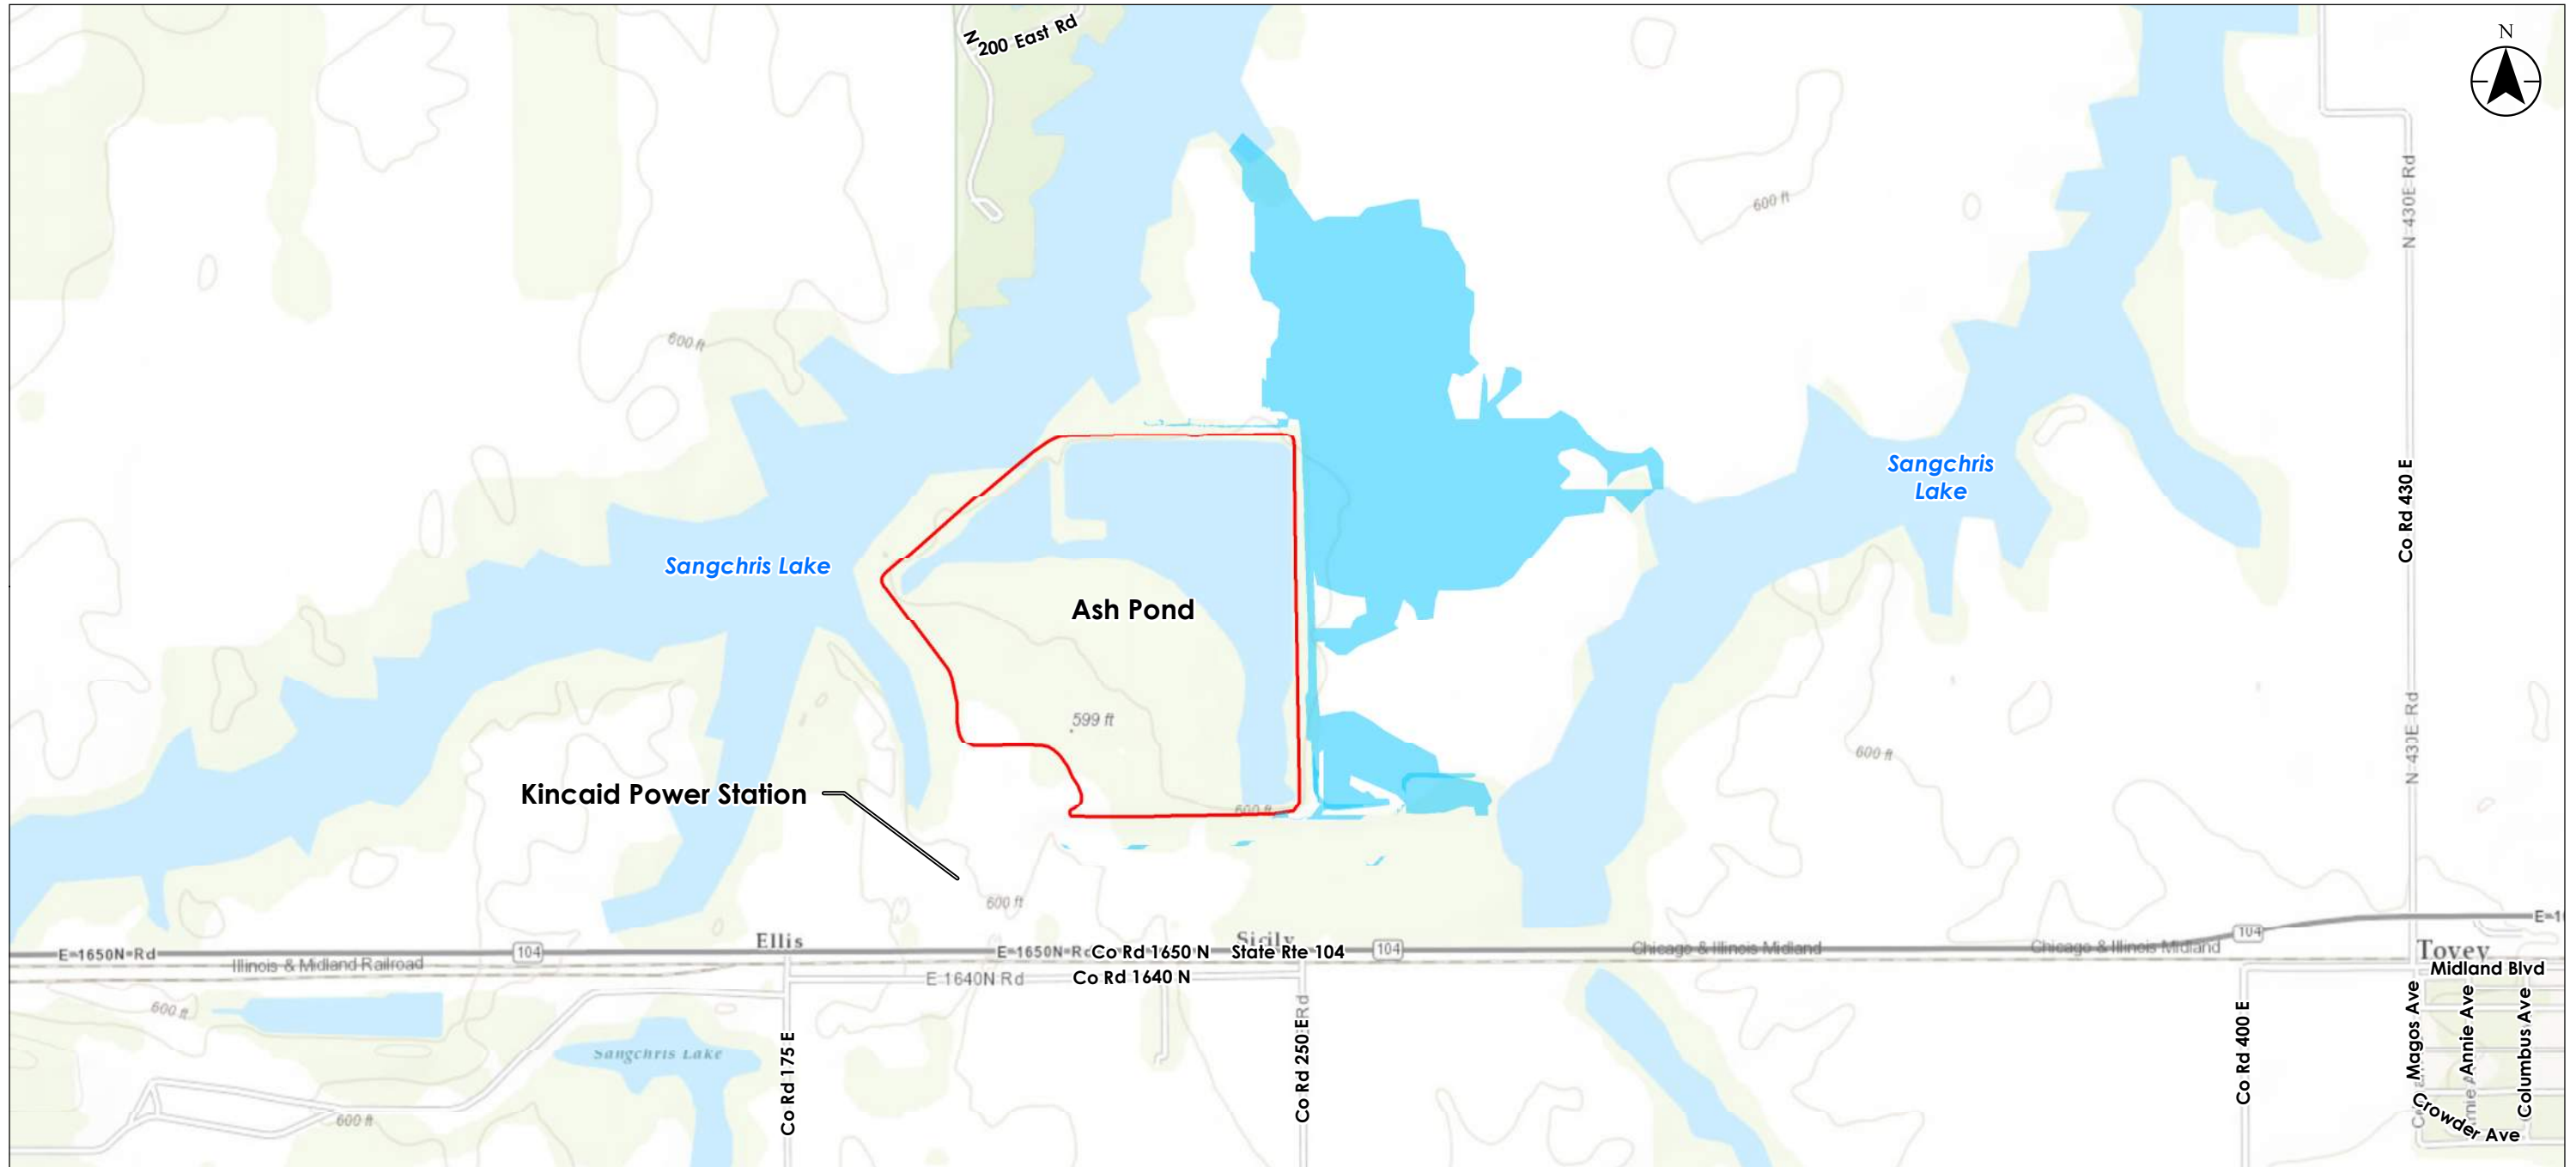
Figure No.
7-1

The inundation limits were mapped using the modeled maximum water surface elevations (WSE) and a combination of digital elevation data from the topographic survey prepared by Weaver Consultants Group – December, 2015 (2015 – Kincaid Topography) and 1/3 Arc Second DEM data downloaded from The National Map website.

The approximate inundation area is illustrated in Figure 7-1.

- CCR Surface Impoundment Boundary
- Expected Breach Inundation Area
