## ANNUAL CCR SURFACE IMPOUNDMENT INSPECTION REPORT (per 40 CFR 257.83(b)(2))

Power Station: Newton Power Station

CCR Impoundment: Primary Ash Pond

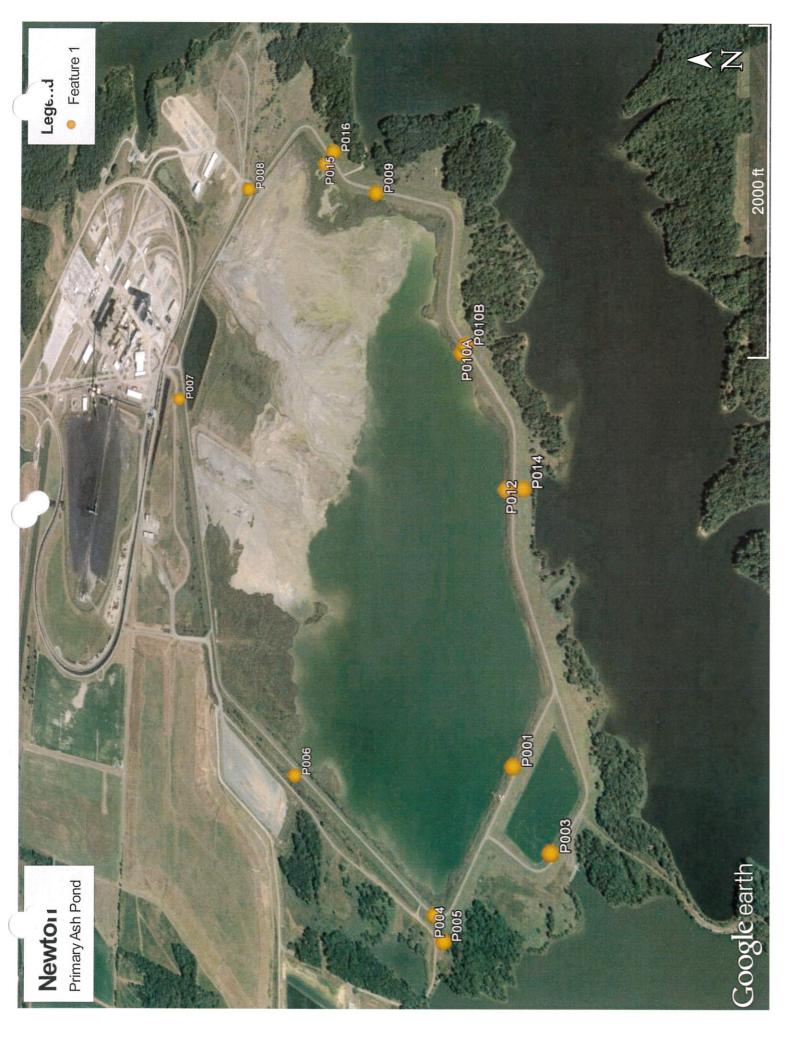
ii) Instrumentation (Please see following page for instrumentation location map)

Instrument ID #	Туре	Maximum recorded reading since previous annual inspection (ft)		
B001	Piezometer	509.2'		
B003	Piezometer	519.6'		
B004	Piezometer	550.0'		
B005	Piezometer	537.7'		
B006	Piezometer	539.3'		
B007	Piezometer	549.7'		
B008	Piezometer	535.0'		
B009	Piezometer	526.9'		
B010A	Piezometer	539.8'		
B010B	Piezometer	526.9'		
B012	Piezometer	519.1'		
B014	Piezometer	507.1'		
B015	Piezometer	535.5'		
B016	Piezometer	510.4'
