**ANNUAL CCR SURFACE IMPOUNDMENT  
INSPECTION REPORT (per 40 CFR 257.83(b)(2))**

Power Station: Wood River Power Station

CCR Impoundment: West Ash Pond 1

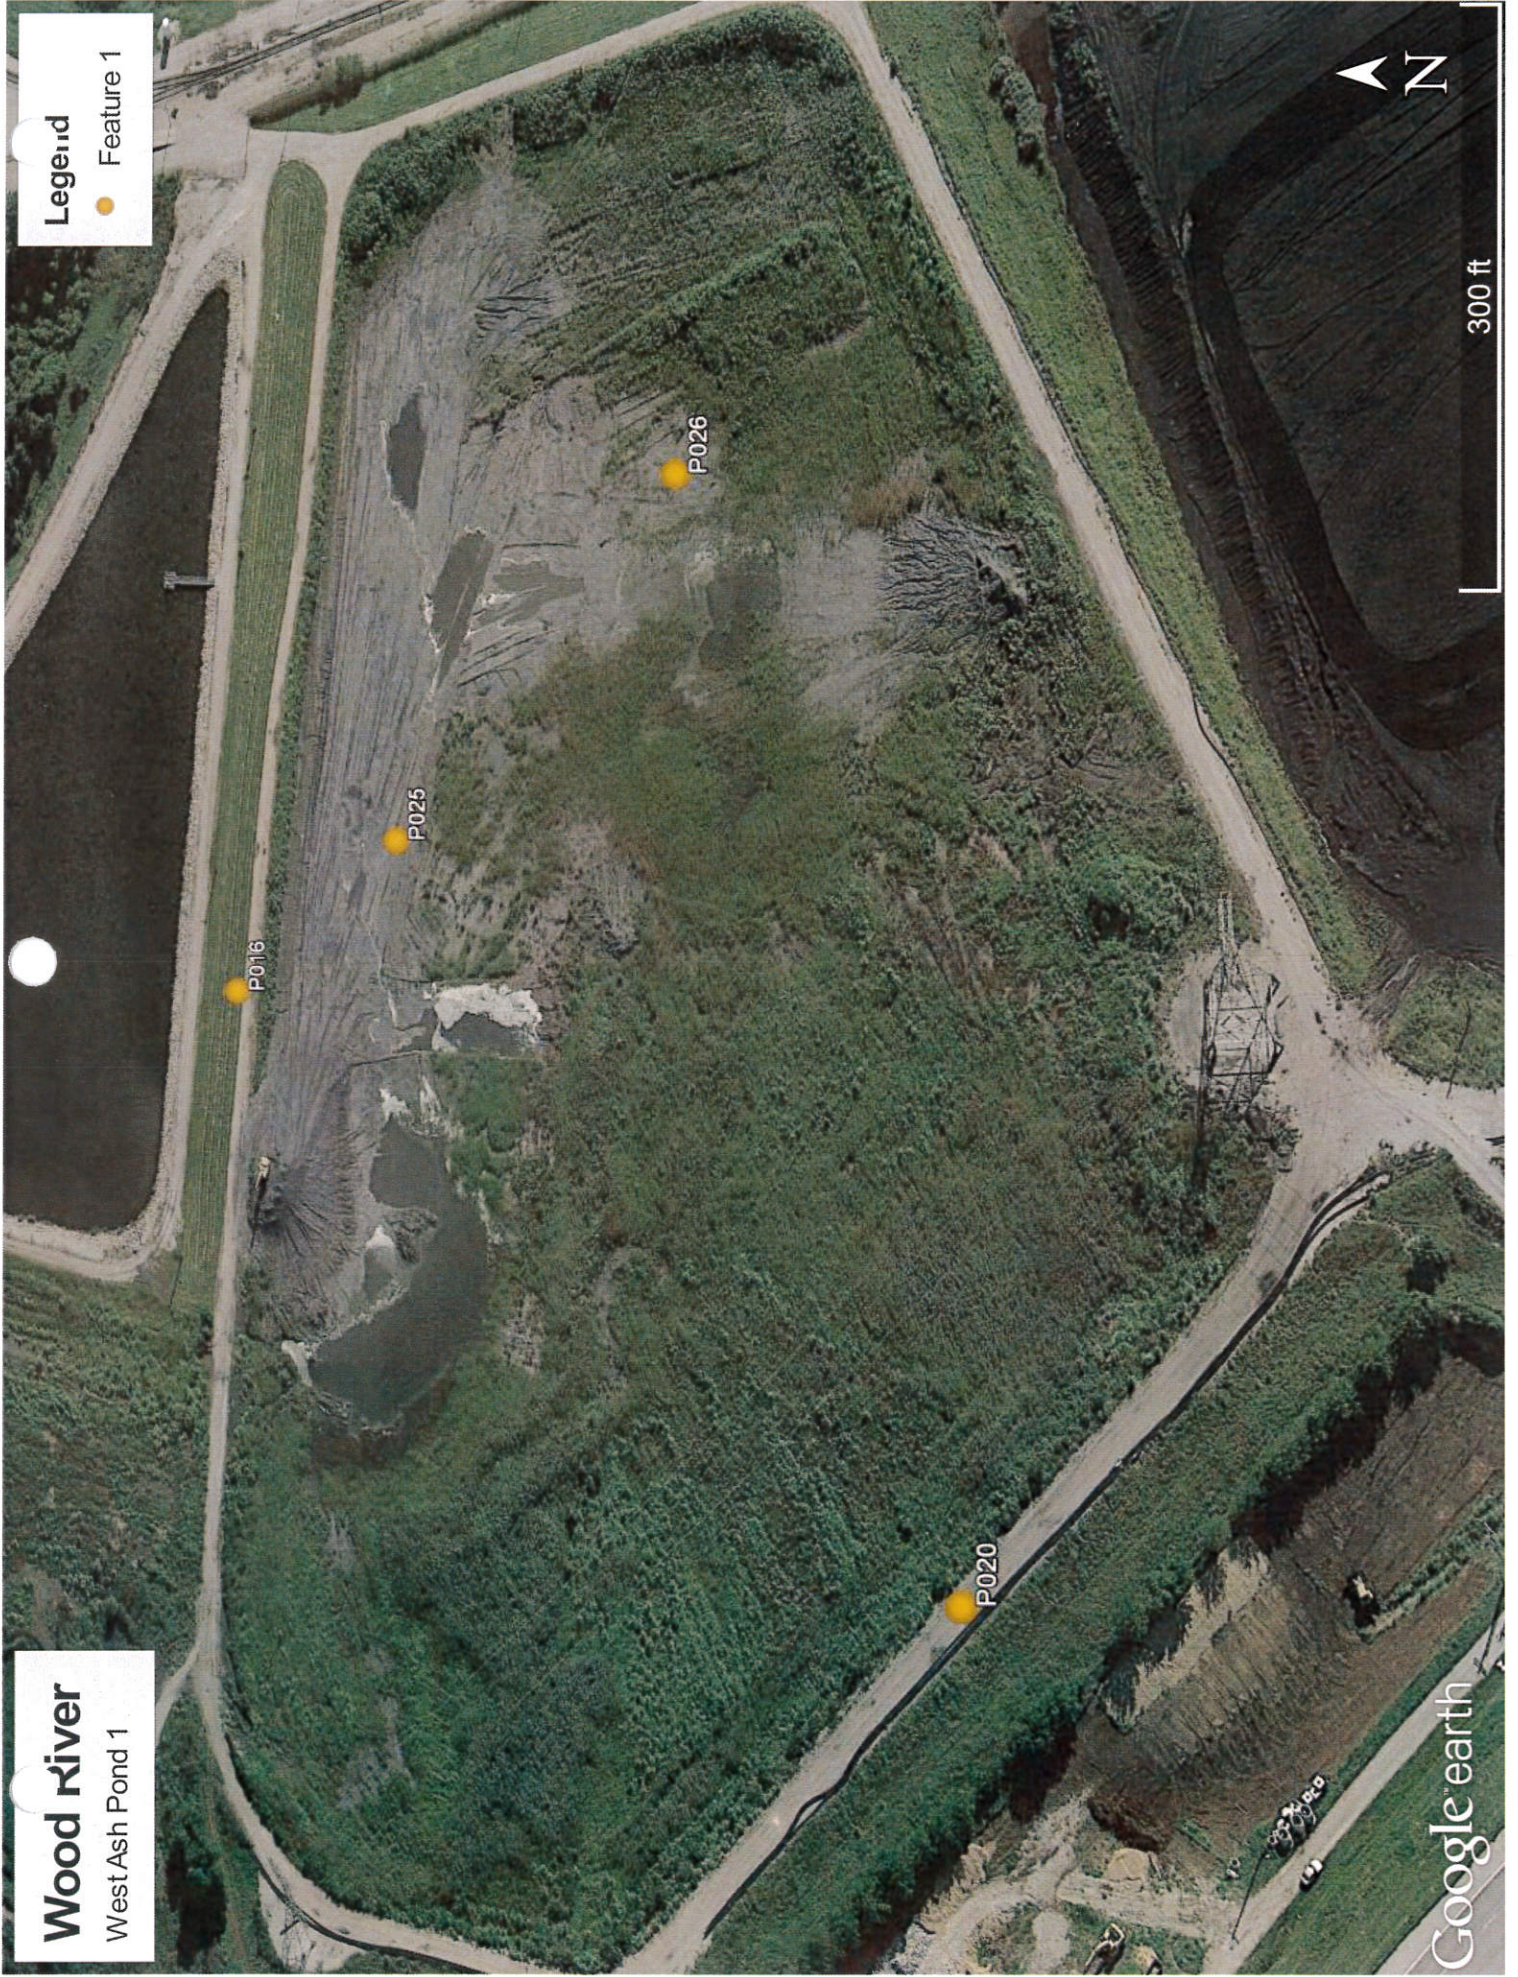
West Ash Pond 1

- ii) Instrumentation  
(Please see following page for instrumentation location map)

Instrument ID #	Type	Maximum recorded reading since previous annual inspection (ft)
P016	Piezometer	426.0'
P020	Piezometer	406.0'
P025	Piezometer	427.8'
P026	Piezometer	426.9'

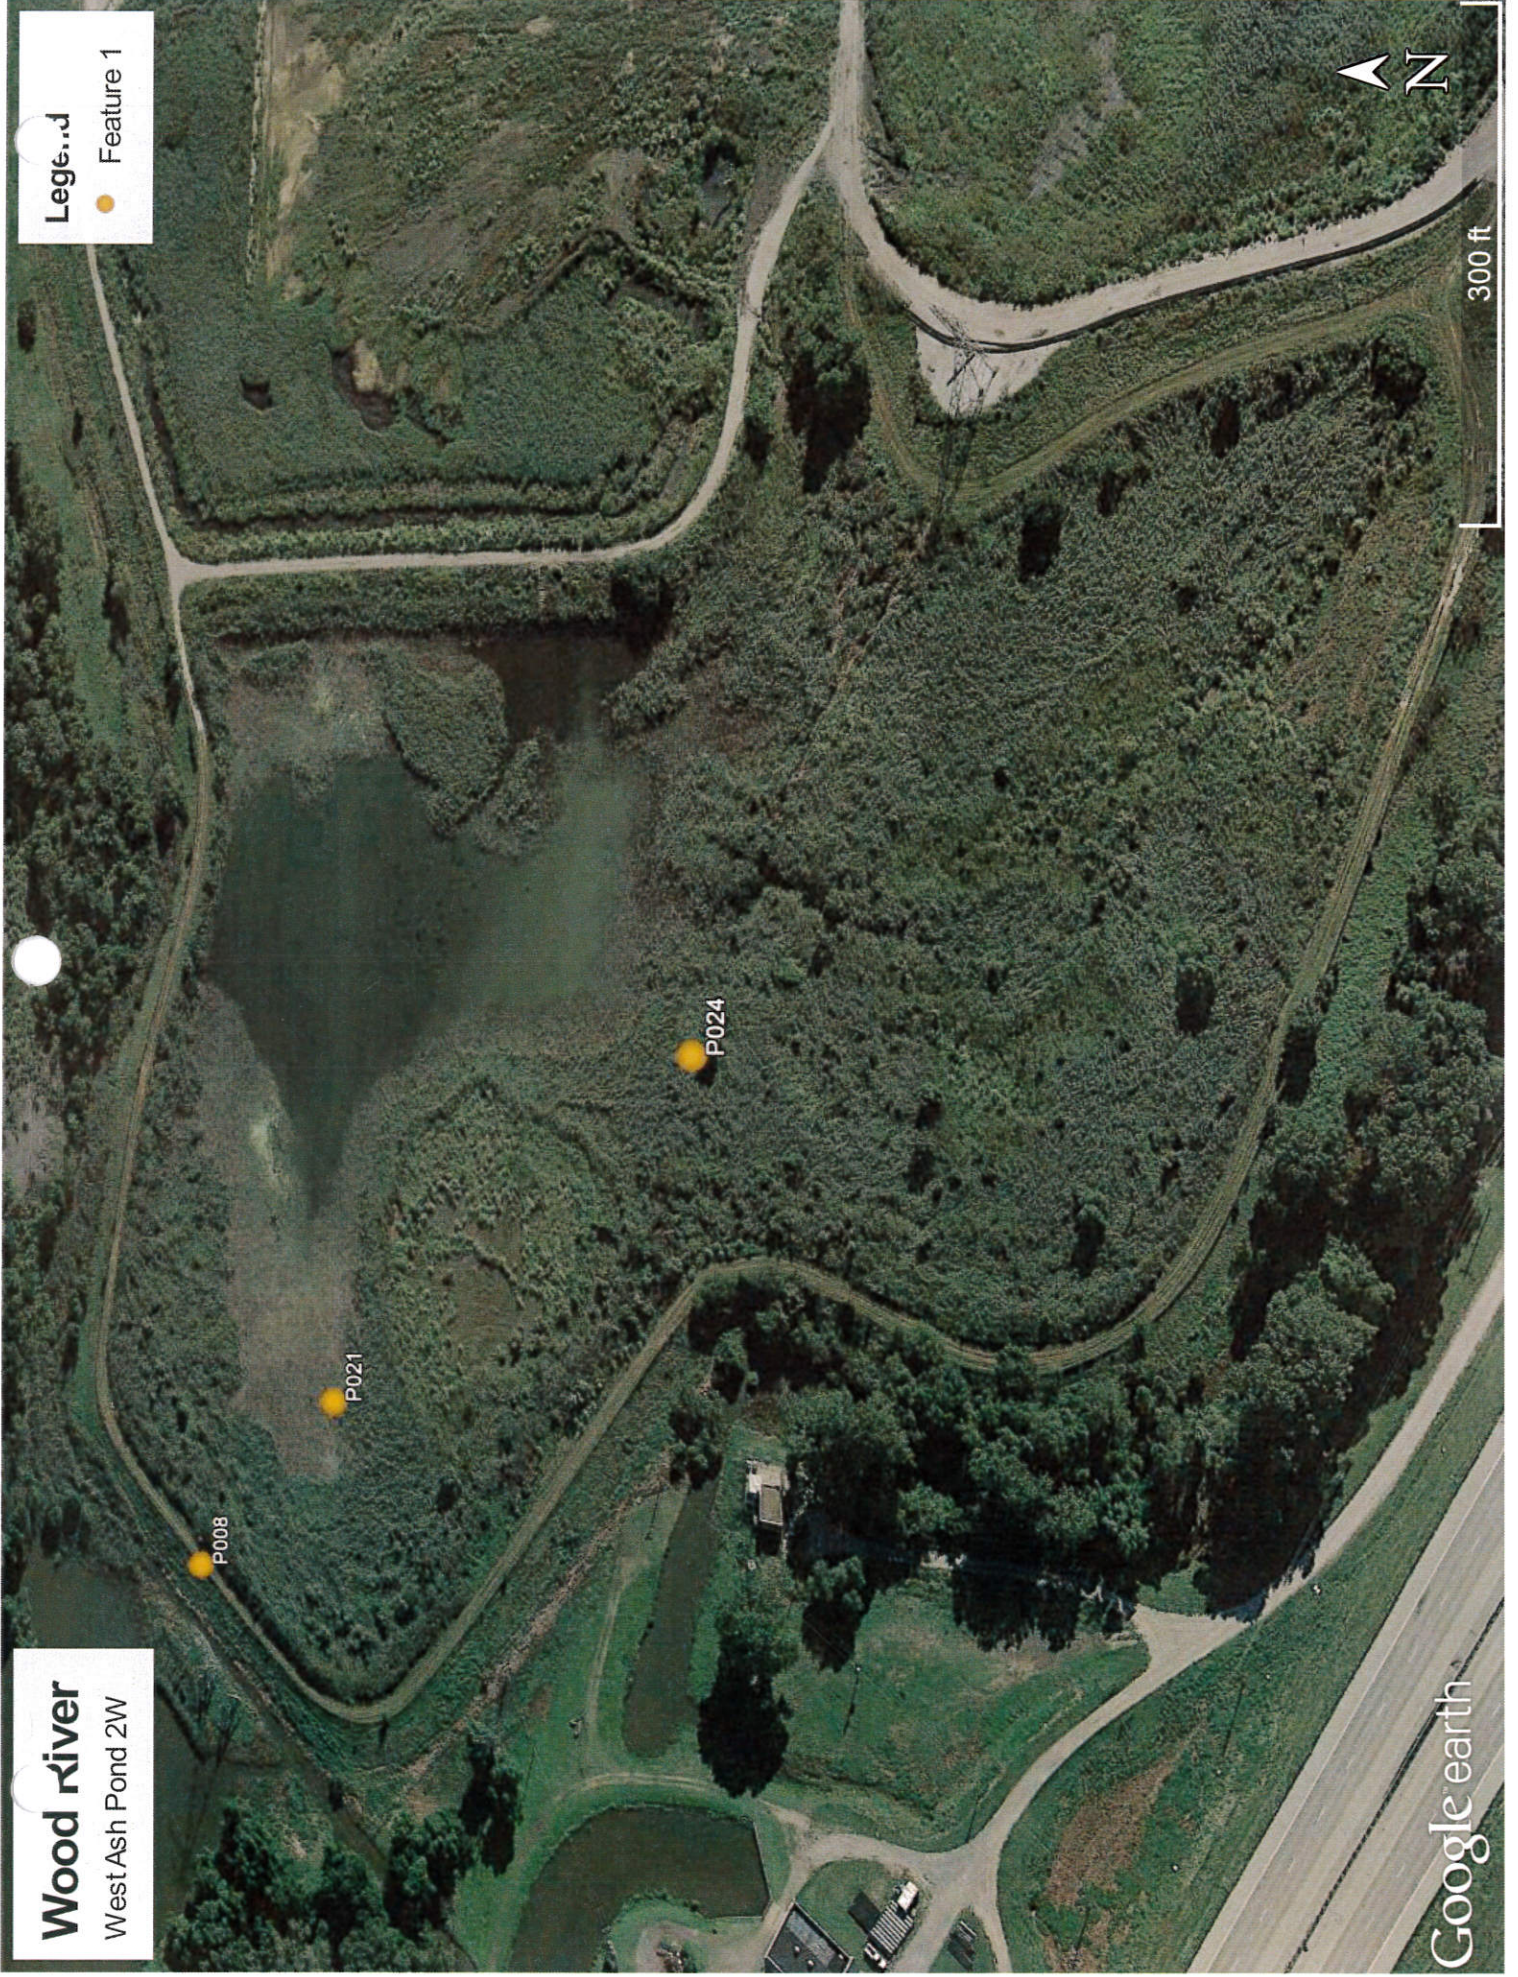
**Wood River**  
West Ash Pond 2W

- ii) Instrumentation  
(Please see following page for instrumentation location map)

Instrument ID #	Type	Maximum recorded reading since previous annual inspection (ft)
P008	Piezometer	407.5'
P021	Piezometer	406.9'
P024	Piezometer	406.6'
