**ANNUAL CCR SURFACE IMPOUNDMENT
INSPECTION REPORT (per 40 CFR 257.83(b)(2))**

Power Station: Wood River Power Station

CCR Impoundment: West Ash Pond 1

Date of Inspection: 8/22/2016

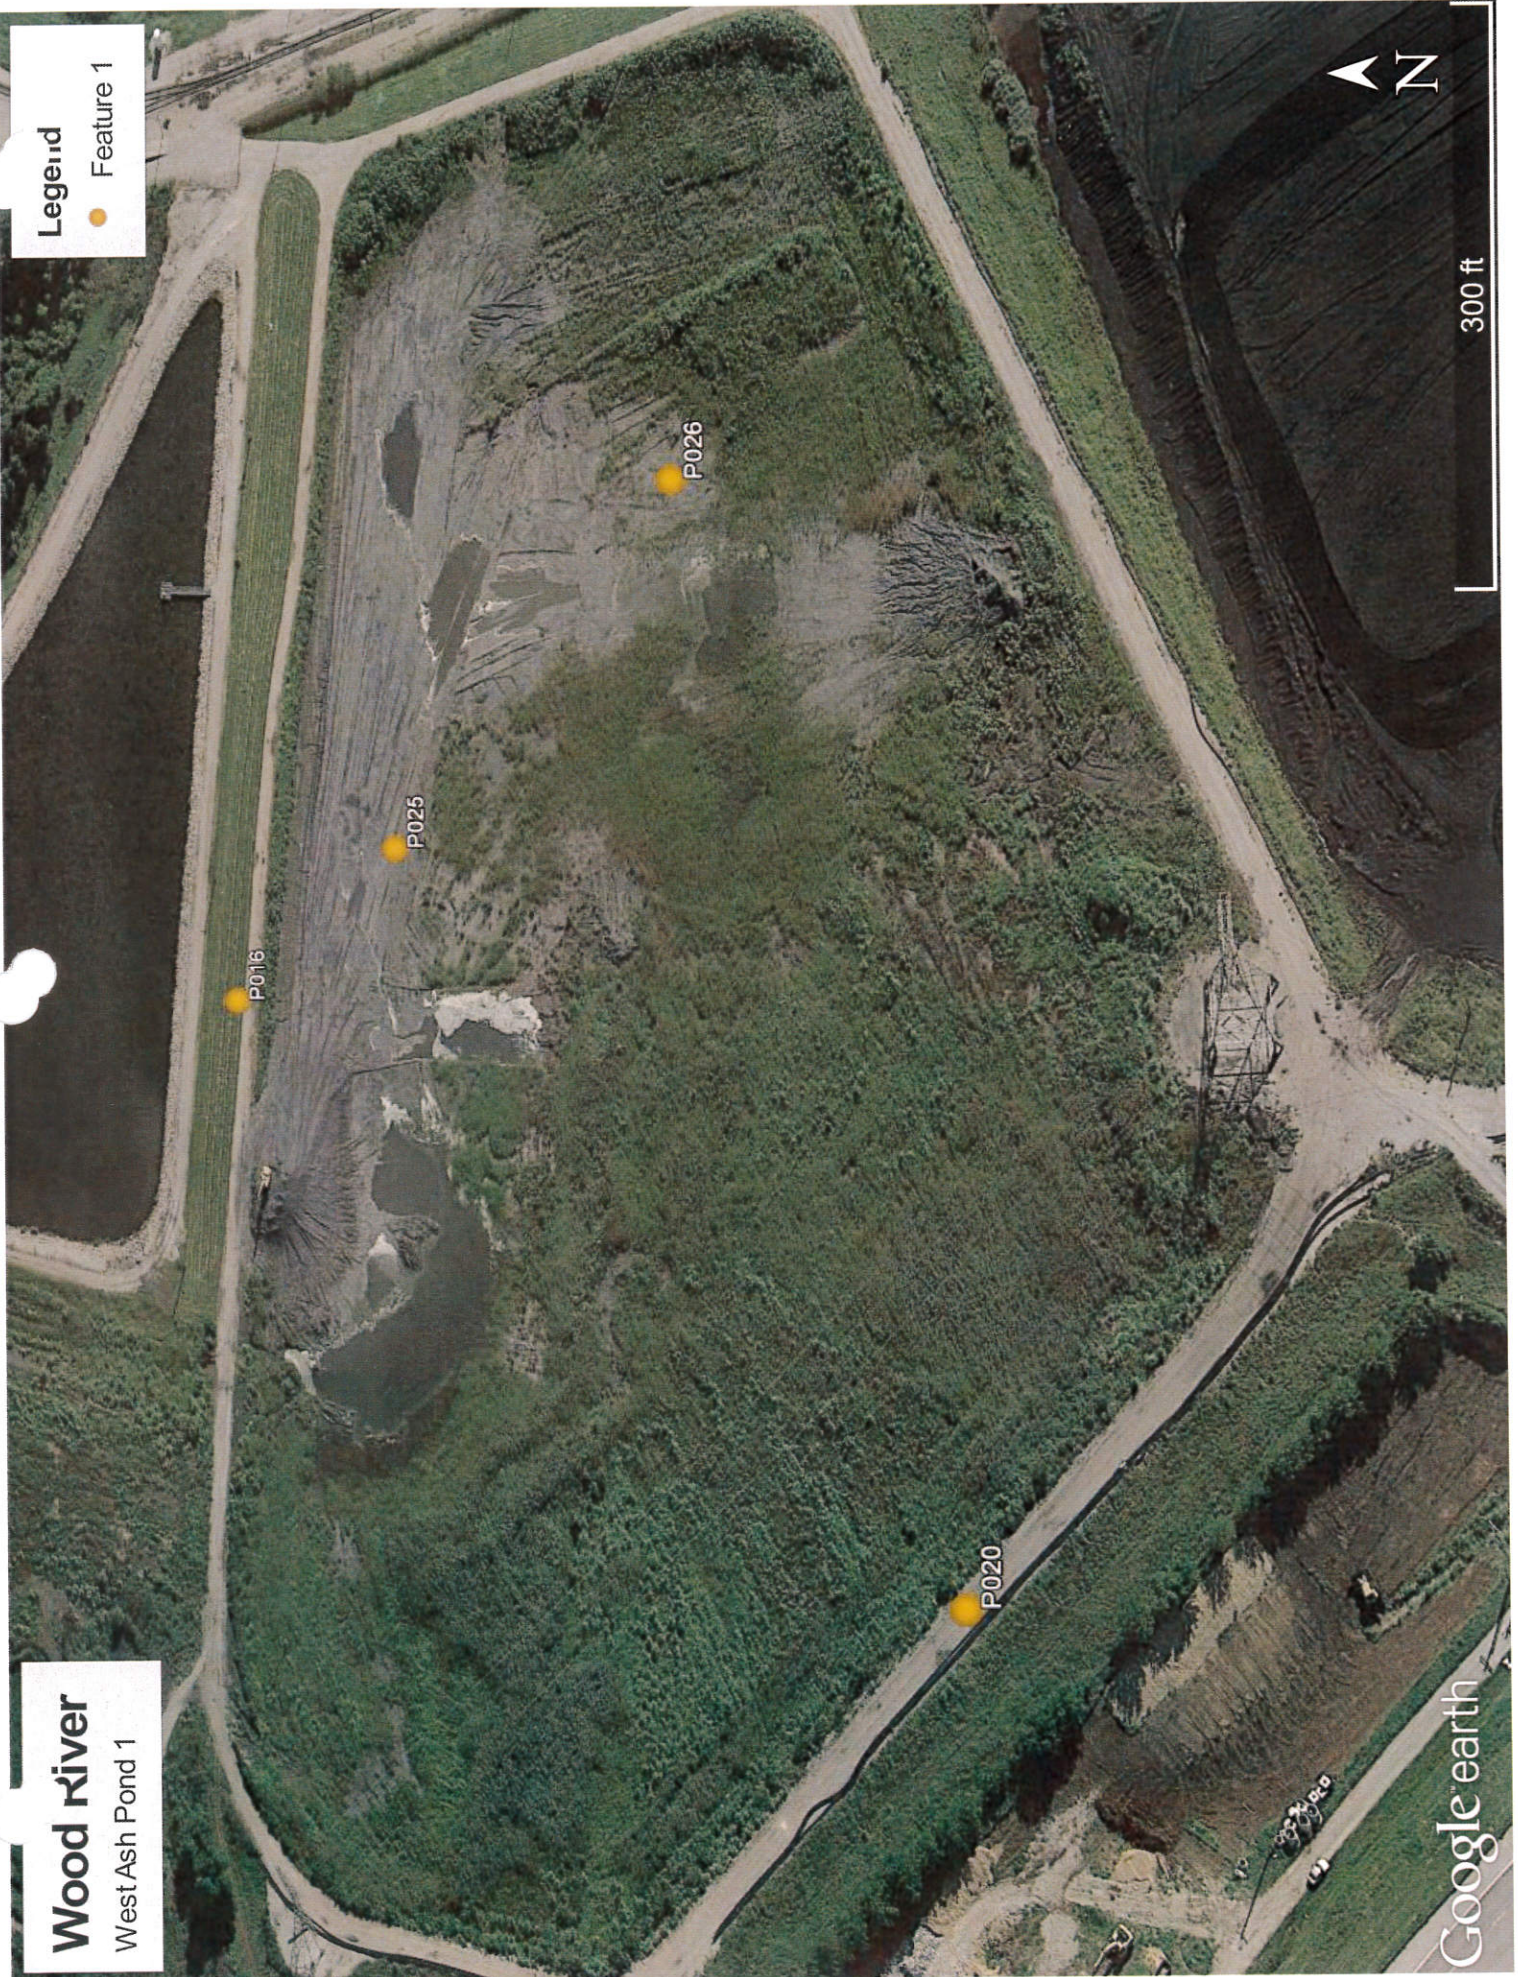
- ii) Instrumentation
(Please see following page for instrumentation location map)

West Ash Pond 1

P016

P025

P026

P020
