REPORT

Structural Stability Assessment 5-Year Update

Martin Lake Steam Electric Station

Ash Pond Area and Permanent Disposal Pond 5

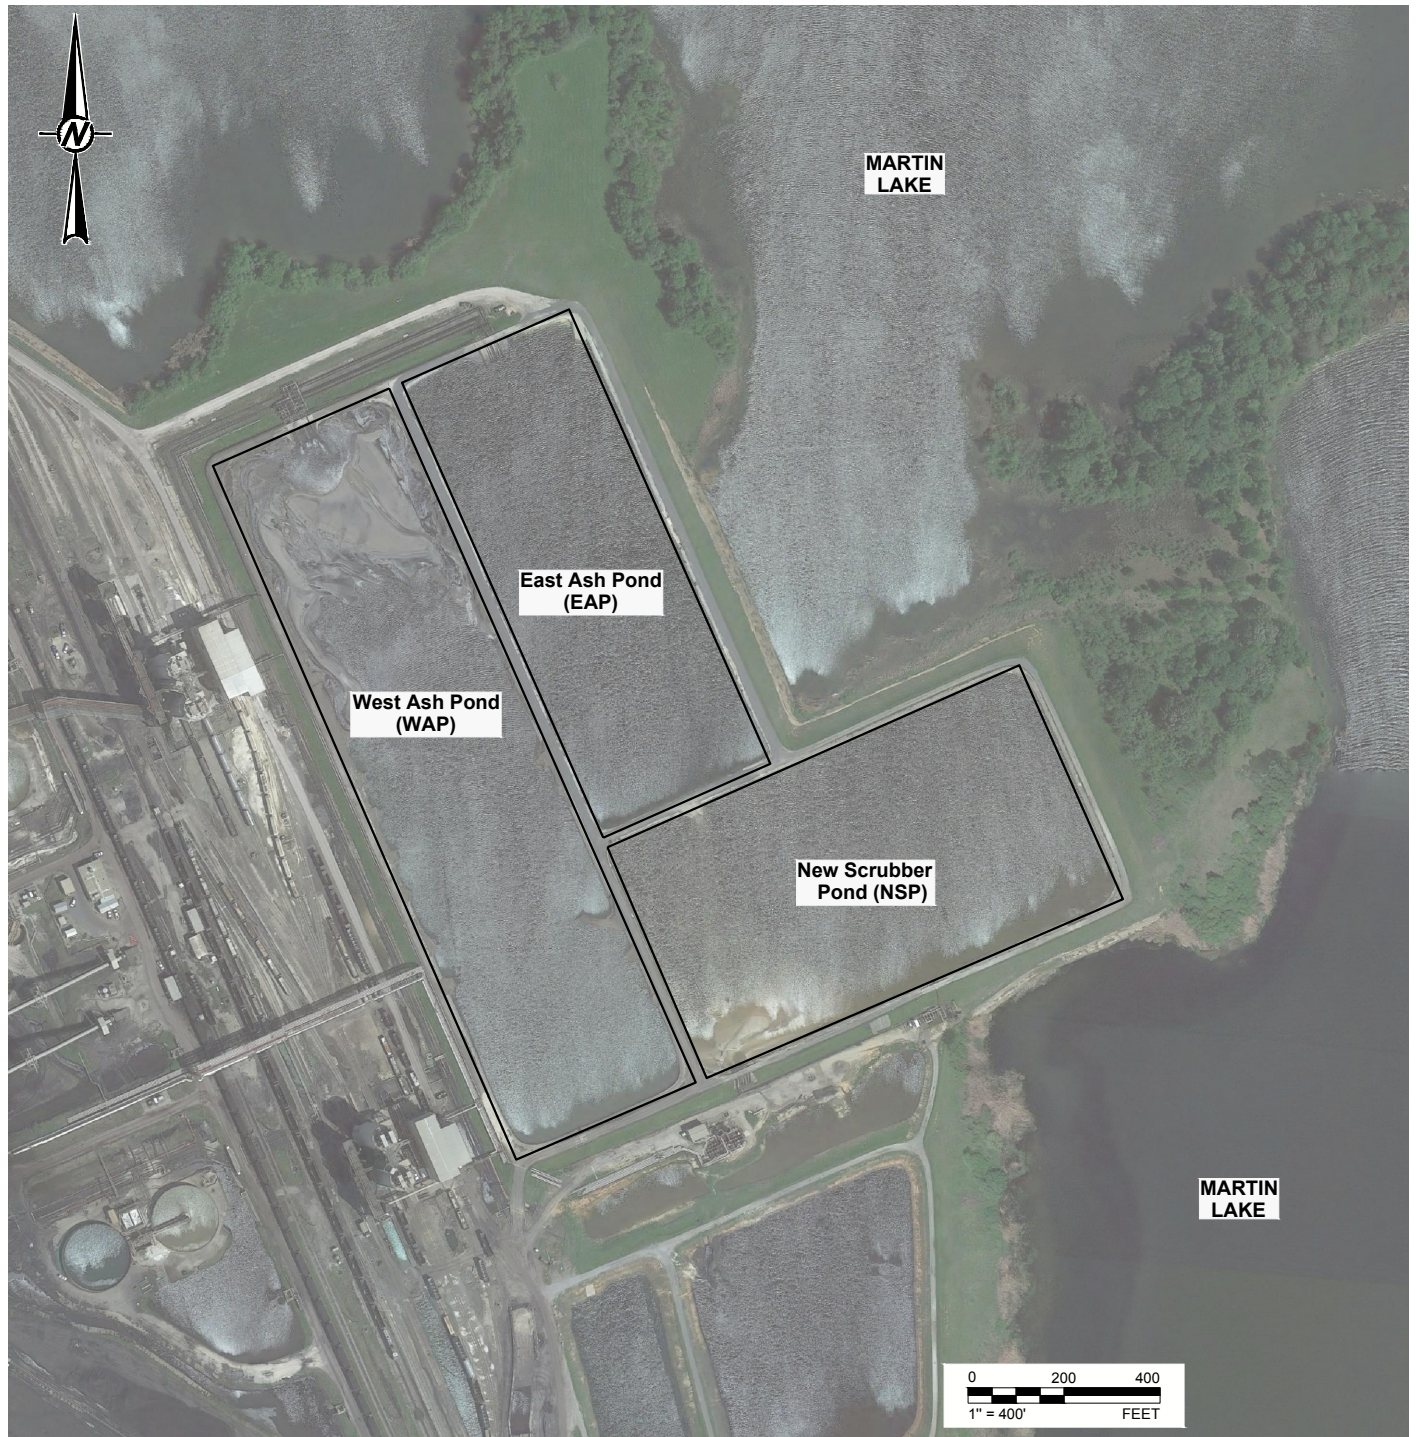
PROJECT NO. CONTROL REV. FIGURE
21465177 0 2

PROJECT
MARTIN LAKE STEAM ELECTRIC STATION
ASH POND AREA AND PDP-5
STRUCTURAL STABILITY ASSESSMENT UPDATE

REFERENCE(S)
BASE MAP TAKEN FROM GOOGLE EARTH, IMAGERY DATED 4/9/19.

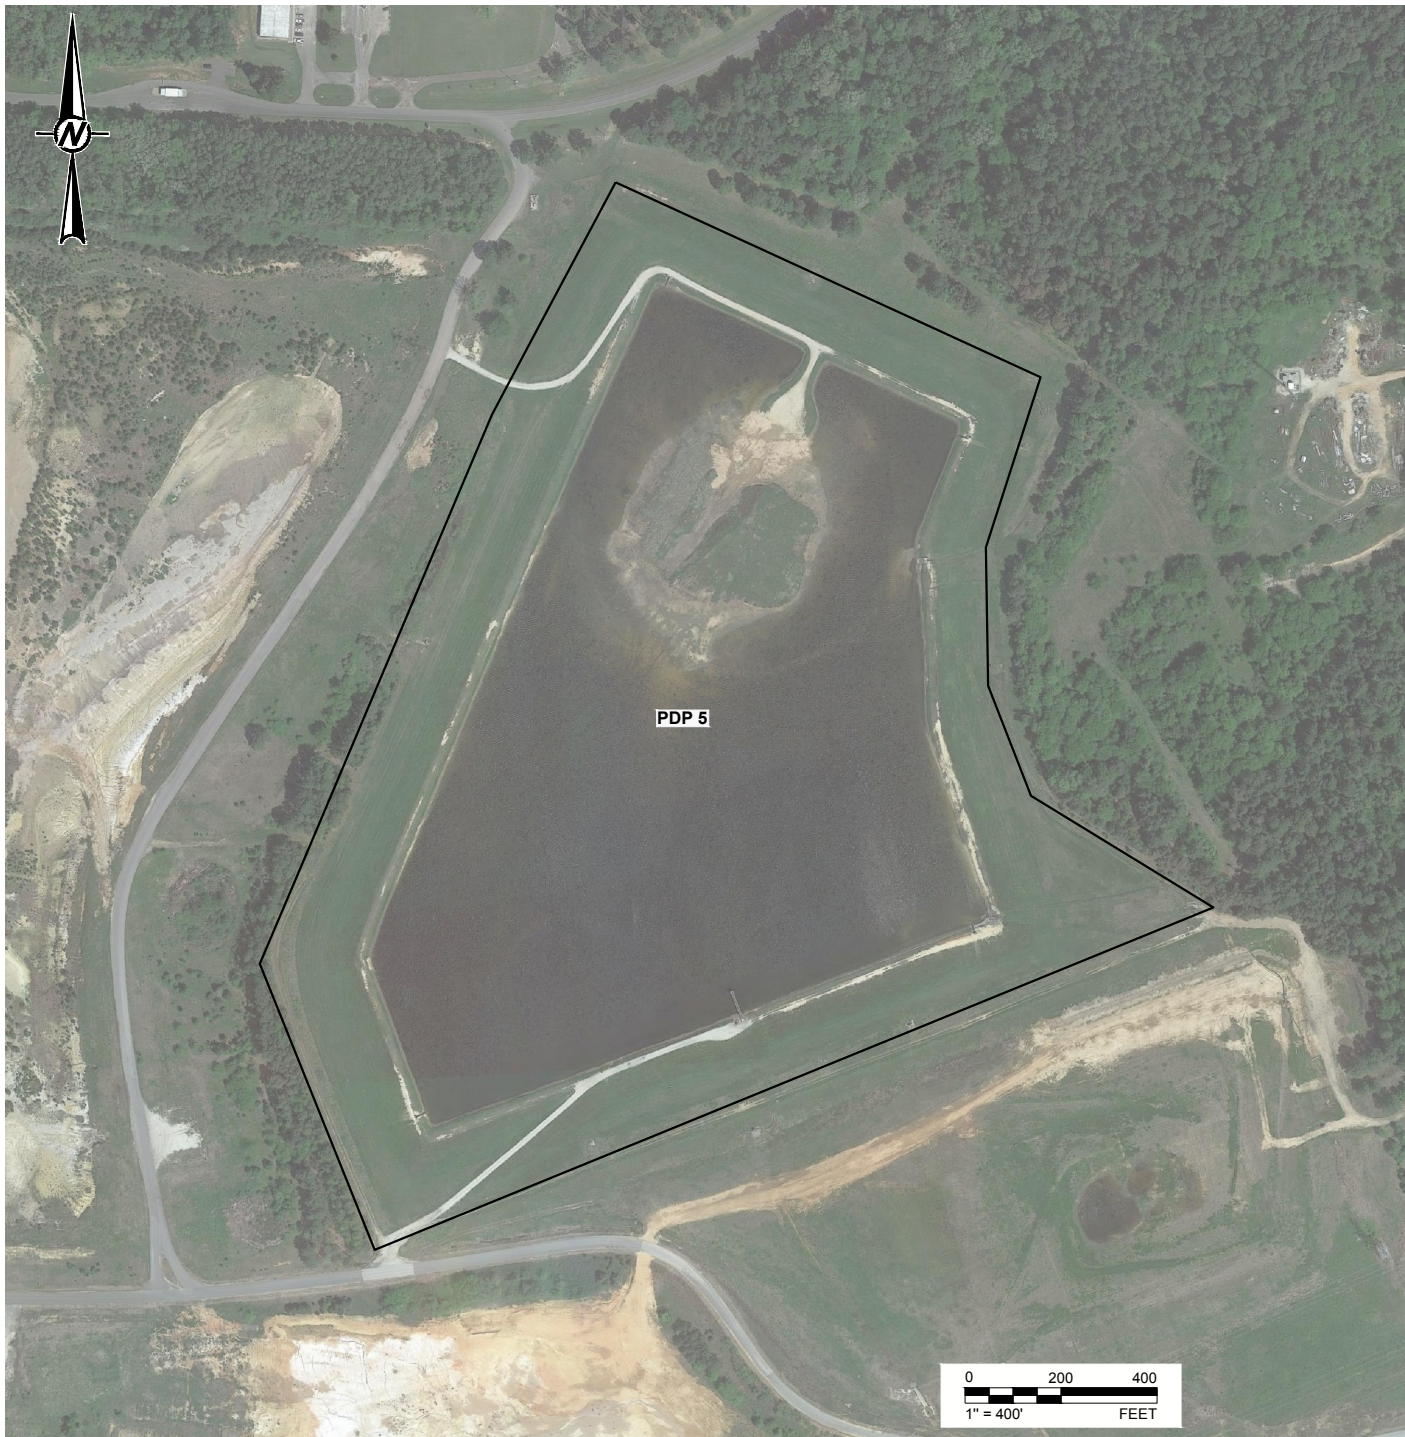
Last Edited By: adiamond Date: 2021-10-01 Time: 4:29:55 PM | Printed By: adiamond Date: 2021-10-01 Time: 4:27:31 PM
 Path: \\golder-gdskomplex\adialoffice\Toxer\kamat\Projects - Round Rock_2021\21465177 - Luminant MLSES\PRODUCTION\2021\SSA | File Name: 3-PDP-5 Area Map.dwg
