Documentation of Initial
Hazard Potential
Classification
Assessment

Ash Pond
Kincaid Power Station
Christian County, Illinois

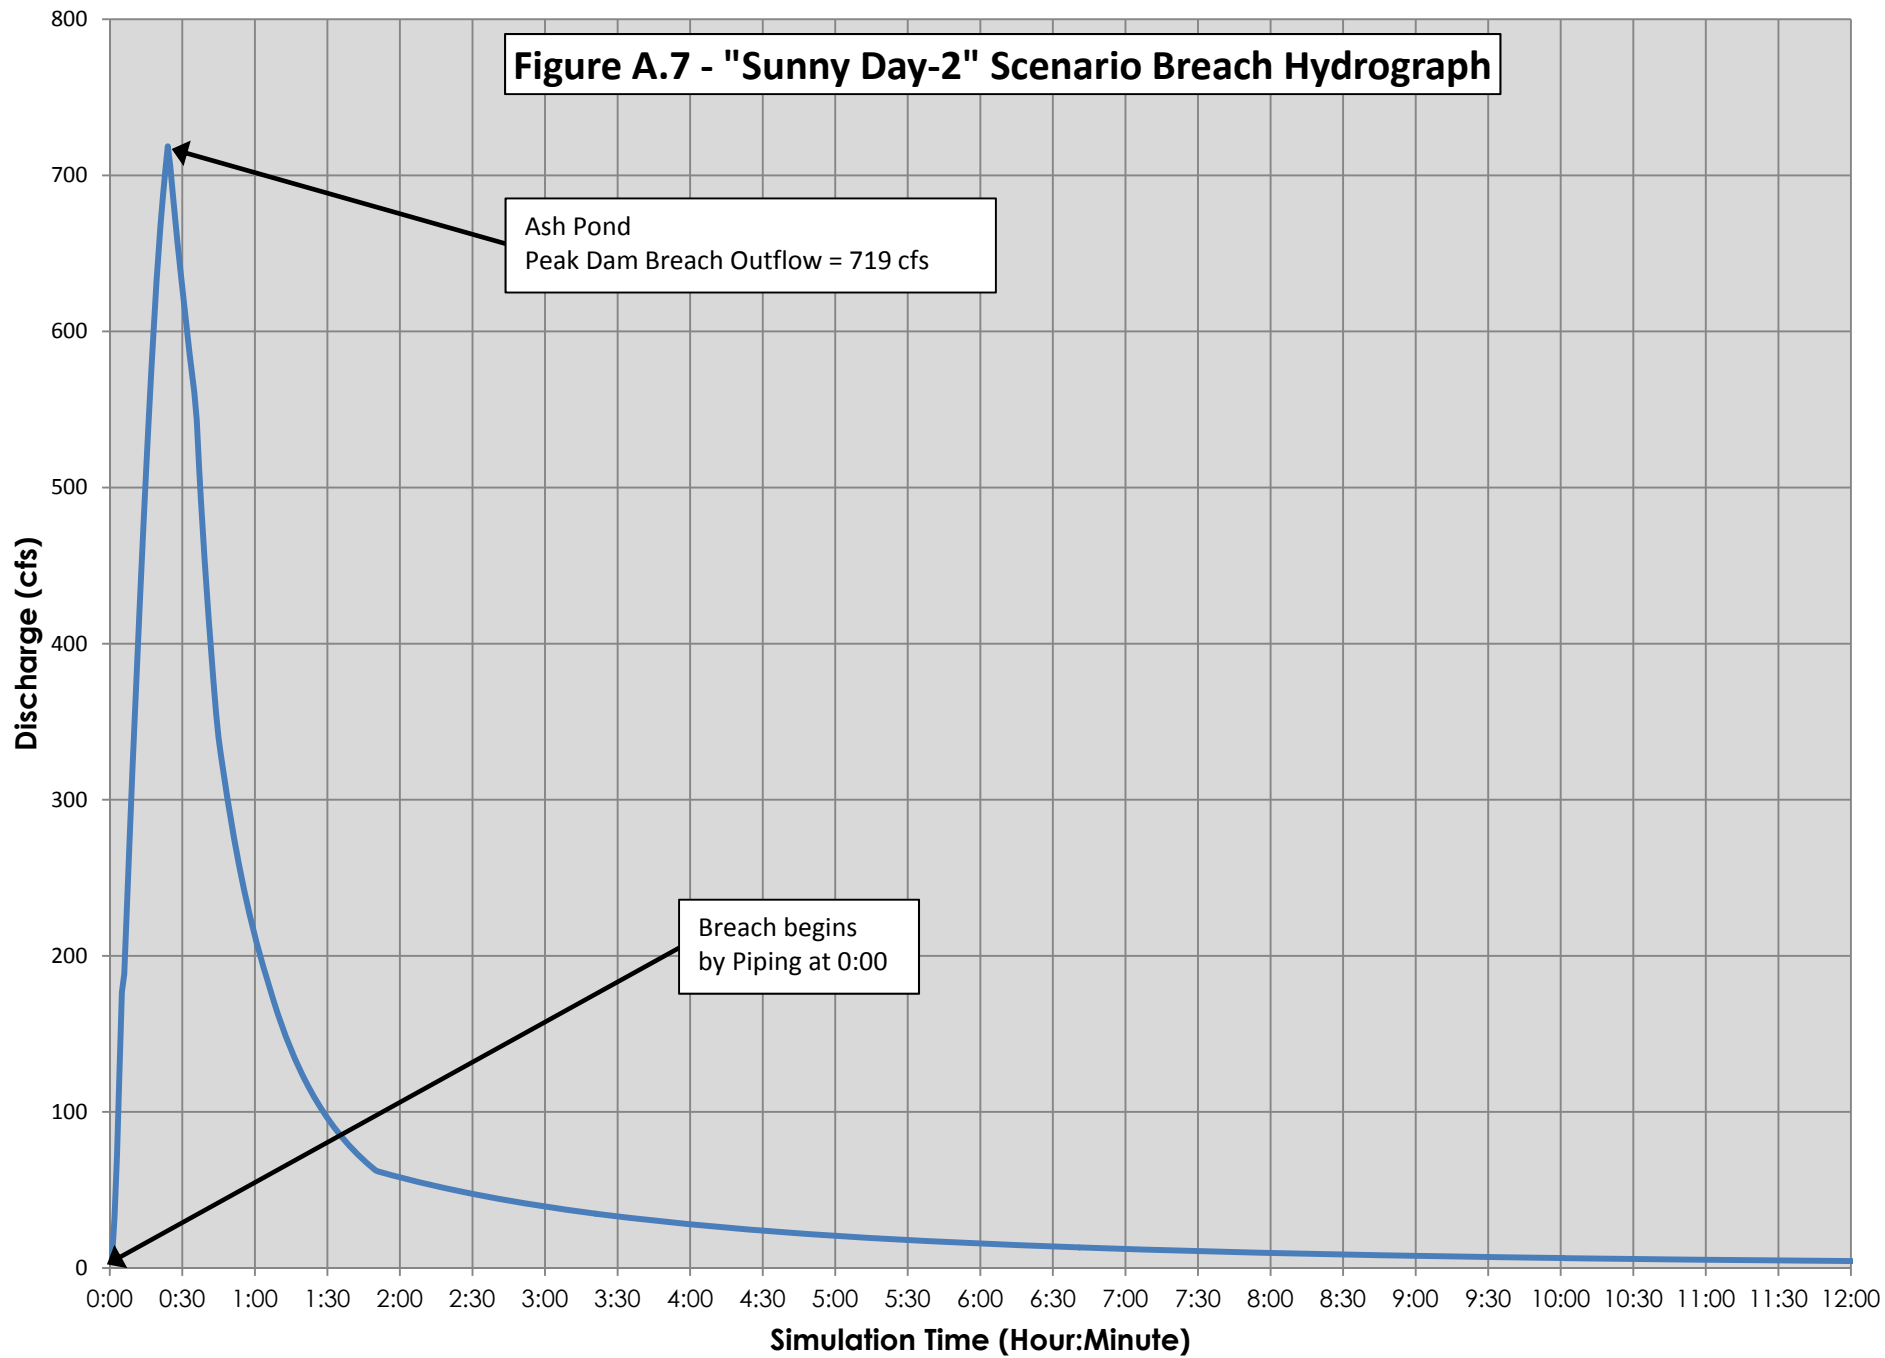
Ash Pond
Peak Dam Breach Outflow = 719 cfs

Breach begins
by Piping at 0:00

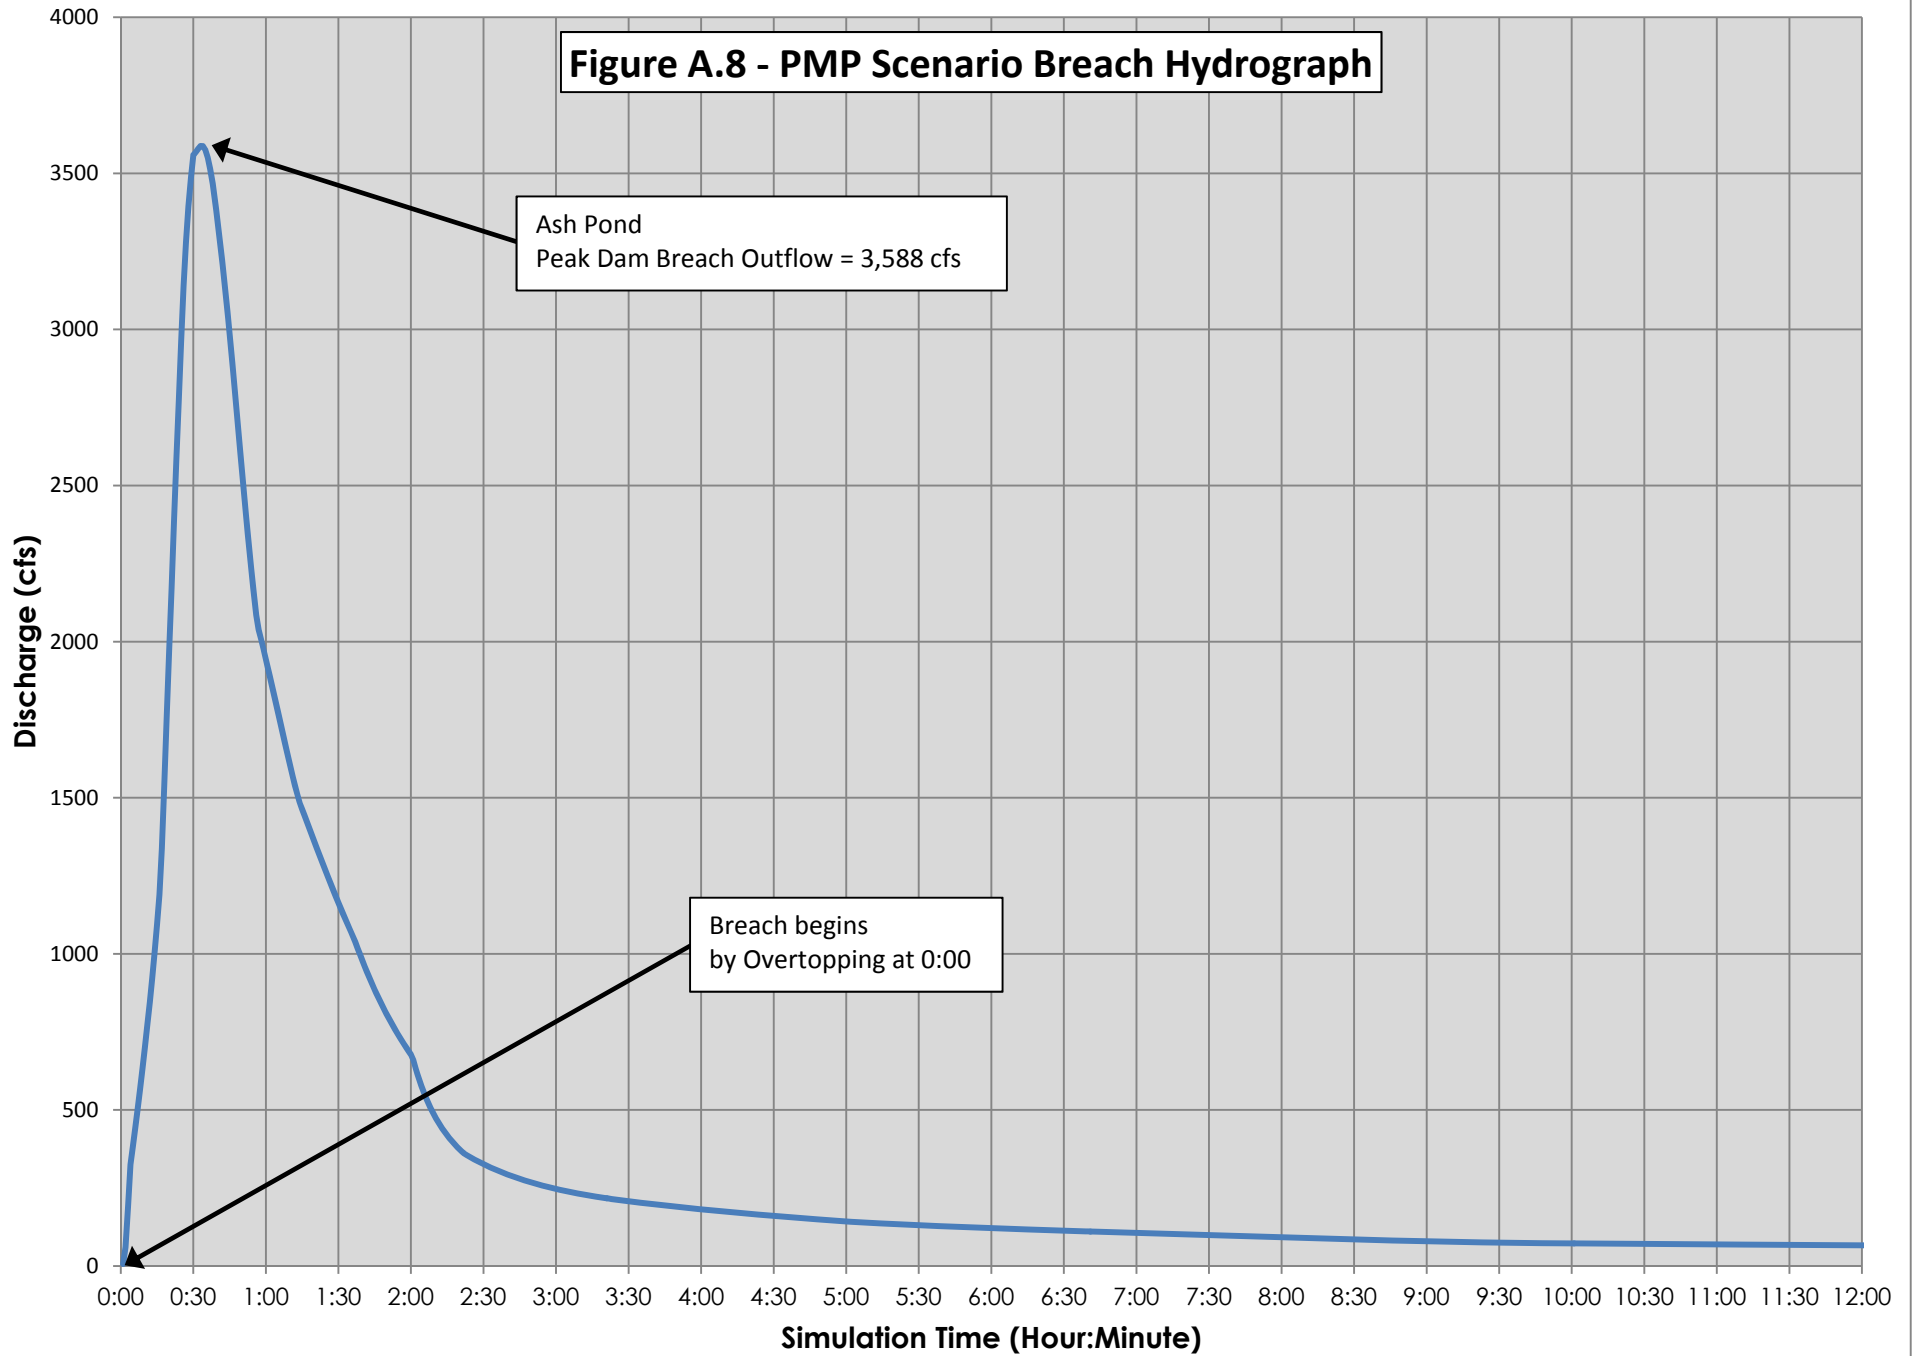
Figure A.8 - PMP Scenario Breach Hydrograph

Ash Pond
Peak Dam Breach Outflow = 3,588 cfs

Breach begins
by Overtopping at 0:00

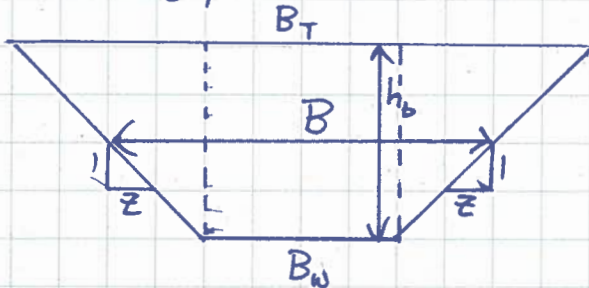
1. BREACH BOTTOM WIDTH GIVEN AVG. BREACH WIDTH B , BREACH HEIGHT h_b , AND BREACH SIDE SLOPES Z

$$B = \frac{B_T + B_W}{2}$$

$$B_T = B_W + 2h_b Z$$

$$B_W = B - h_b Z$$

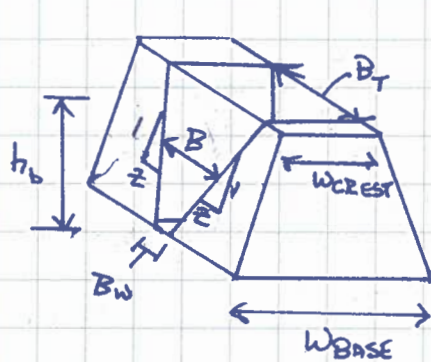
2. VOLUME OF EMBANKMENT ERODED

AREA AT CENTER

$$A_c = B_W h_b + Z h_b^2$$

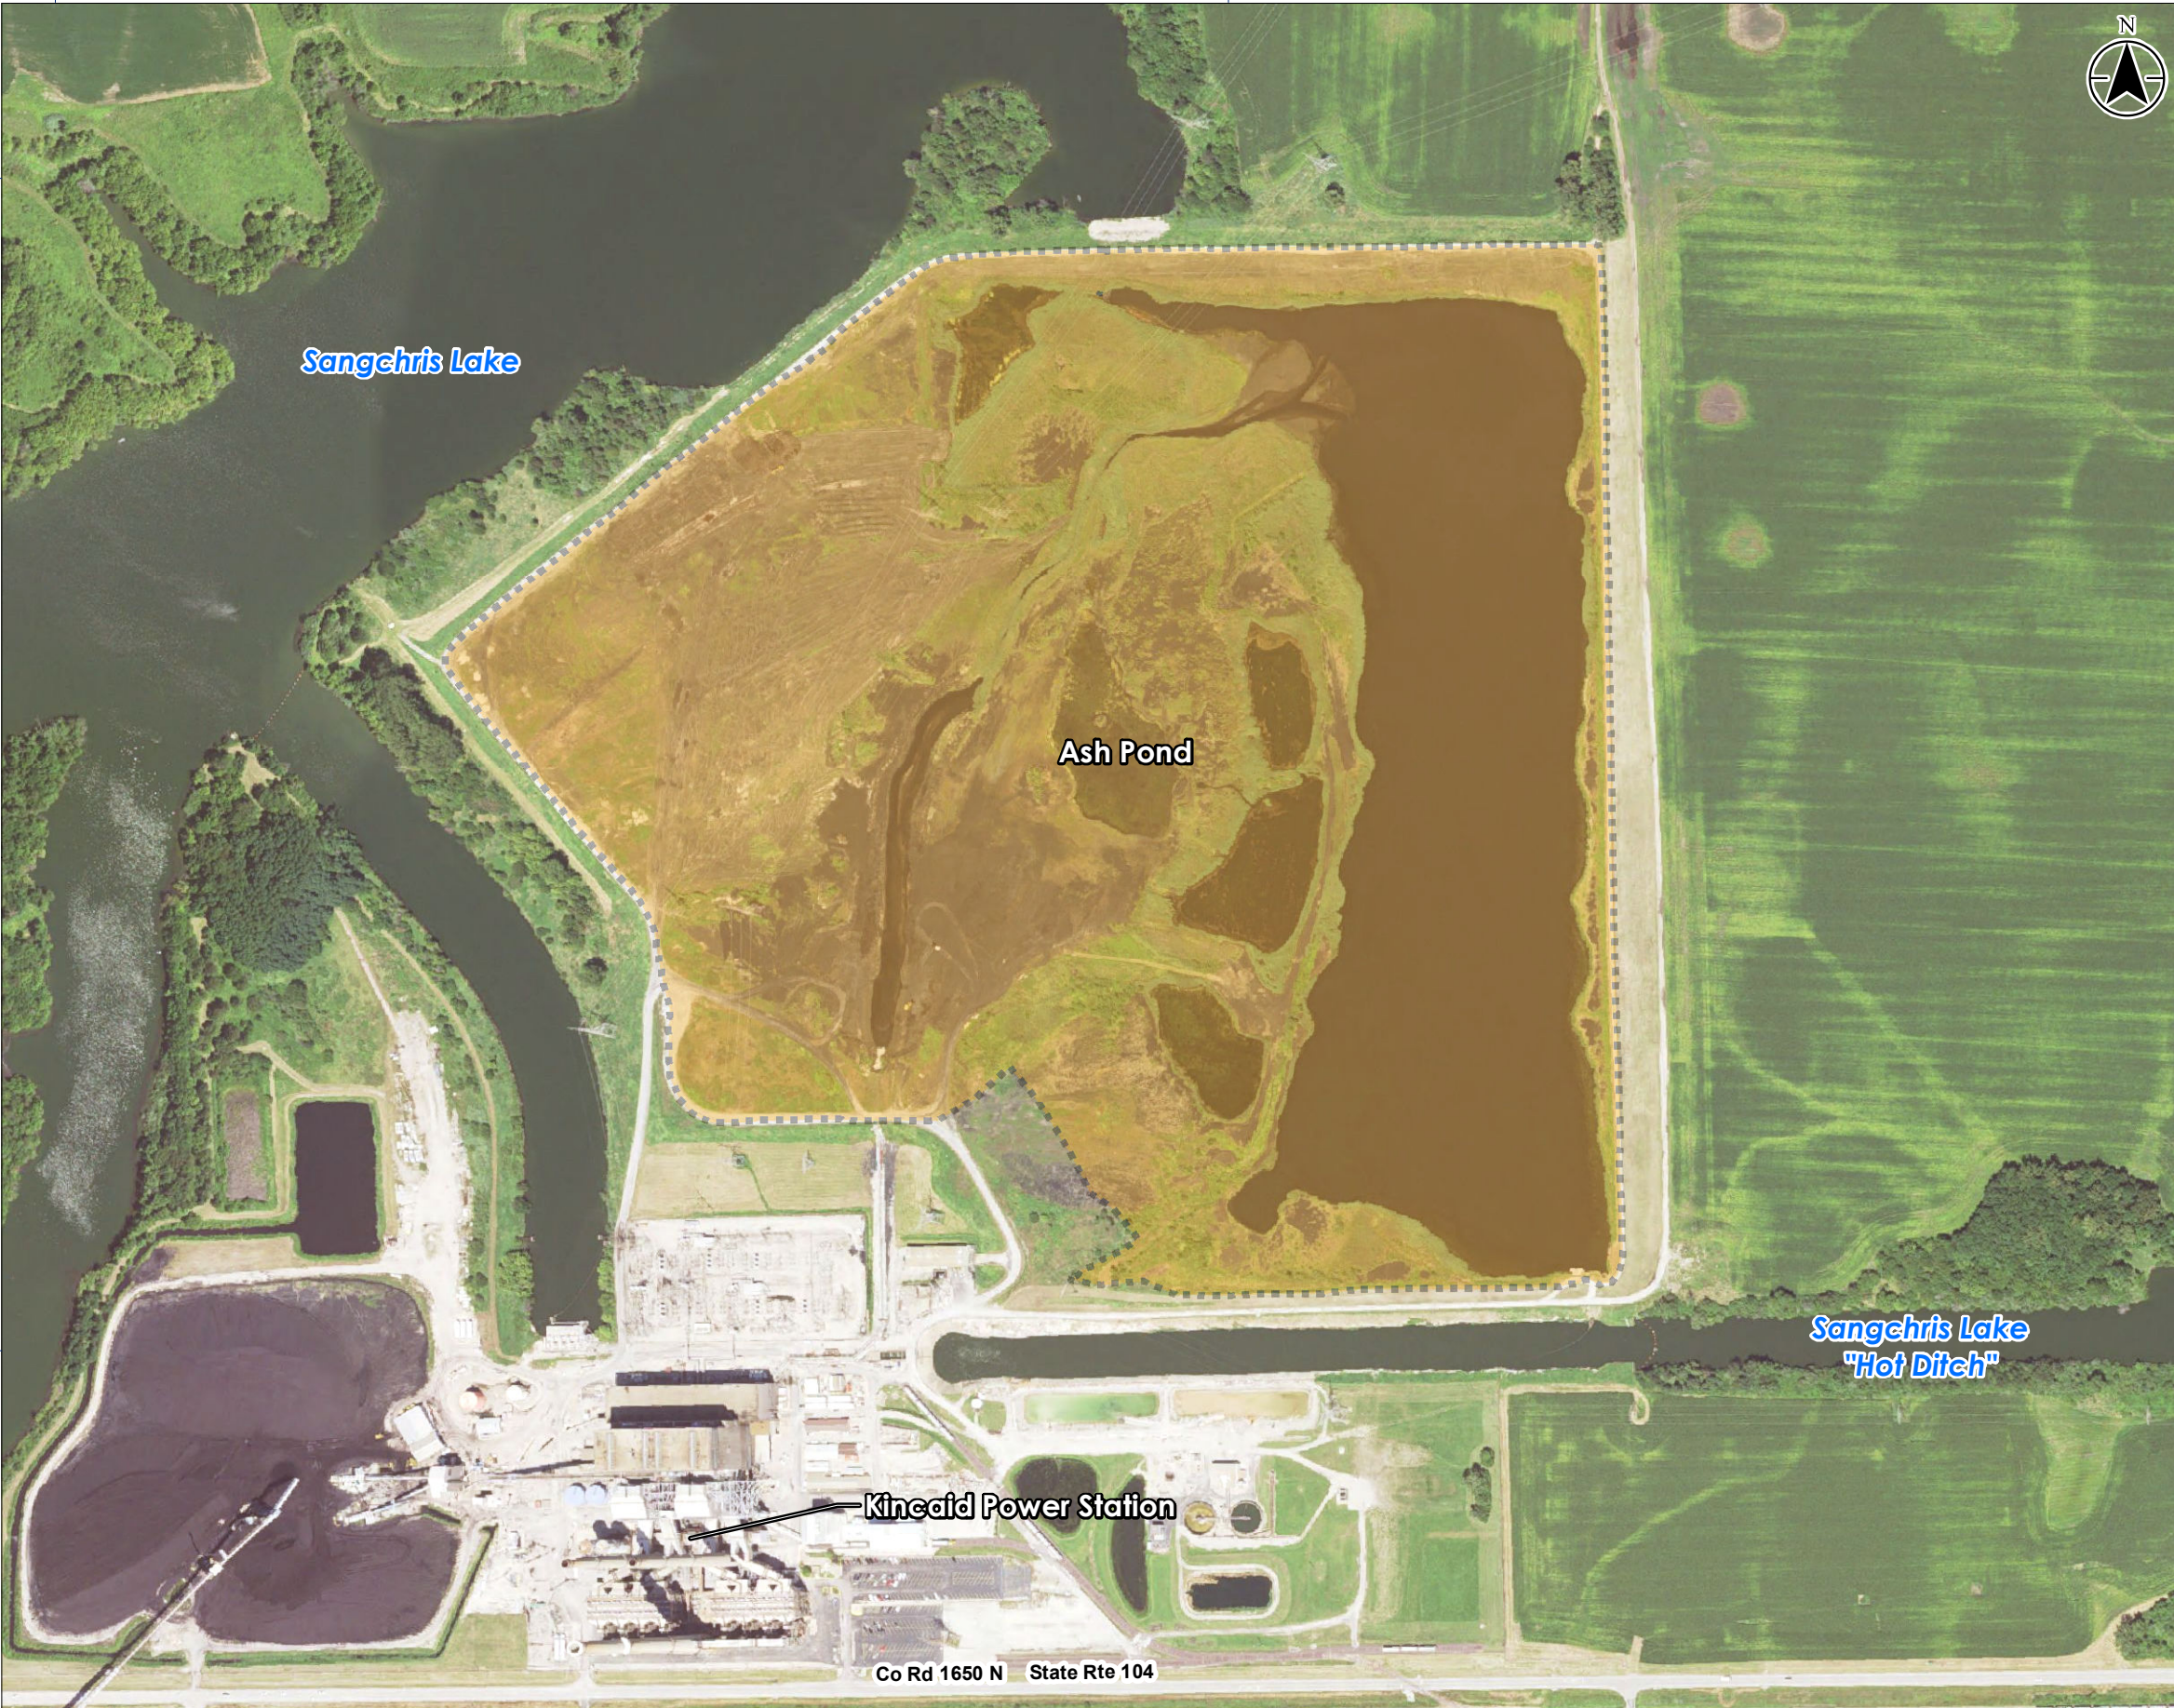
Figure No.
B.1
 Title
**Watershed Figure
 Ash Pond
 Kincaid Power Station**

Ash Pond Watershed Area

Appendix B Watershed Figure
