Documentation of Initial
Hazard Potential
Classification
Assessment

East Ash Pond
Joppa Power Station
Massac County, Illinois

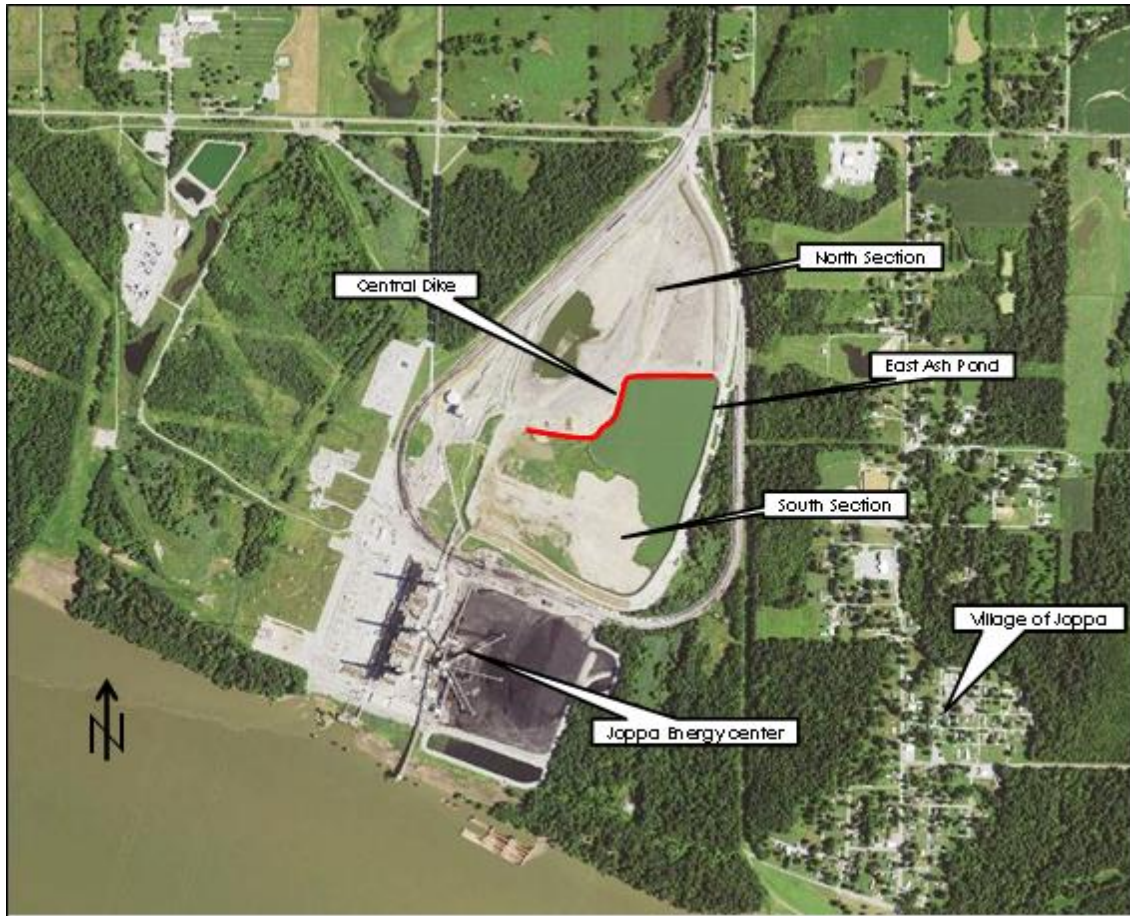
Figure 1 Site Overview

The Joppa Power Station is located in Massac County, Illinois approximately 18 miles downstream of the confluence of the Tennessee River and the Ohio River. The plant is located on the northern bank of the Ohio River, adjacent to the village of Joppa. The East Ash Pond is located to the north of the main facility. The project site overview can be seen in Figure 1.

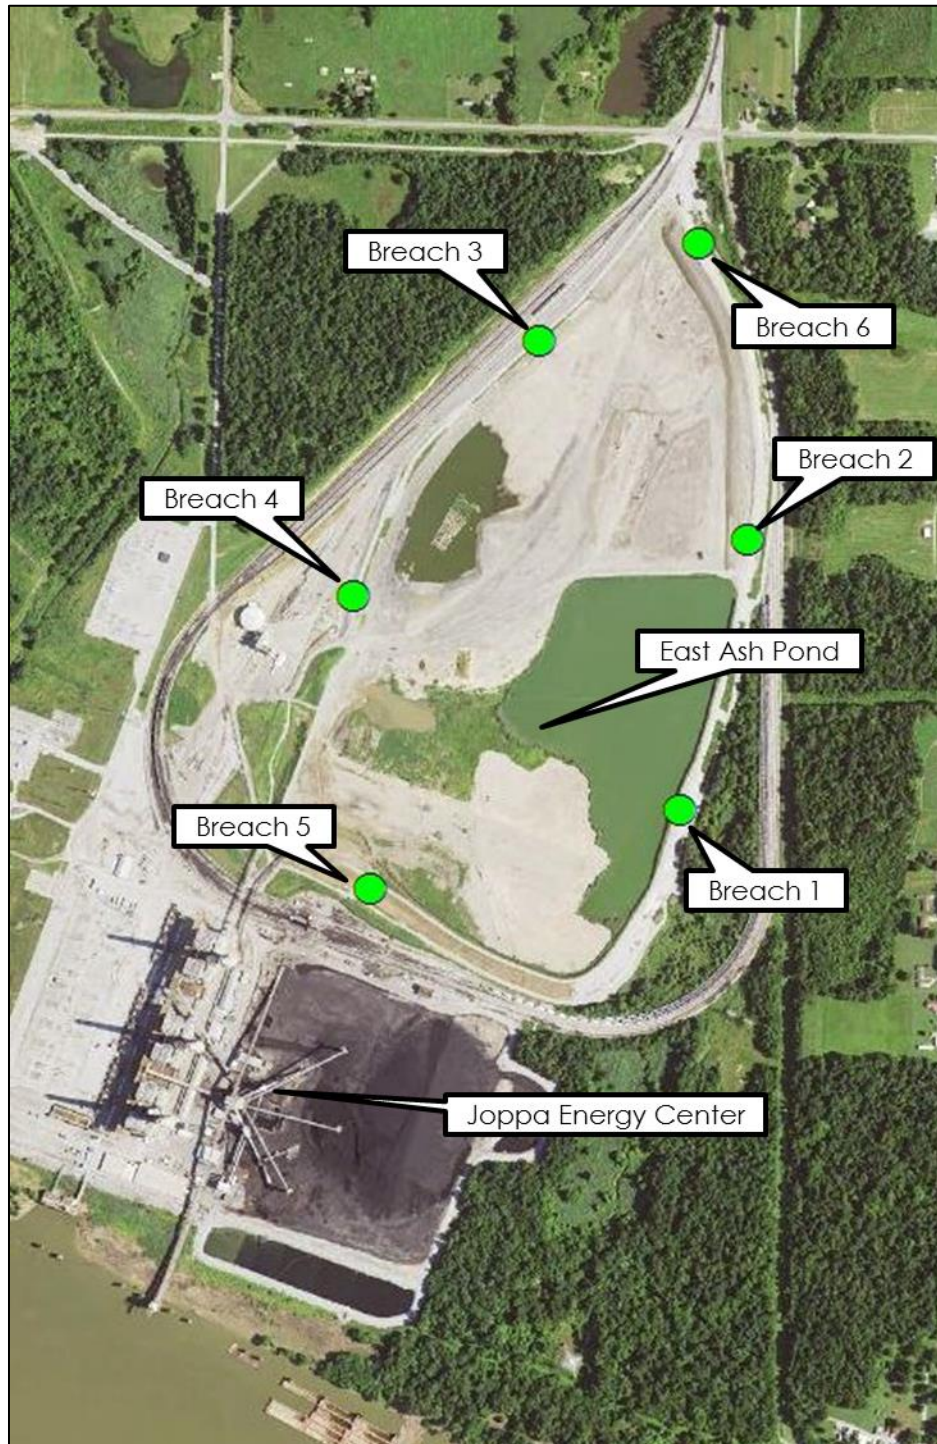
Figure 2 Joppa East Ash Pond Breach Locations

Six breach locations were selected around the East Ash Pond. These locations include: one to the north, two breaches to the west, one breach to the south and two breaches to the east. The six breach scenarios can be seen in Figure 2. Breach locations were selected to evaluate inundation at representative and reasonable breach locations at which a failure might occur.

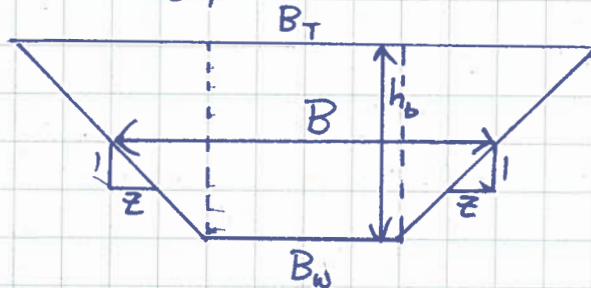
1. BREACH BOTTOM WIDTH GIVEN AVG. BREACH WIDTH B , BREACH HEIGHT h_b , AND BREACH SIDE SLOPES Z

$$B = \frac{B_T + B_W}{2}$$

$$B_T = B_W + 2h_b Z$$

$$B_W = B - h_b Z$$

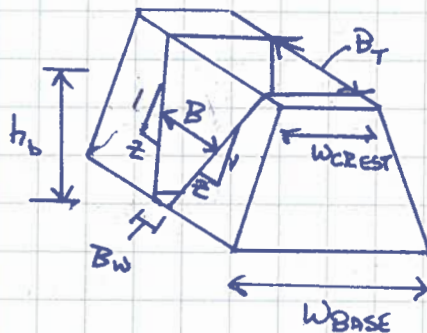
2. VOLUME OF EMBANKMENT ERODED

AREA AT CENTER

$$A_c = B_W h_b + Z h_b^2$$
