2021 USEPA CCR RULE PERIODIC OPERATING RECORD RUN-ON AND RUN-OFF CONTROL PLAN REVIEW REPORT §257.81 CCR LANDFILL Hennepin Power Plant Hennepin, Illinois

October 11, 2021

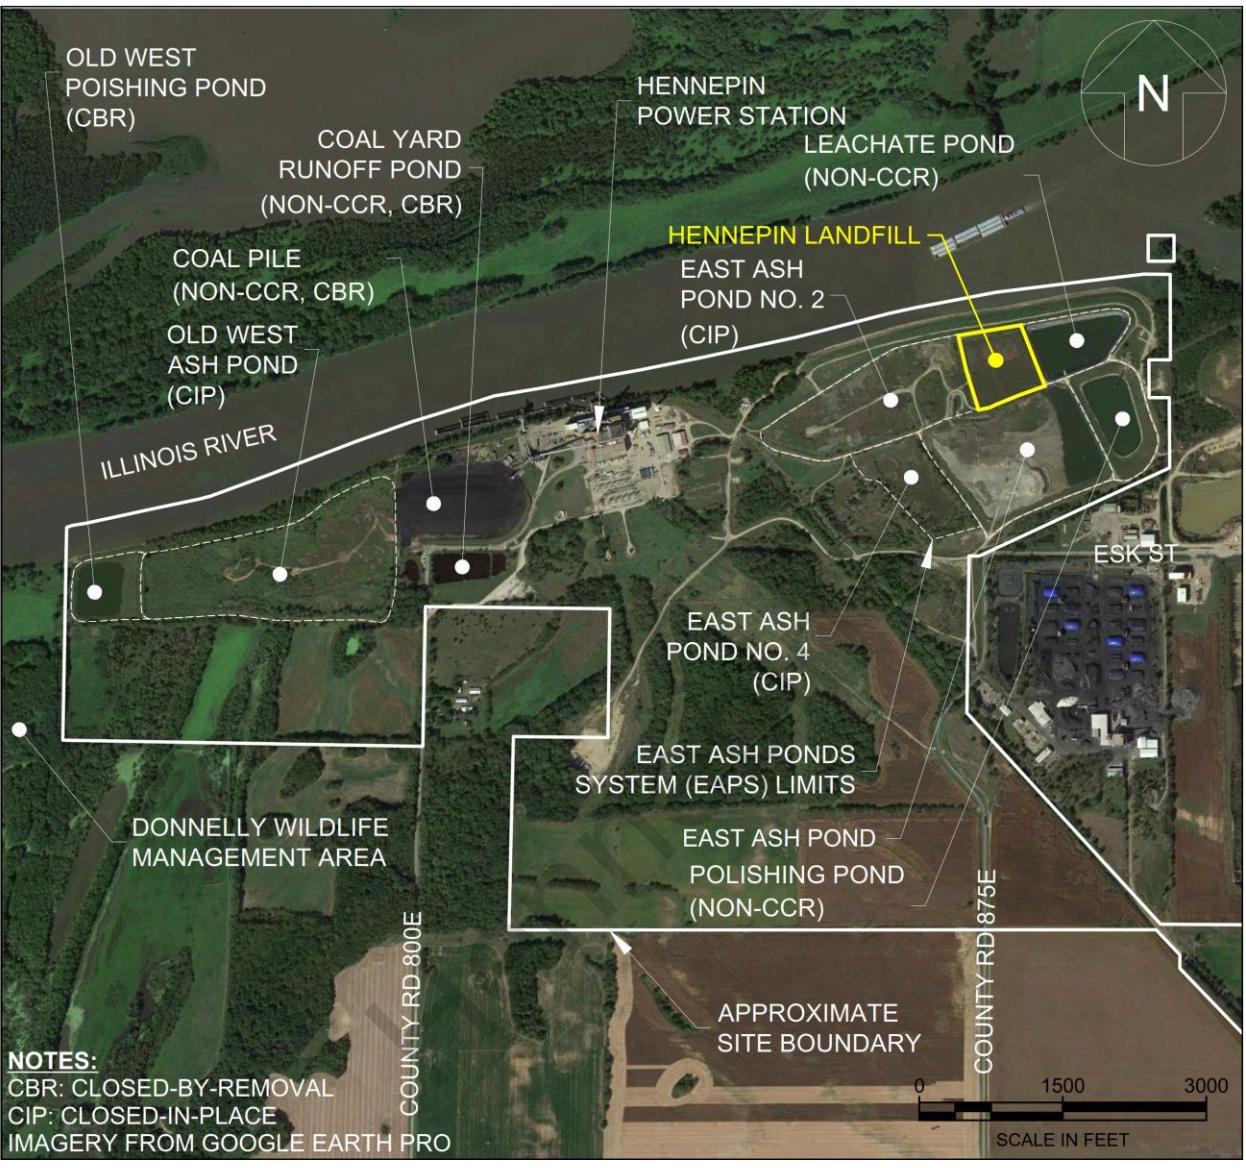
Figure 2 – Site Plan

HPP is located at 13498 East 800th Street in Hennepin, Illinois, 61327. The location of HPP is illustrated in **Figure 1**, and a site plan showing the location of the LF, among other closed and open CCR and non-CCR surface impoundments, is provided in **Figure 2**.

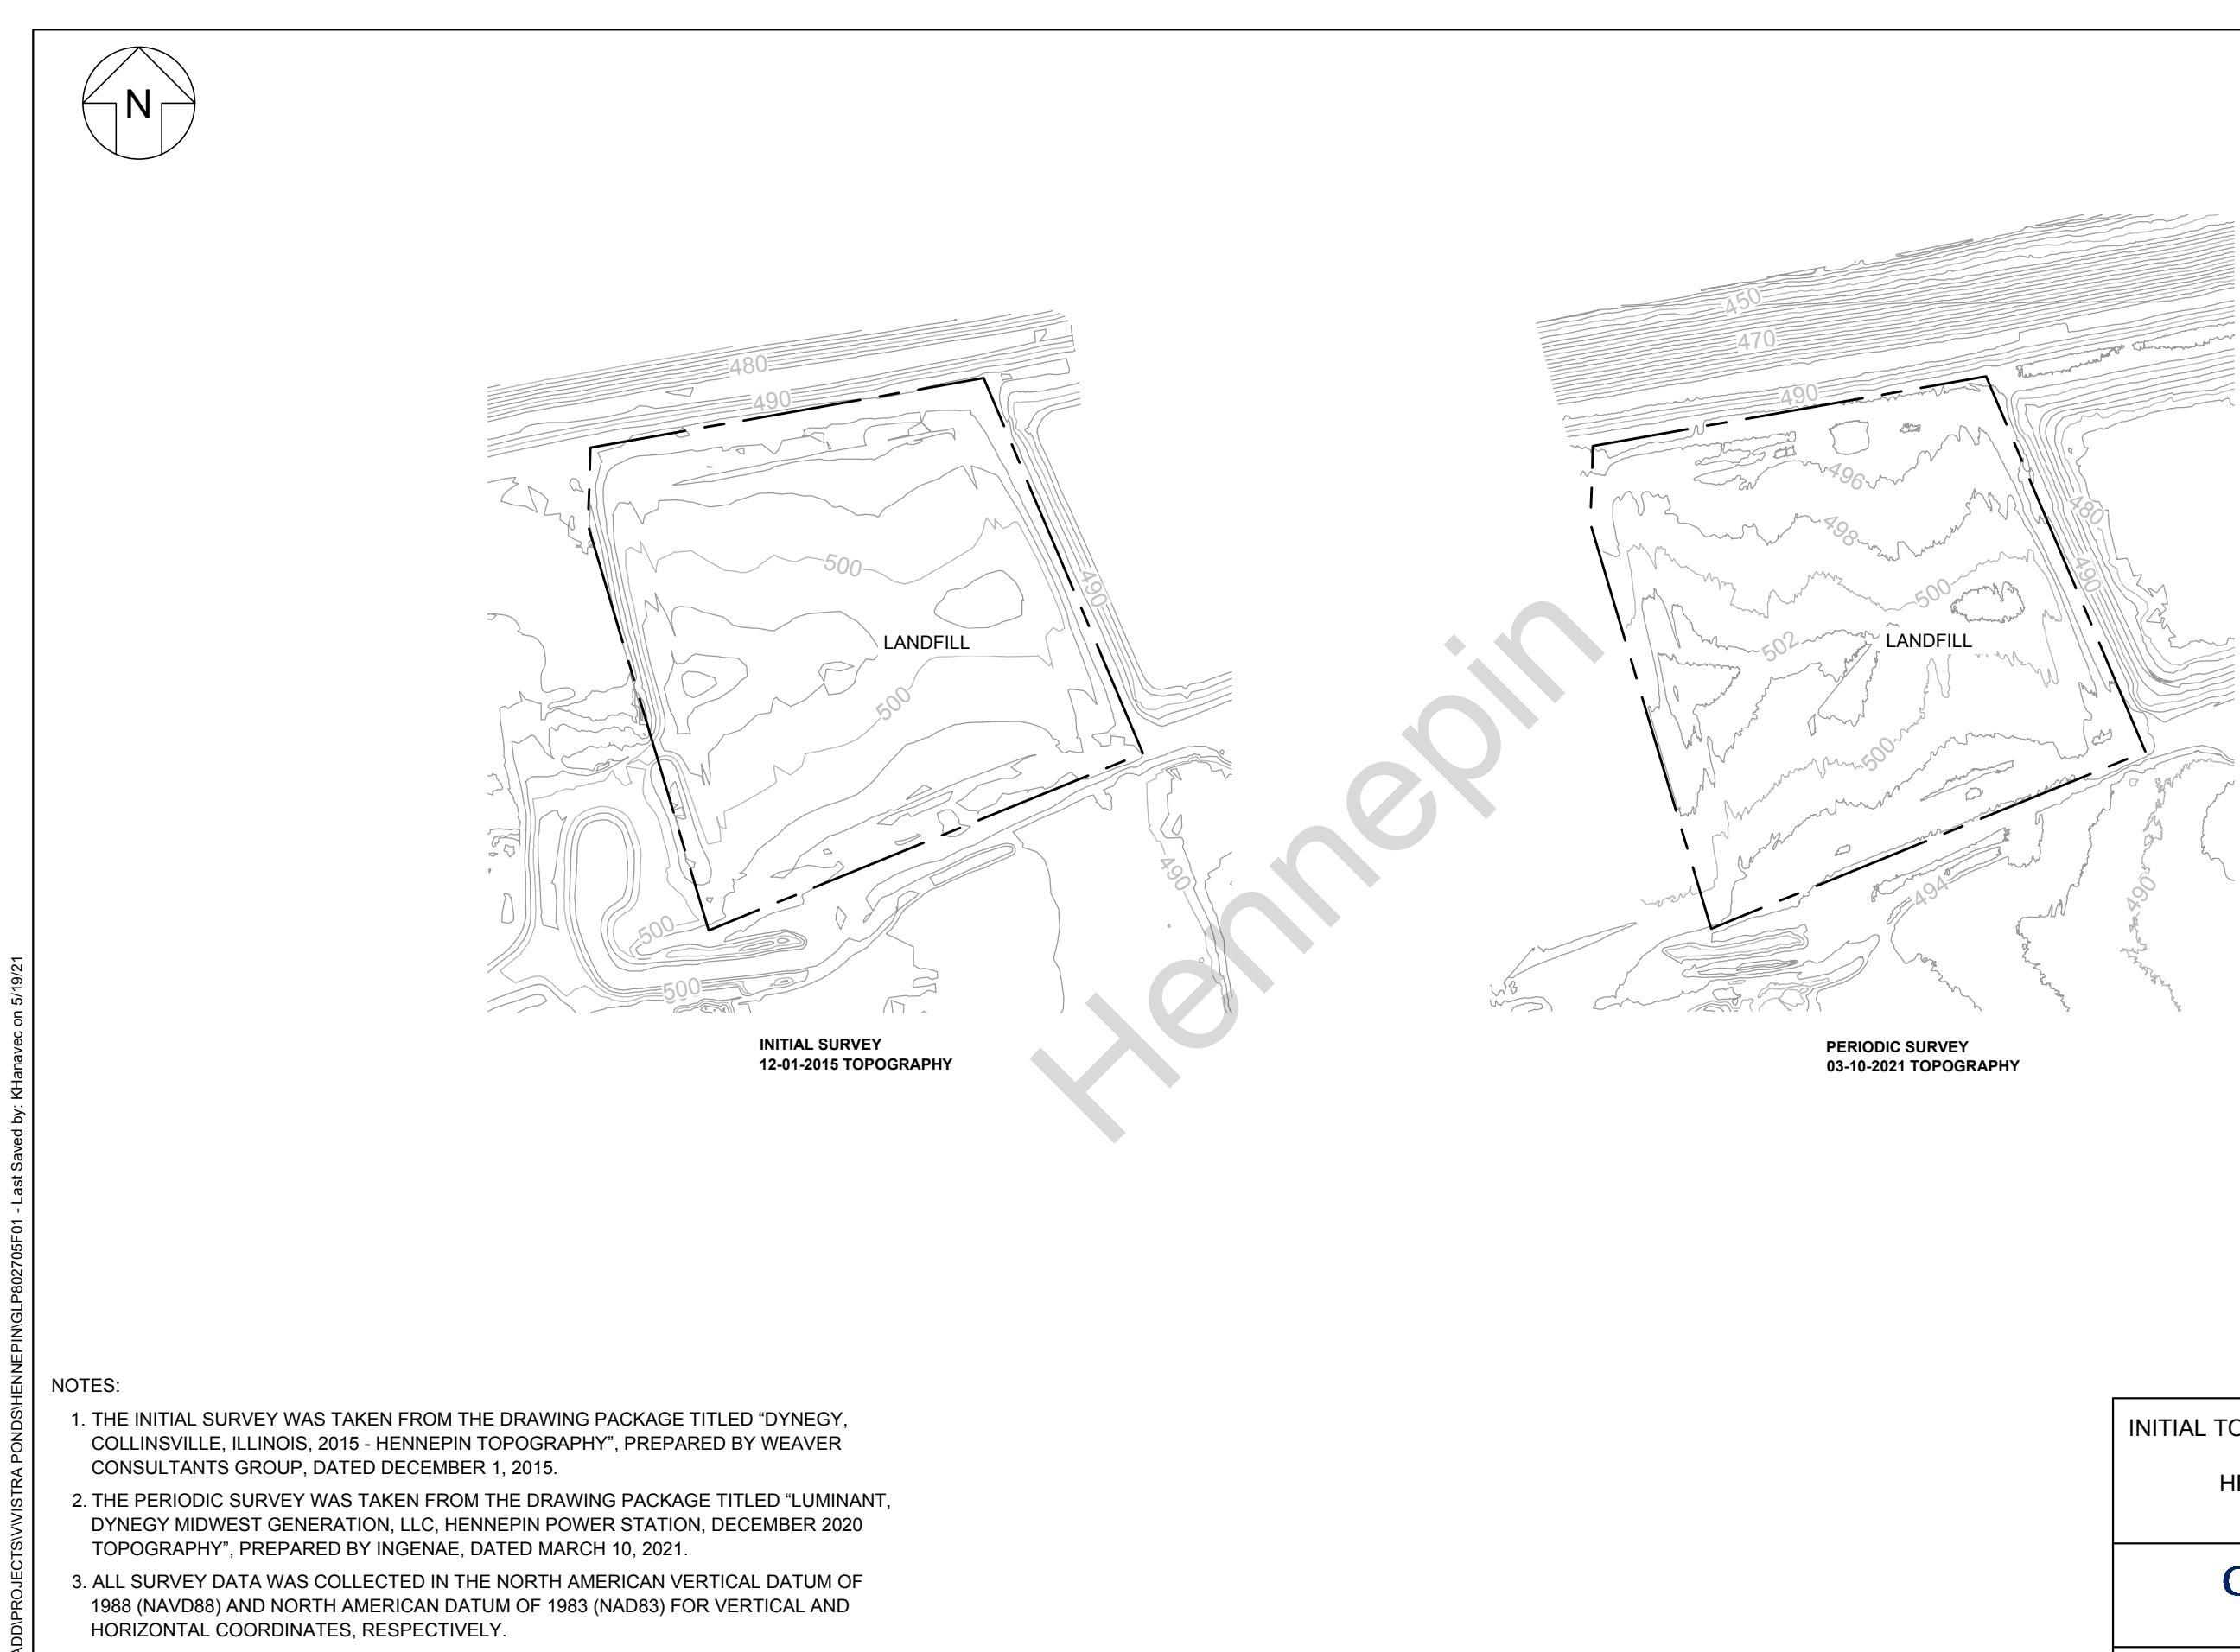
INITIAL TO PERIODIC SURVEY COMPARISON
LANDFILL
HENNEPIN POWER PLANT
HENNEPIN, ILLINOIS

The initial survey of the LF, conducted at the site by Weaver Consultants (Weaver) in 2015 [12], was compared to the periodic survey of the LF, conducted by IngenAE, LLC (IngenAE) in 2020 [13], using AutoCAD Civil3D 2021 software. This comparison was intended to quantify changes in the volume of CCR placed within the LF, evaluate potential changes in surface stormwater drainage around the LF, and evaluate if CCR may have been placed outside of the grades of the LF used for the existing run-on, run-off control plan [2]. This comparison is presented in a plan view side-by-side of the surveys in **Drawing 1** and an isopach map denoting changes in ground surface elevation in **Drawing 2**. A summary of the changes in CCR volumes is provided in **Table 2**.

The comparison indicated that there was approximately 2,300 CY less CCR in 2015 compared to 2021. However, no known waste was removed from the LF during this time, as indicated by the annual inspection reports ([4], [5], [6], [7], [8], [9]). Therefore, the apparent difference in CCR volumes may be due to differences in the survey data which was collected utilizing by different methods. Changes in surface grades in adjacent EAP#2 did occur, as EAP#2 was closed in 2020 [14], however stormwater flow within EAP#2 is directed away from the LF and is routed towards a series of ditches, channels, and downchutes within EAP#2 that drain away from the LF [14]. The comparison did not indicate that CCR had been placed outside the design grades of the LF [15].

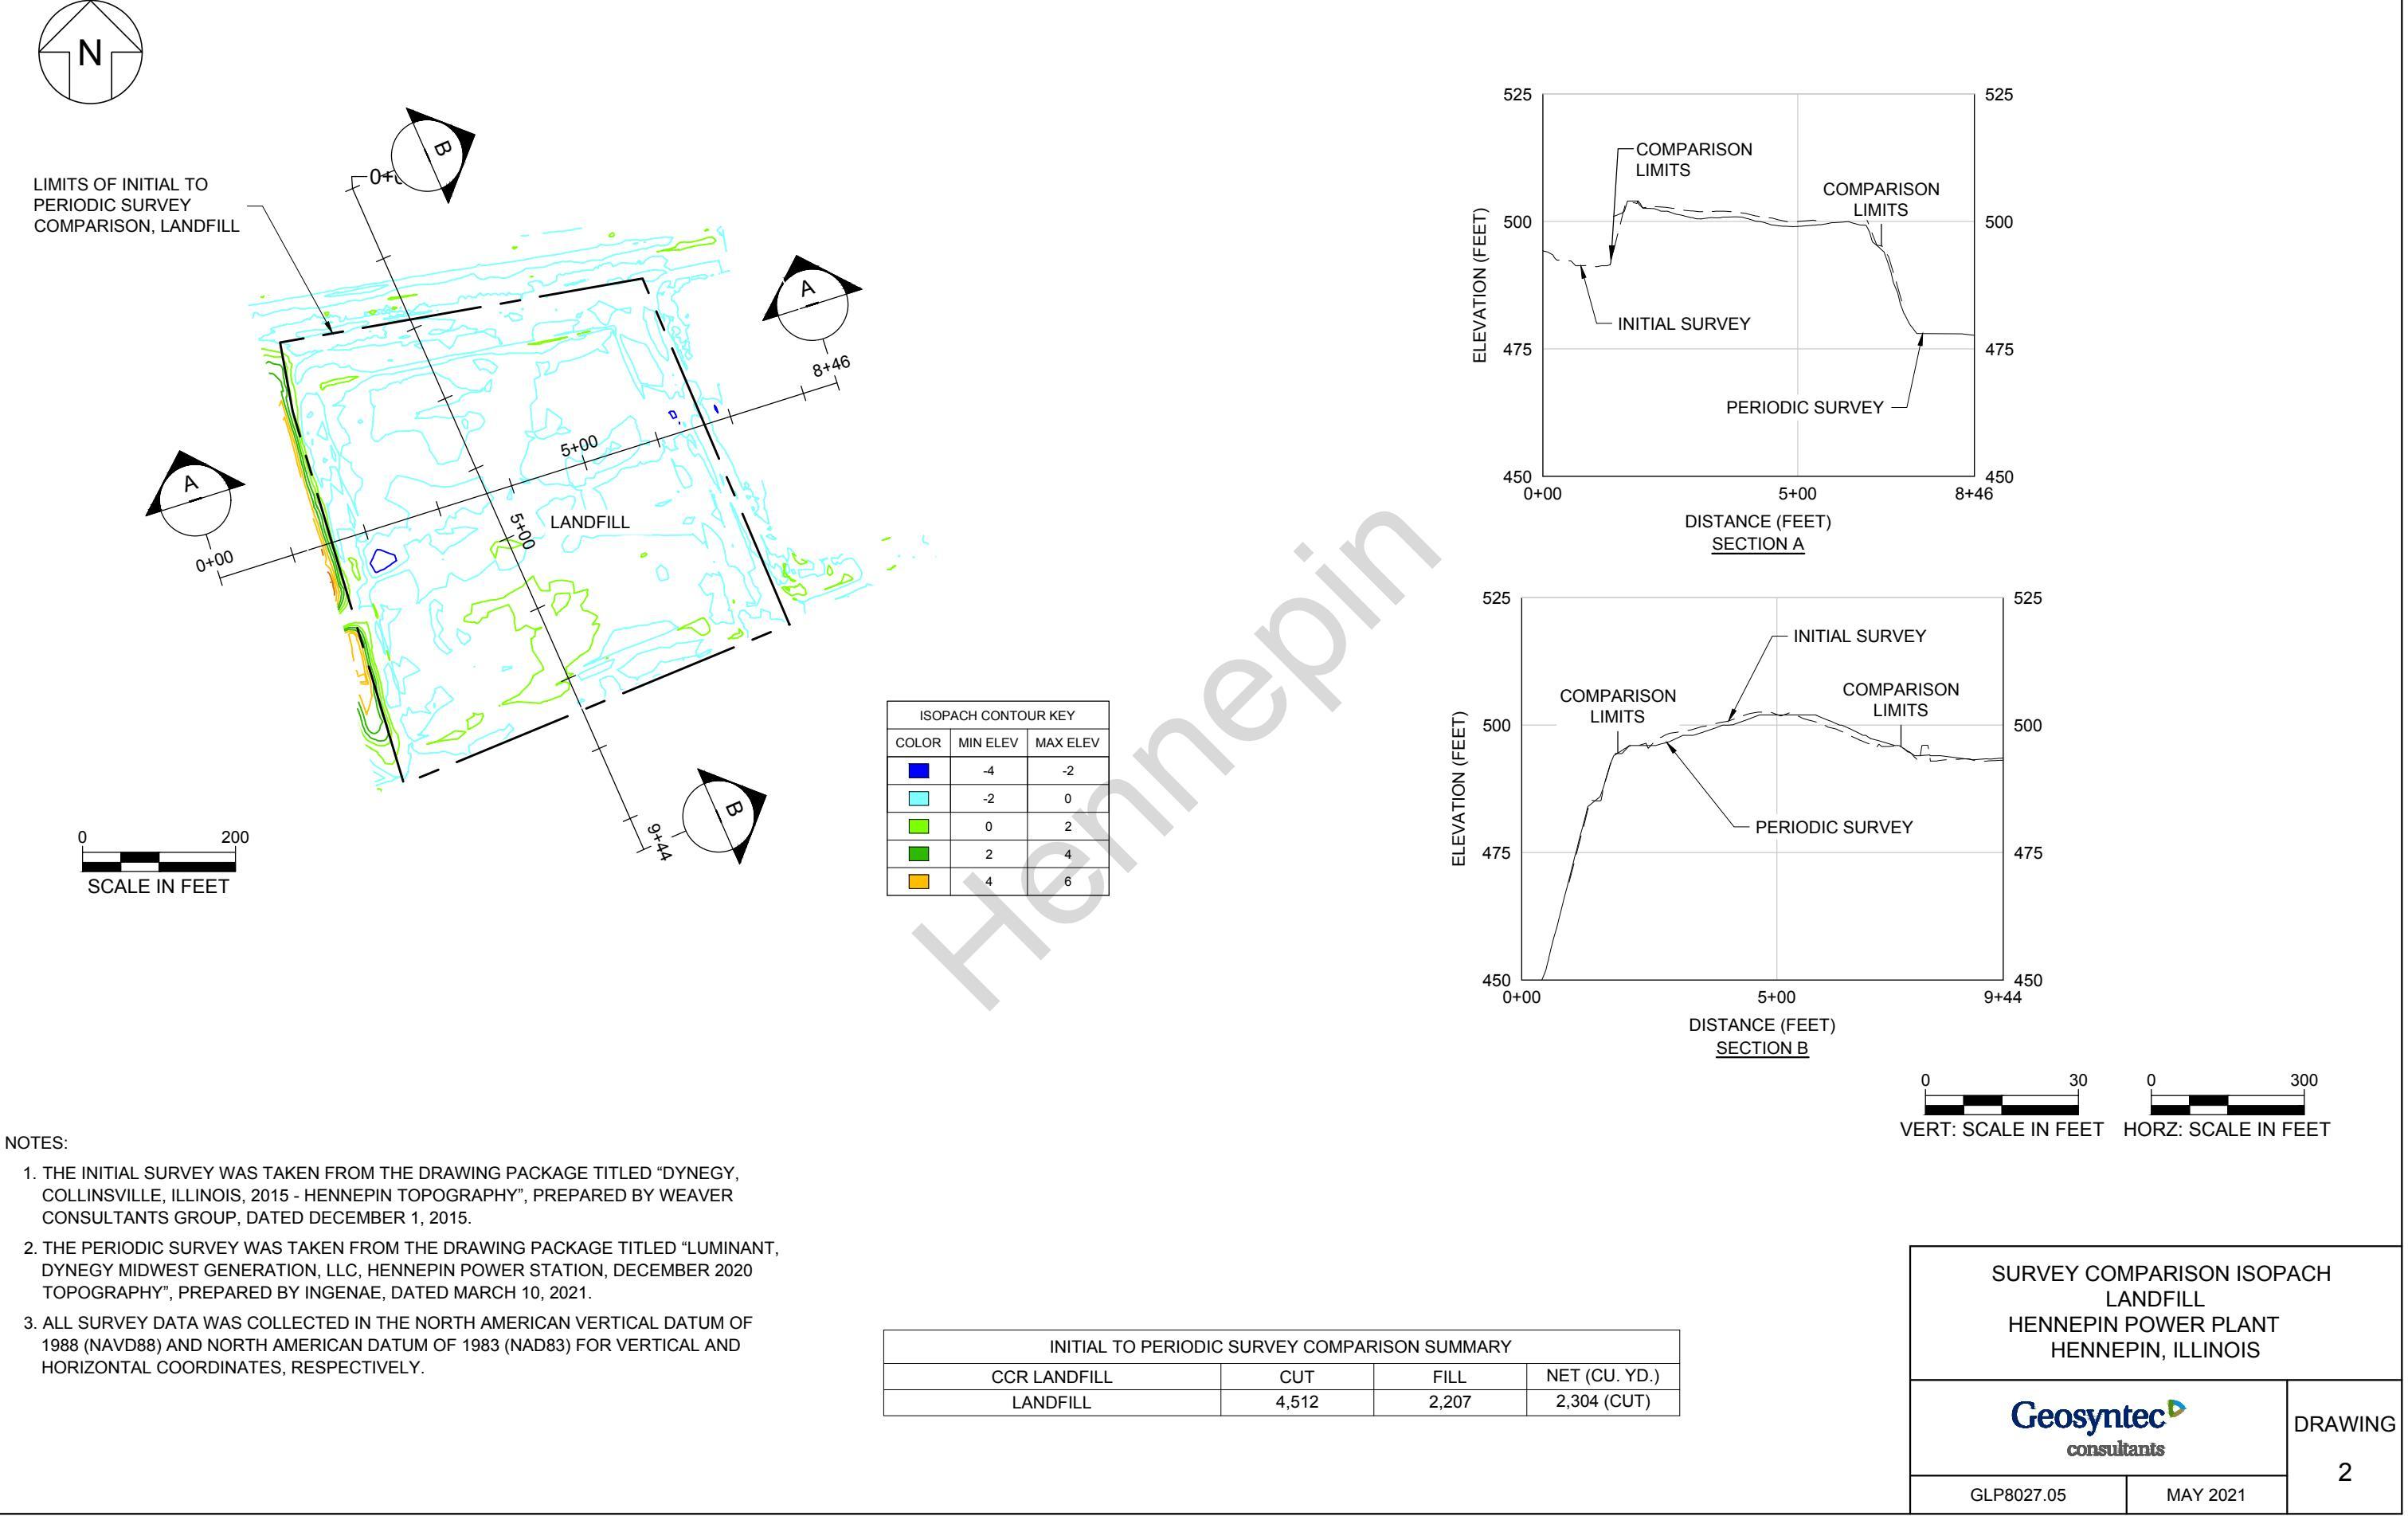
INITIAL TO PERIODIC SURVEY COMPARISON SUMMARY				
CCR LANDFILL	CUT	FILL	NET (CU. YD.)	
LANDFILL	4,512	2,207	2,304 (CUT)

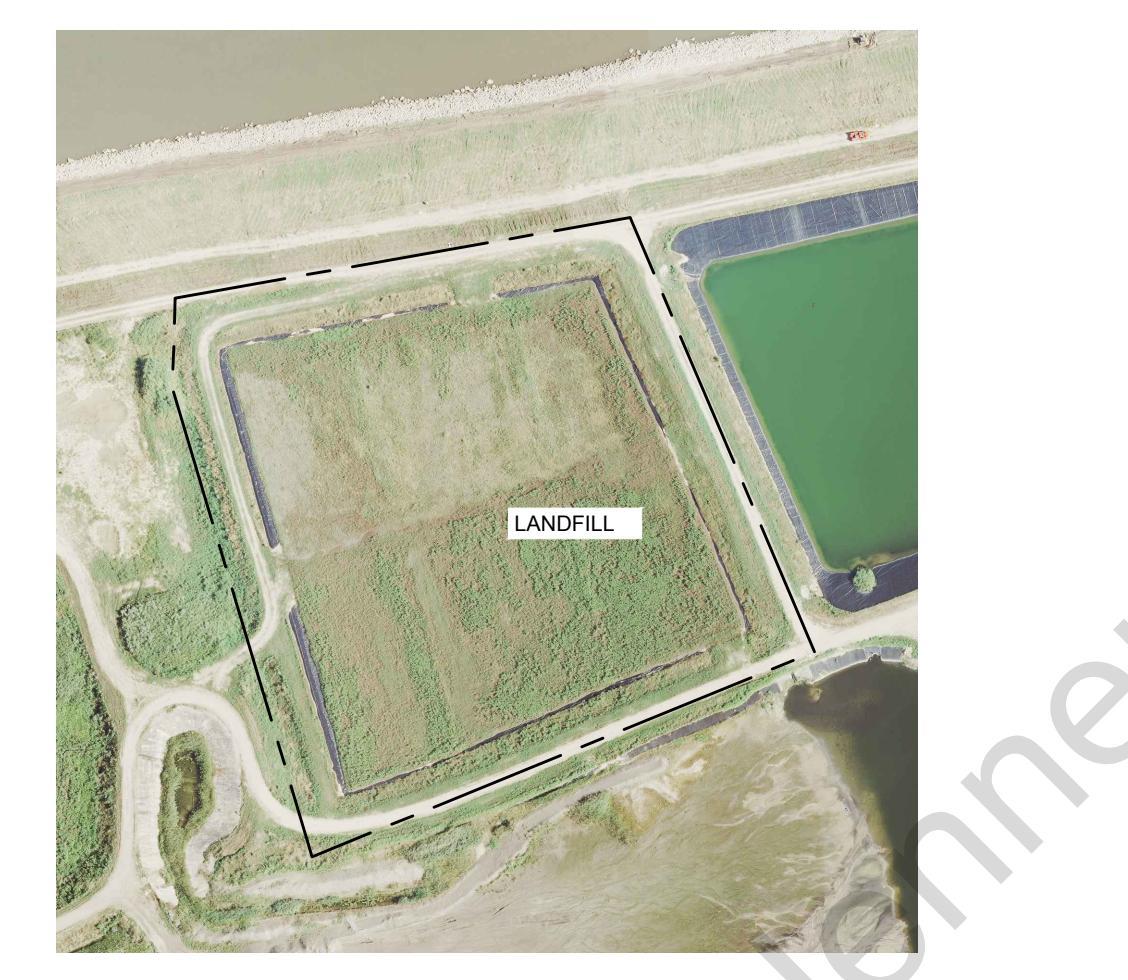
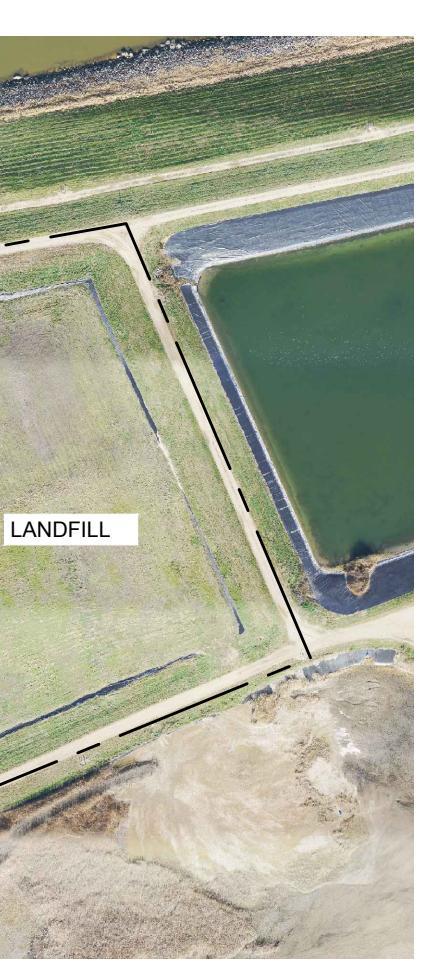
INITIAL TO PERIODIC AERIAL IMAGERY COMPARISON LANDFILL HENNEPIN POWER PLANT HENNEPIN, ILLINOIS Geosyntec[▶] DRAWING consultants 3

Initial aerial photographs of the LF collected by Weaver Consultants in 2015 [12] were compared to periodic aerial photographs collected by IngenAE, LLC in 2020 [13] to visually evaluate if potential site changes (i.e., construction of new ditches, changes in site operations, or changes to other appurtenances) may have occurred between 2015 and 2020. A comparison of these aerial photographs is provided in **Drawing 3**, and the following changes were identified:

- Adjacent CCR surface impoundments, including EAP#2 and EAP#4, were closed. This included tying in the final cover system of EAP#2 into the bottom liner of the LF and constructing a new gravel access road along the western side of the LF.
 - These changes are not expected to affect run-on, run-off control at the LF as they occurred outside of the perimeter ditches and these other CCR surface impoundments drain away from the LF [14].

INITIAL AERIAL 12-01-2015 IMAGERY PERIODIC AERIAL 03-10-2021 IMAGERY

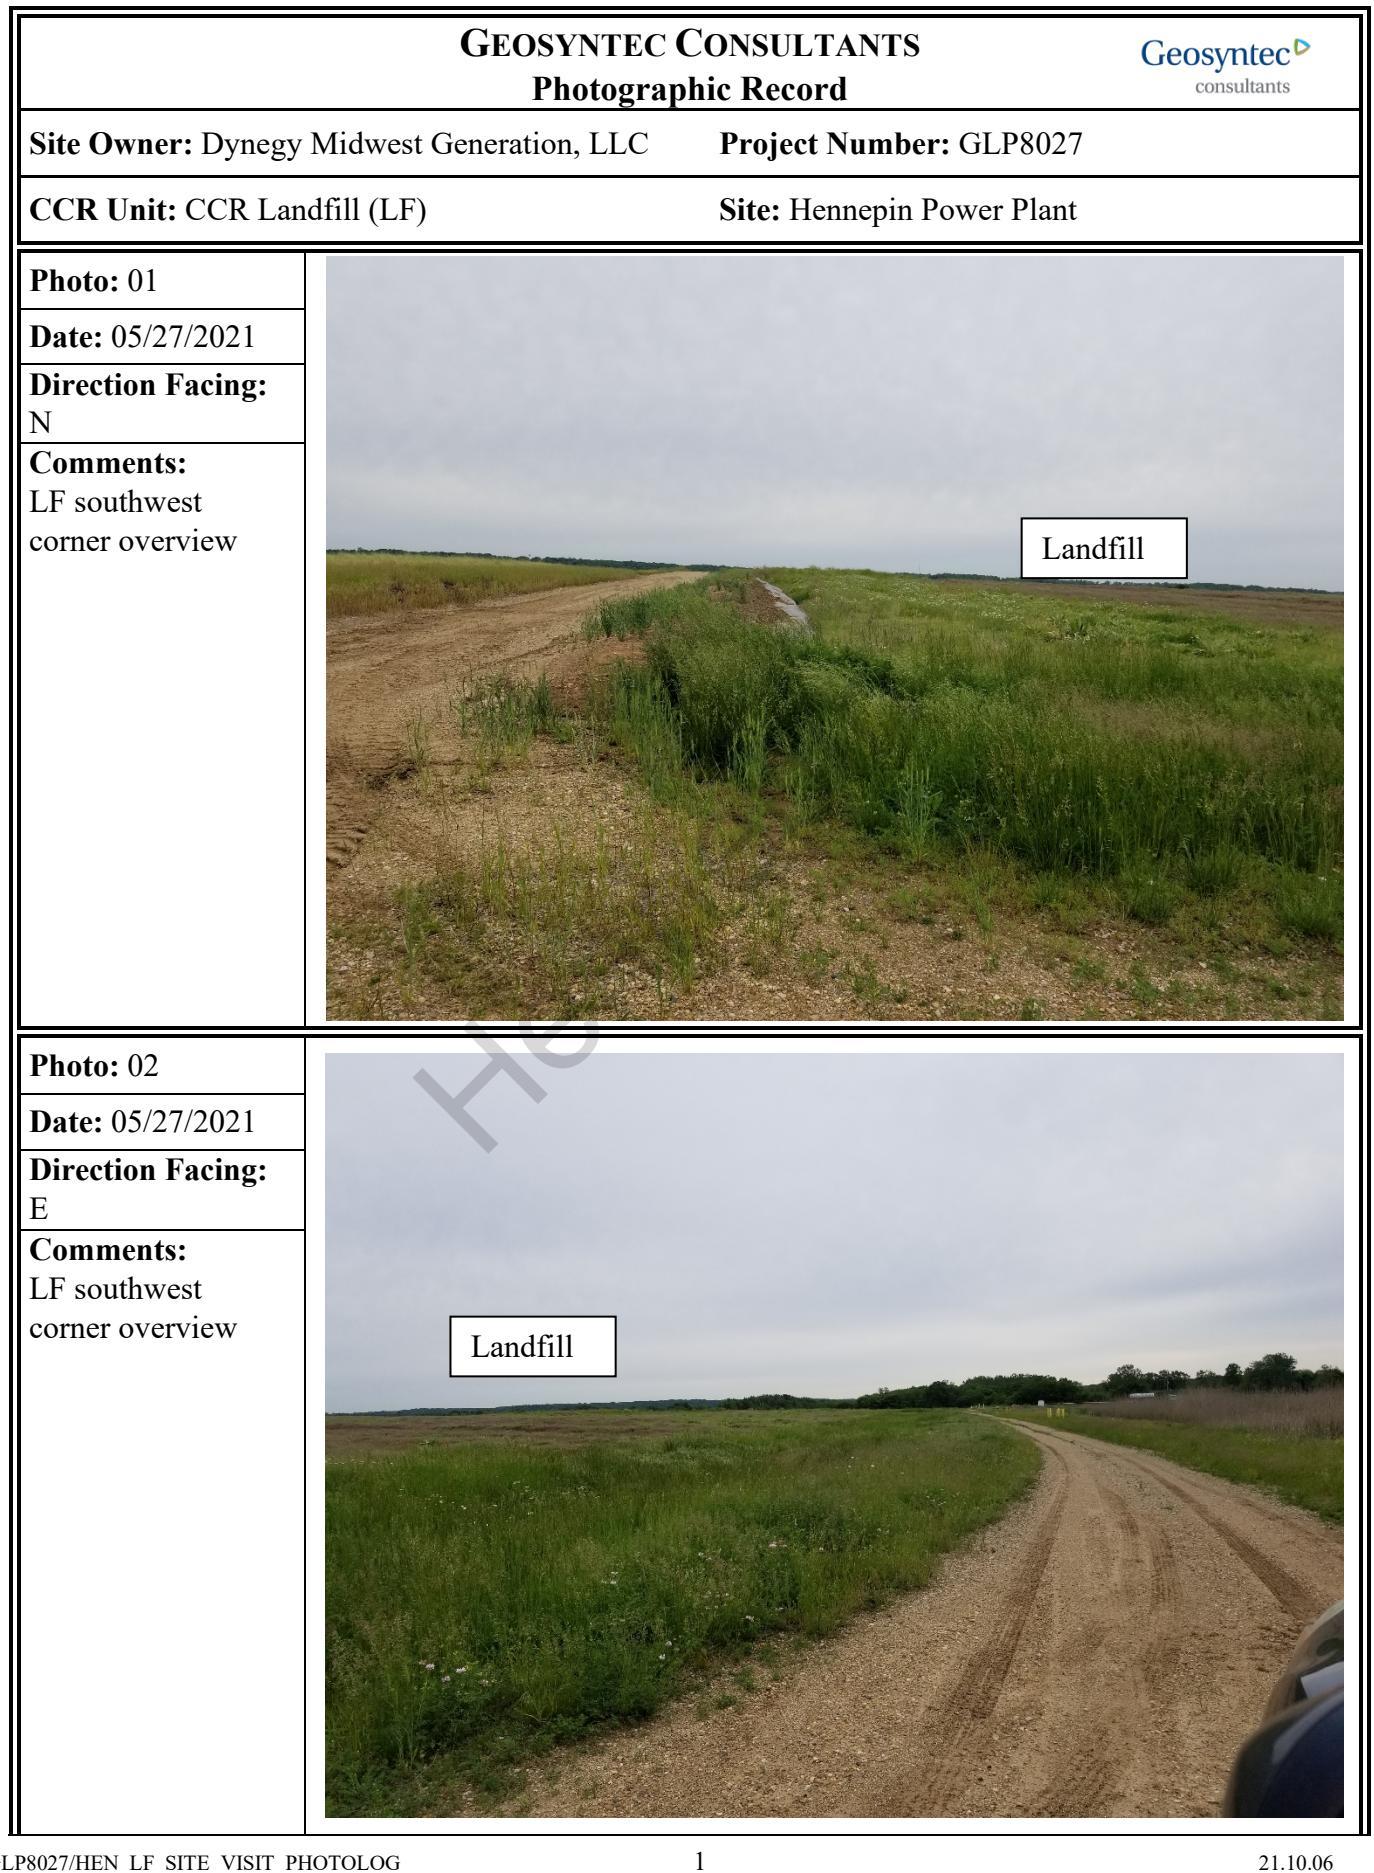
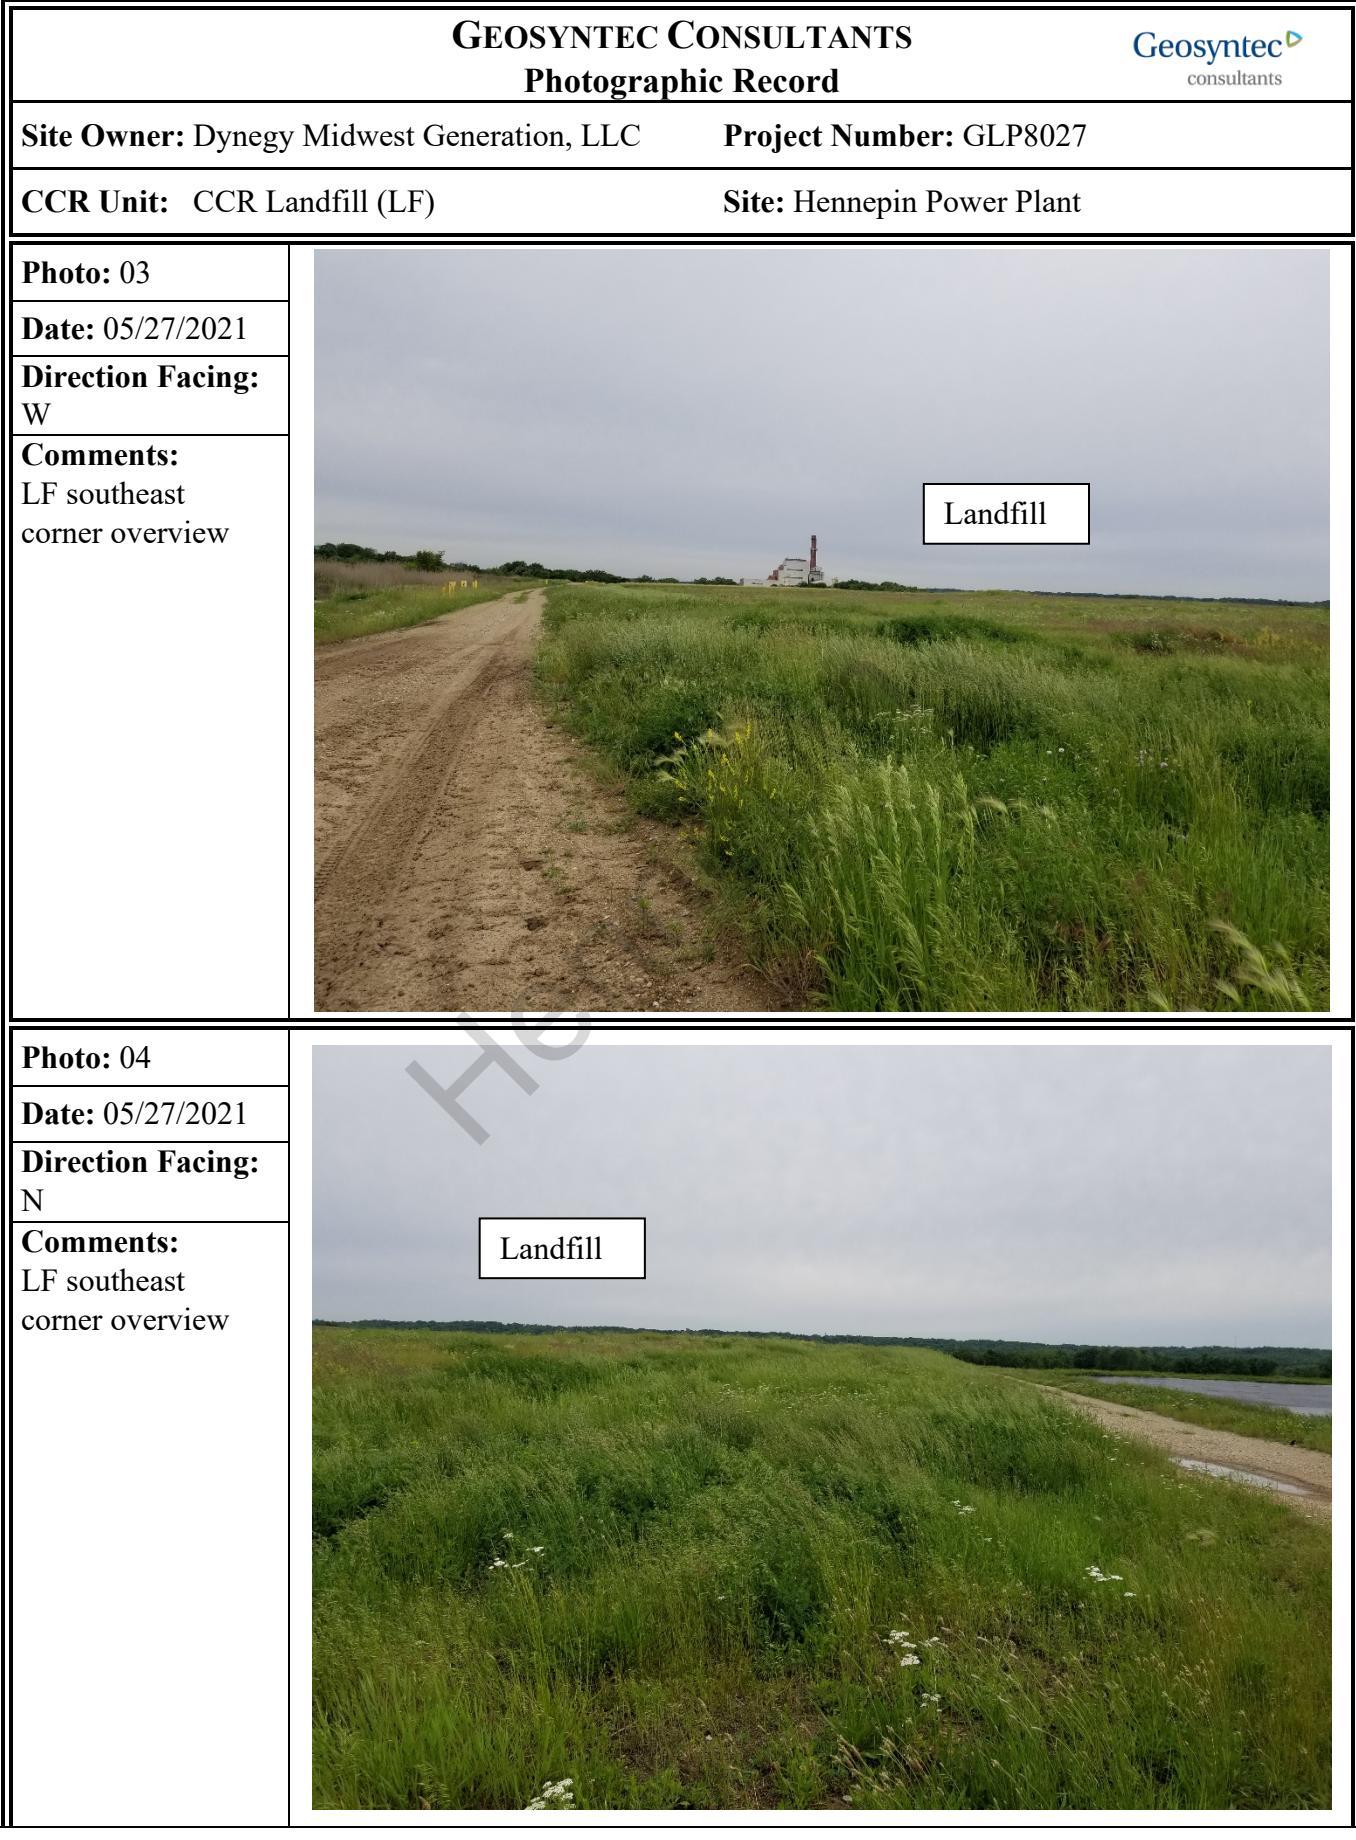
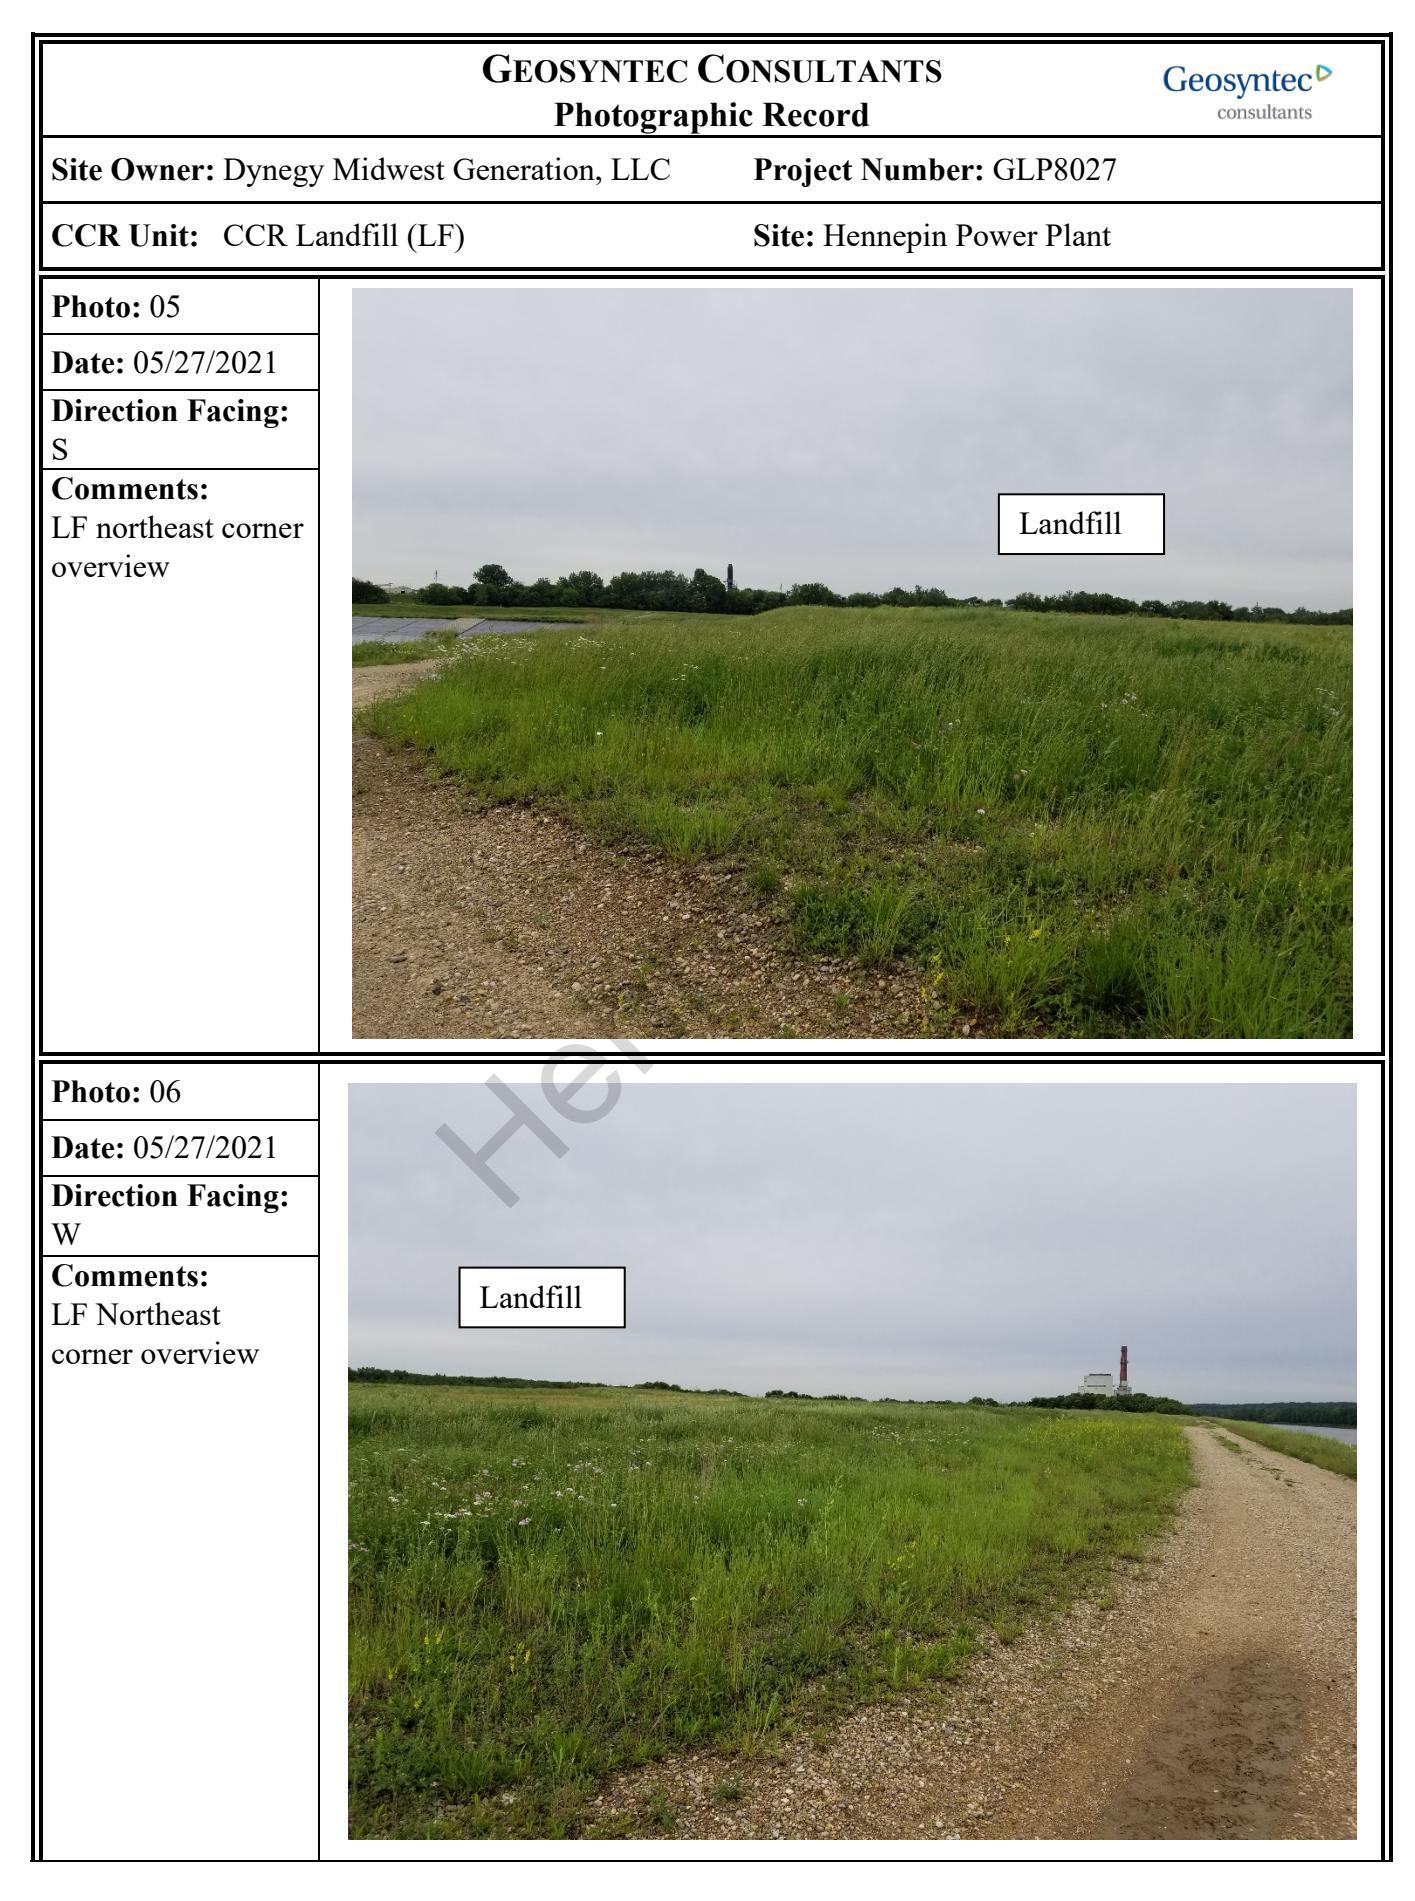
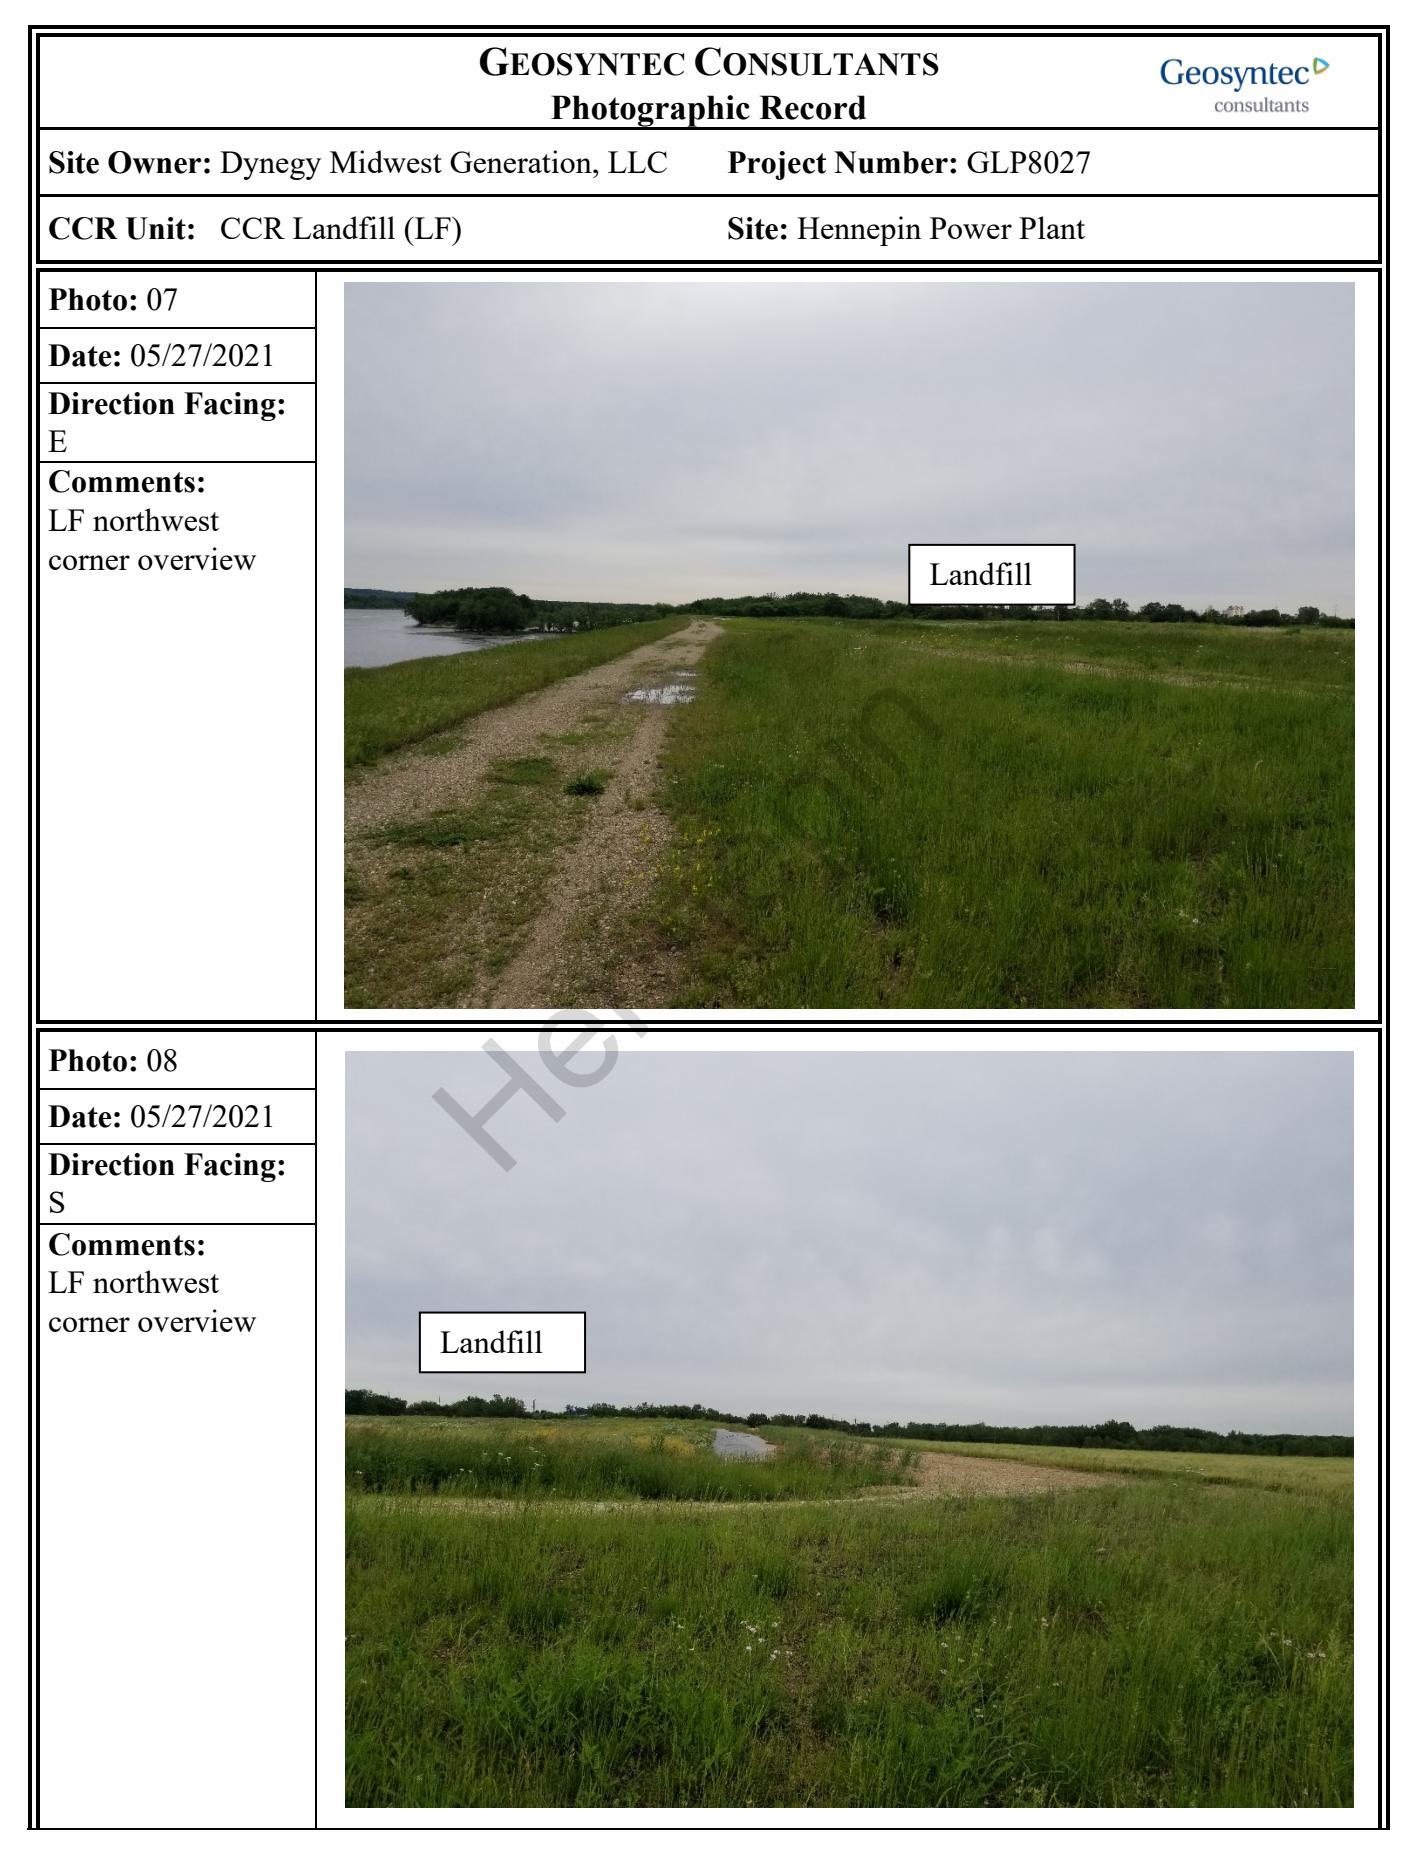
LF Site Visit Photolog

An initial site visit to the LF was conducted by AECOM in 2015 and documented in a Site Visit Summary and corresponding photographs [16]. A periodic site visit was conducted by Geosyntec on May 27, 2021, with Mr. Lucas P. Carr, P.E. conducting the site visit. The site visit was intended to evaluate potential changes at the site since development of the initial run-on and run-off control plan [2] (i.e., modifications to stormwater drainage system(s), modifications to adjacent structures that may route run-on towards the landfill), in addition to performing visual observations of the LF and surrounding area to evaluate if potential maintenance to existing run-on and run-off control systems were required. The site visit is documented in a photographic log provided in **Appendix A**. A summary of significant findings from the site visit is provided below:

- Overall site maintenance appeared similar to conditions in 2015 and no changes to the LF were observed.
- Closures were completed for adjacent CCR surface impoundments EAP#2 and EAP#4, These changes are not expected to affect run-on, run-off control at the LF as they occurred outside of the perimeter ditches and these other CCR surface impoundments drain away from the LF [14].
